Method of Condition Survey

Project	Restoration Works of Lee Mansion at DD54 Lots 258, 262, 263 and 393, Kuk Po, Sha
	Tau Kok, N.T.
Location	Lee Mansion at DD54 Lots 258, 262, 263 and 393, Kuk Po, Sha Tau Kok, N.T.
Surveyed	All purlins (The area observed on the bottom is marked as P with purlin number. The

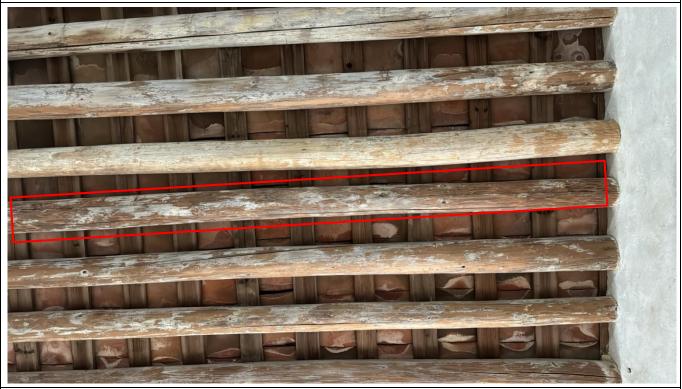
Purlins Photo of Defects R Location P29 Length 2750 Width <5

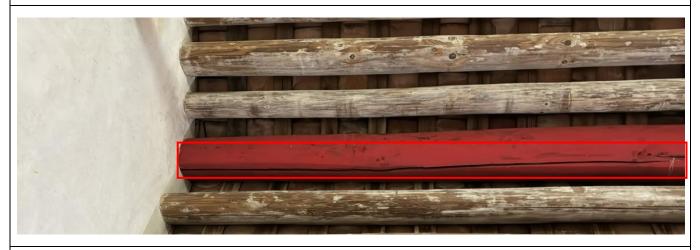
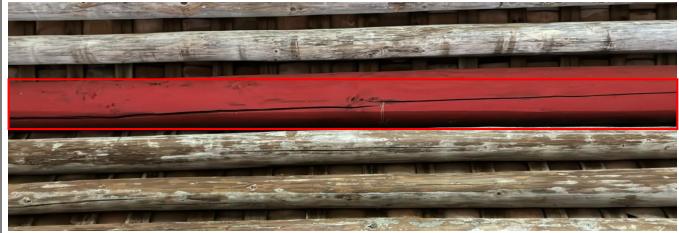
Area M Location P35 Length 3250 mm Width <5 mm

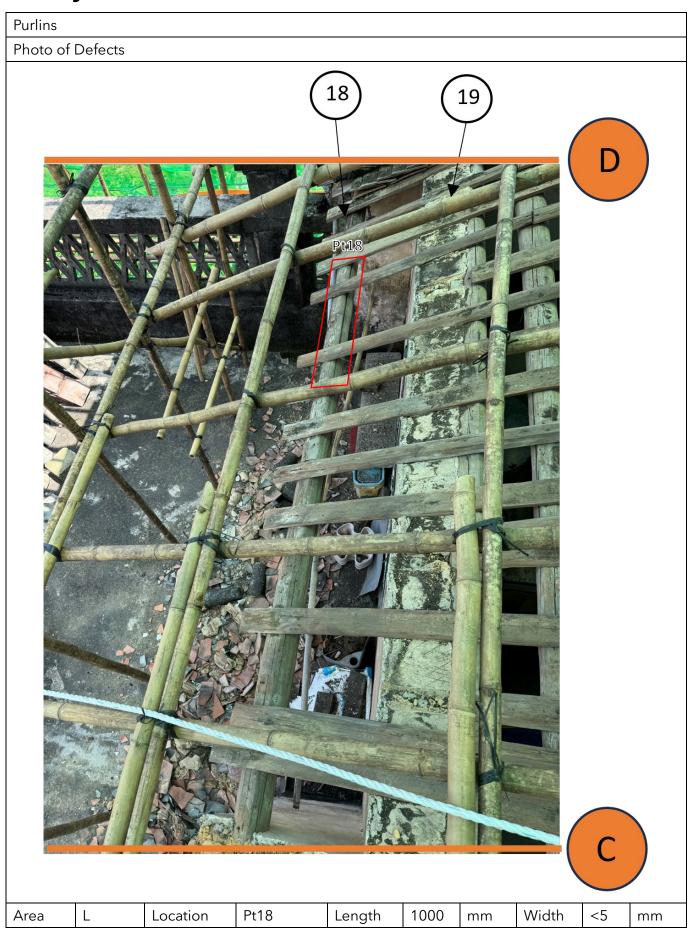
Remarks: Insect bites are found on L-P18, replacement of the purlin R-P18 is proposed as there is potential risk.

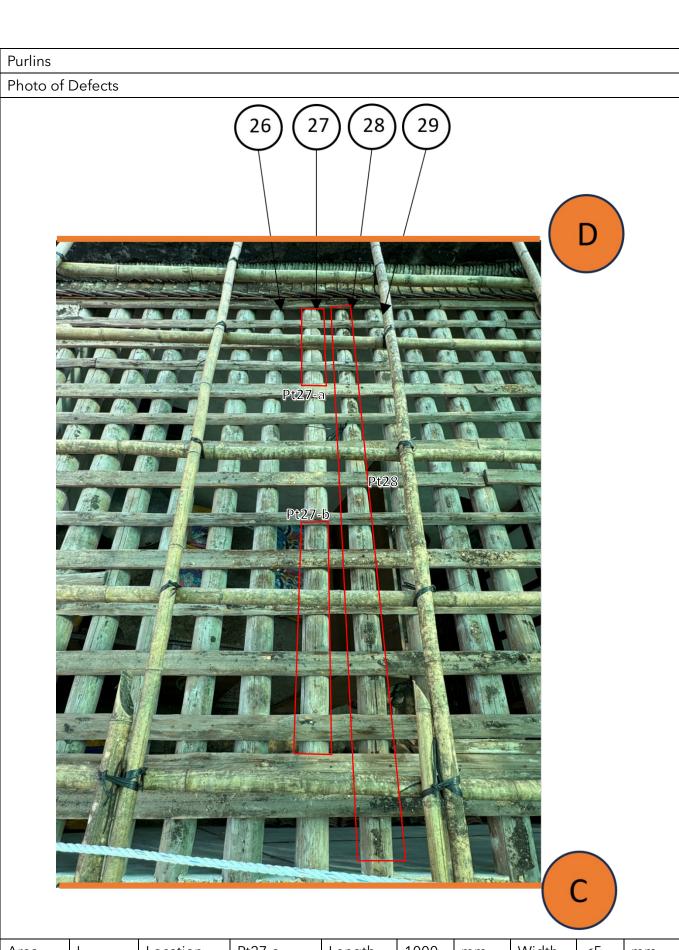
Area	L	Location	Pt27-a	Length	1000	mm	Width	<5	mm
Area	L	Location	Pt27-b	Length	1100	mm	Width	<5	mm
Area	L	Location	Pt28	Length	3500	mm	Width	<5	mm

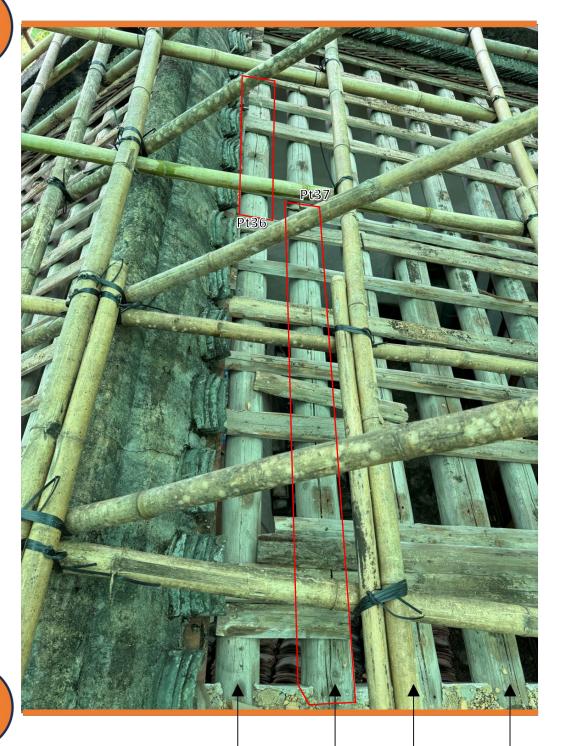
Area	L	Location	Pt36	Length	1000	mm	Width	<5	mm
Area	L	Location	Pt37	Length	2000	mm	Width	<5	mm

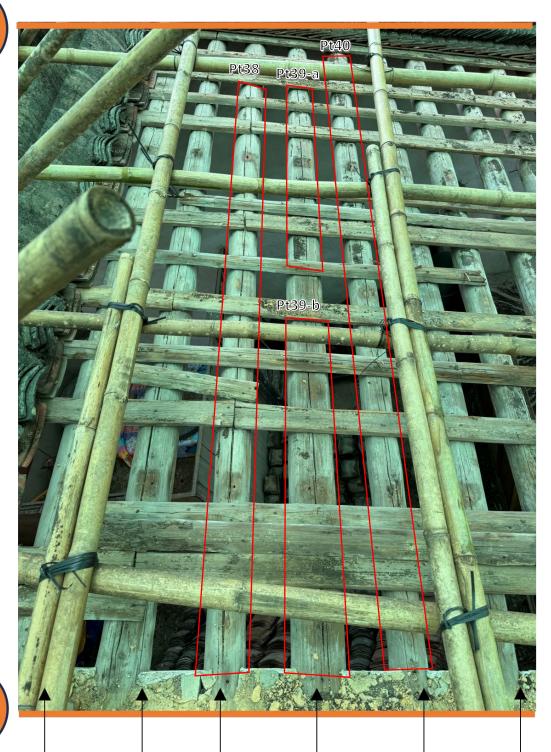
Area	L	Location	Pt38	Length	3250	mm	Width	<5	mm
Area	L	Location	Pt39-a	Length	1250	mm	Width	<5	mm
Area	L	Location	Pt39-b	Length	1250	mm	Width	<5	mm
Area	L	Location	Pt40	Length	3500	mm	Width	<5	mm

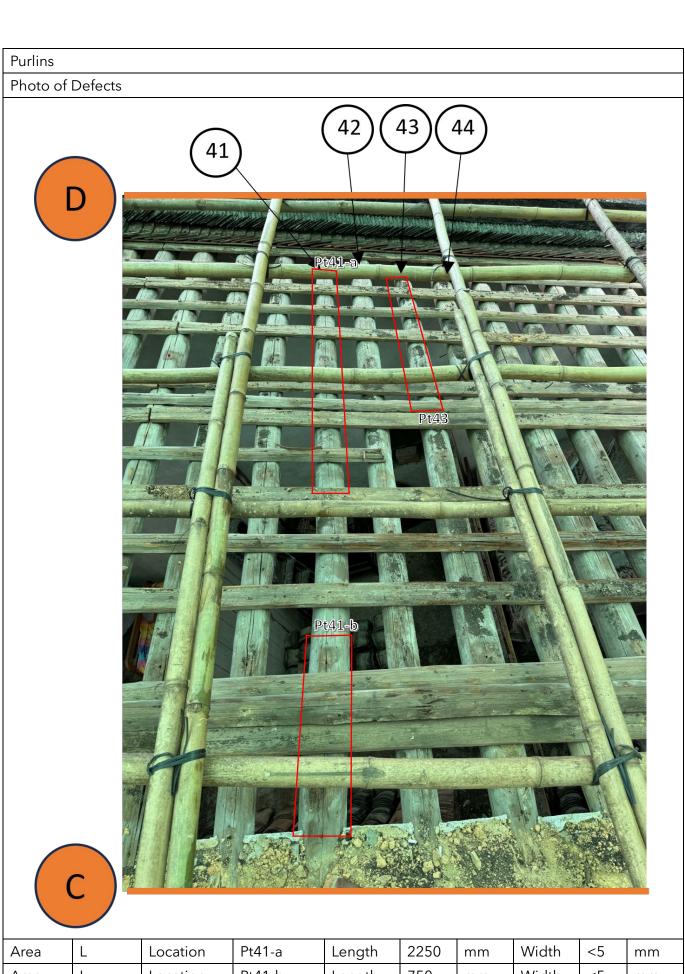
Area	L	Location	Pt41-a	Length	2250	mm	Width	<5	mm
Area	L	Location	Pt41-b	Length	750	mm	Width	<5	mm
Area	L	Location	Pt43	Length	1250	mm	Width	<5	mm

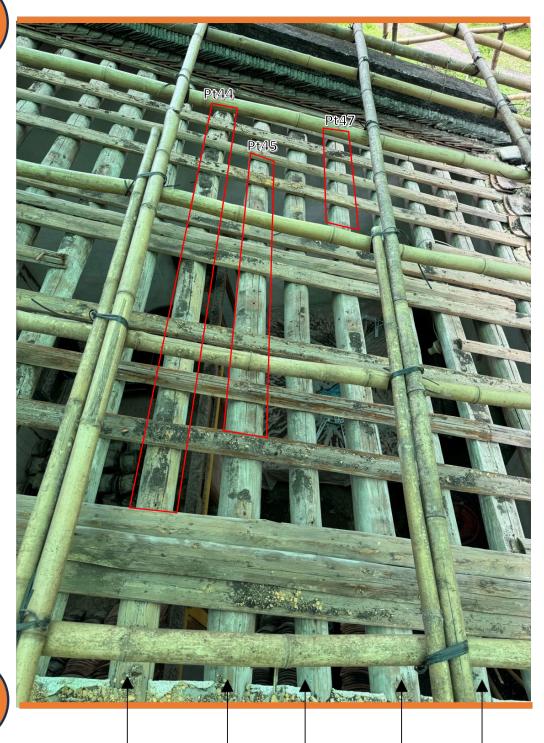
Area	L	Location	Pt44	Length	2500	mm	Width	<5	mm
Area	L	Location	Pt45	Length	2000	mm	Width	<5	mm
Area	L	Location	Pt47	Length	1000	mm	Width	<5	mm

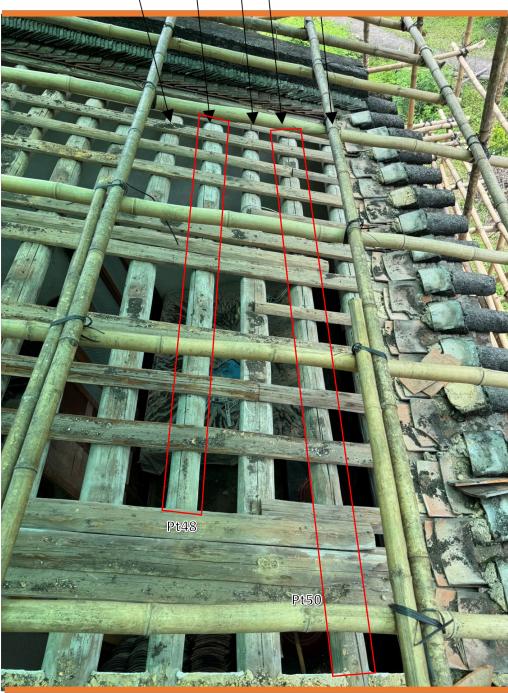
Area	L	Location	Pt48	Length	3000	mm	Width	<5	mm
Area	L	Location	Pt50	Length	3500	mm	Width	<5	mm

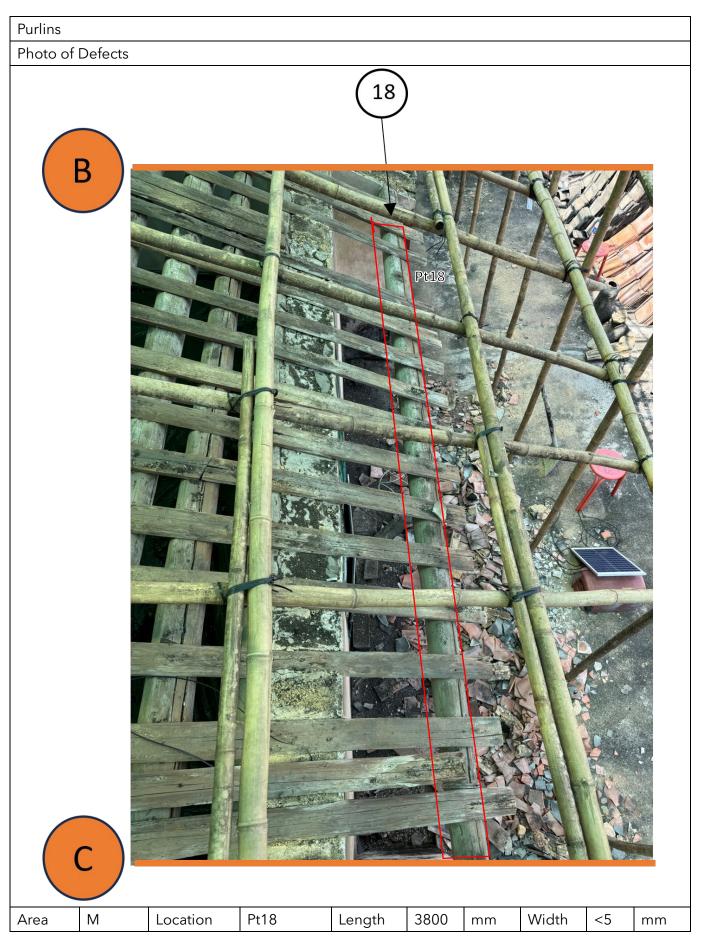
Remarks: Insect bites are found on R-P18, replacement of the purlin M-P18 is proposed as there is potential risk.

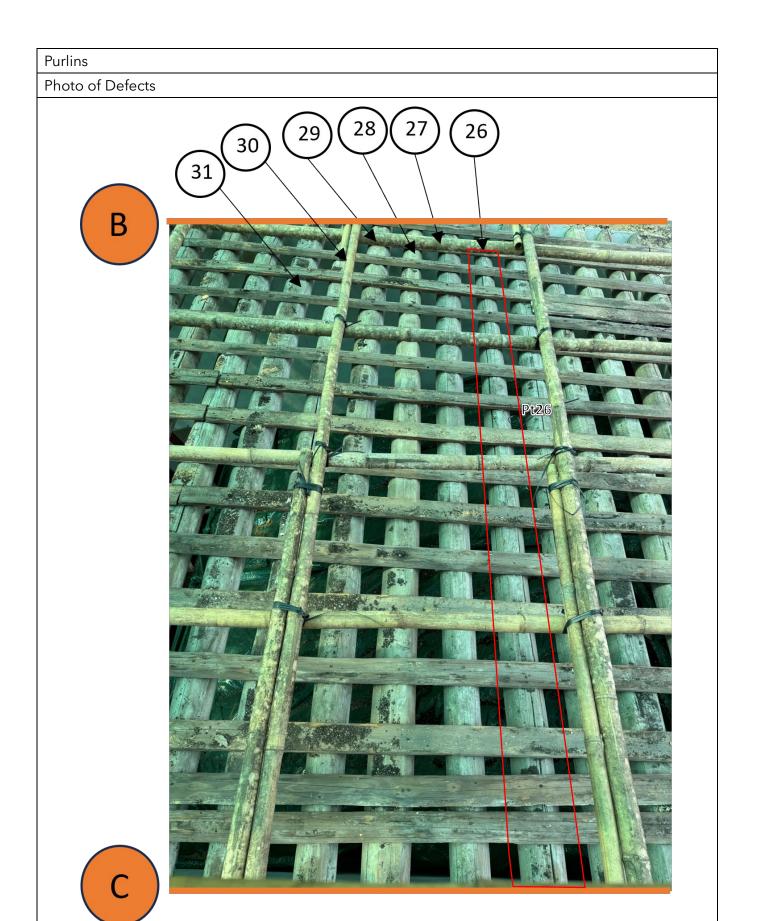
Area M Location Pt26 Length 3800 mm Width <5 mm

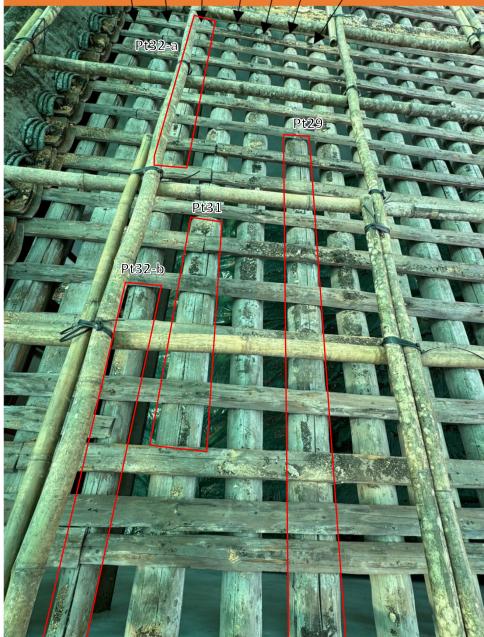
Area	М	Location	Pt29	Length	2500	mm	Width	<5	mm
Area	М	Location	Pt31	Length	1000	mm	Width	<5	mm
Area	М	Location	Pt32-a	Length	2000	mm	Width	<5	mm
Area	М	Location	Pt32-b	Length	1500	mm	Width	<5	mm

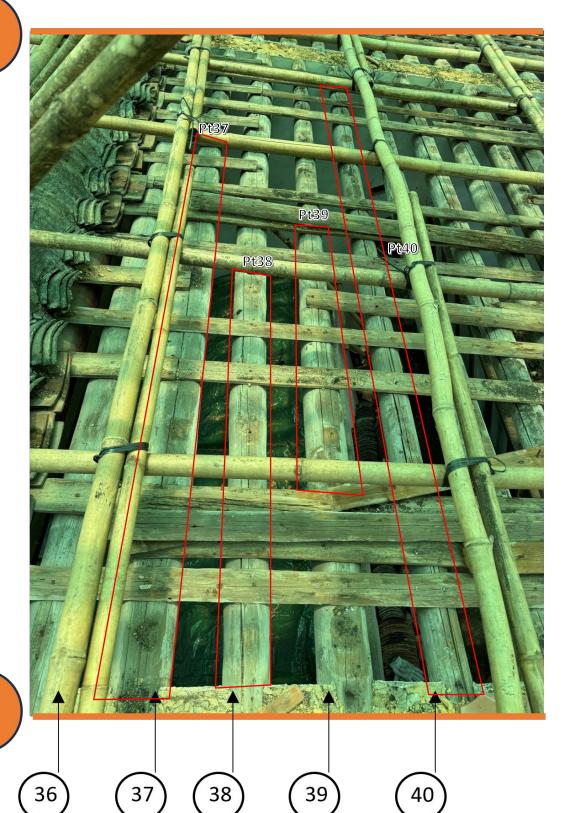
Area	М	Location	Pt37	Length	3000	mm	Width	<5	mm
Area	М	Location	Pt38	Length	1500	mm	Width	<5	mm
Area	М	Location	Pt39	Length	1250	mm	Width	<5	mm
Area	М	Location	Pt40	Length	3800	mm	Width	<5	mm

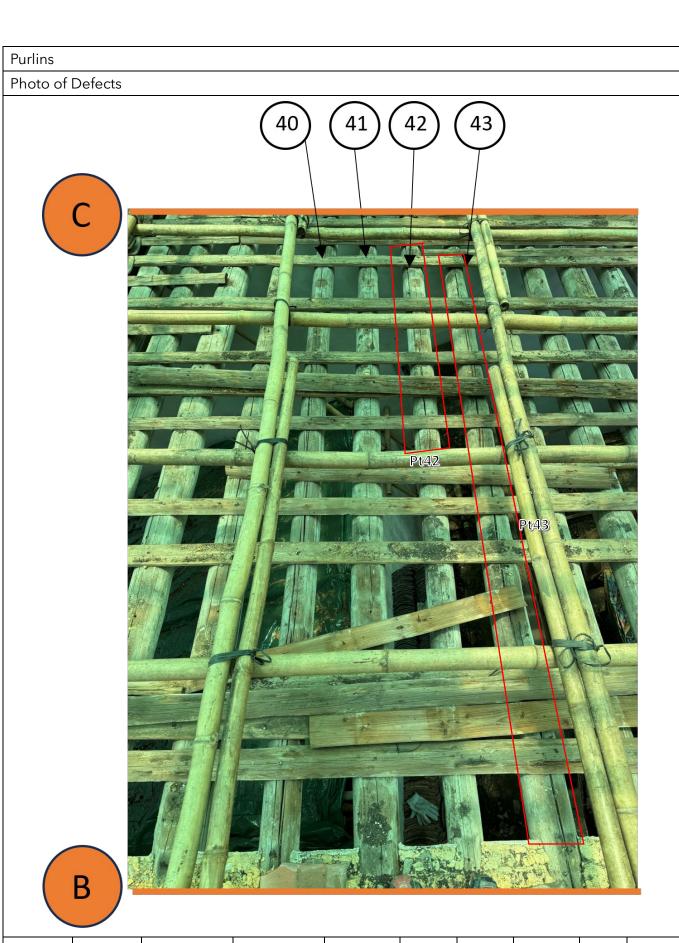
Area	М	Location	Pt42	Length	1250	mm	Width	<5	mm
Area	М	Location	Pt43	Length	3800	mm	Width	<5	mm

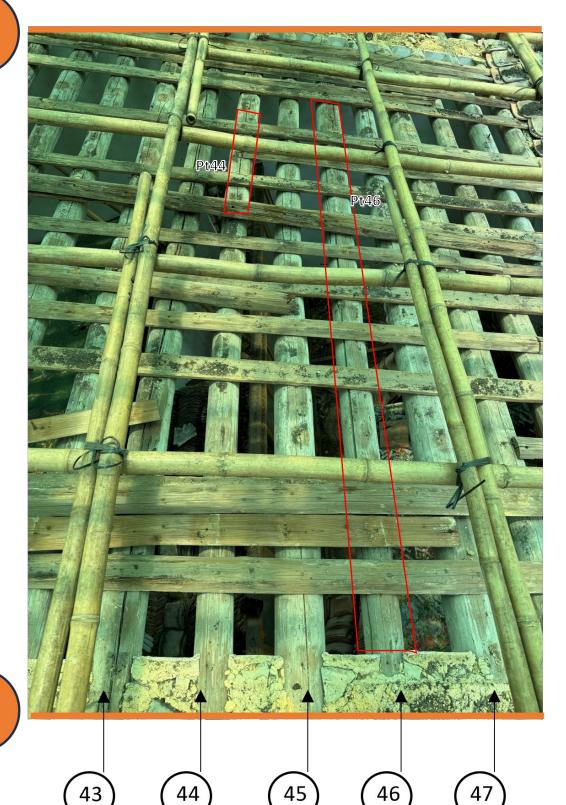
Μ Pt44 500 Width <5 Location Length Area mm $\mathsf{m}\mathsf{m}$ Length Width Μ Pt46 3800 <5 Area Location mm mm

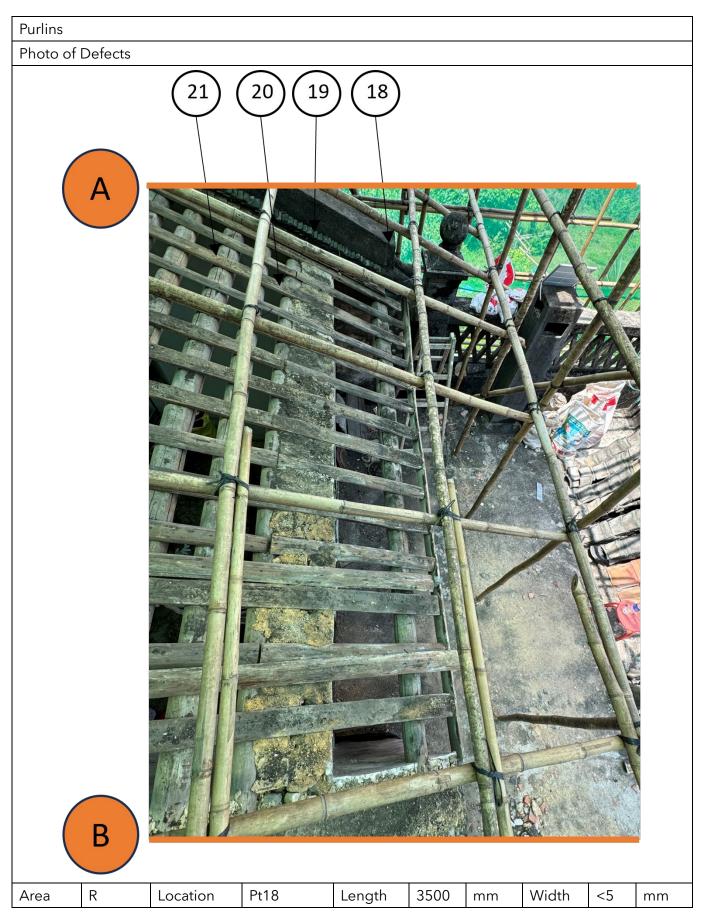
Remarks: Insect bites are found on R-P18, replacement of the purlin R-P18 is proposed as there is potential risk.

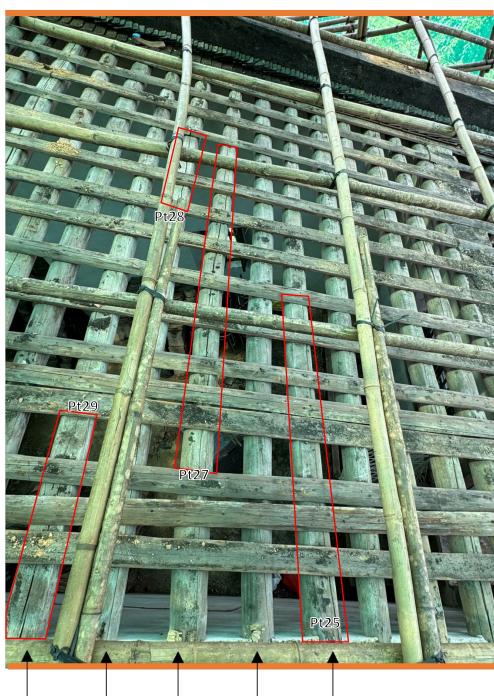
Area	R	Location	Pt25	Length	1500	mm	Width	<5	mm
Area	R	Location	Pt27	Length	2250	mm	Width	<5	mm
Area	R	Location	Pt28	Length	750	mm	Width	<5	mm
Area	R	Location	Pt29	Length	750	mm	Width	<5	mm

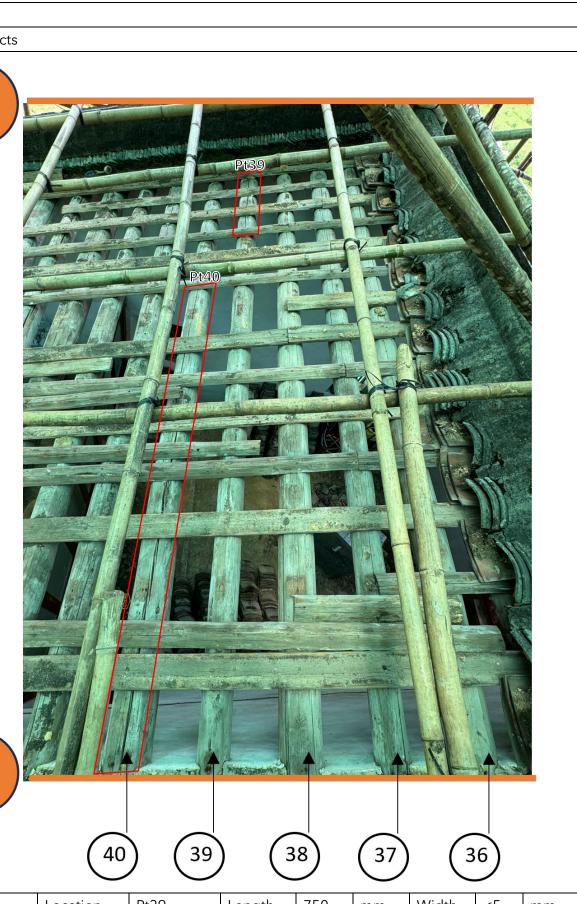
Area	R	Location	Pt39	Length	750	mm	Width	<5	mm
Area	R	Location	Pt40	Length	2250	mm	Width	<5	mm

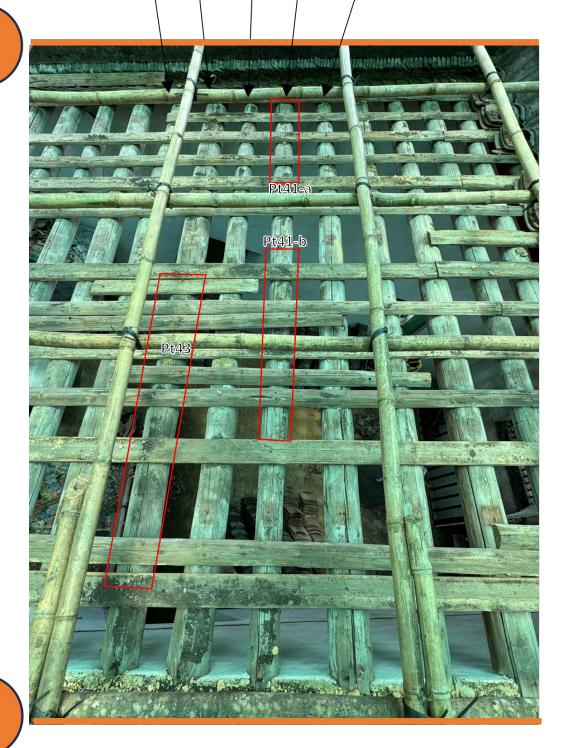
Area	R	Location	Pt41-a	Length	1000	mm	Width	<5	mm
Area	R	Location	Pt41-b	Length	1000	mm	Width	<5	mm
Area	R	Location	Pt43	Length	1000	mm	Width	<5	mm
