1.1	Project title	From Valley to Plain: Conservation and Revitalisation from 'Ng To' to Kuk Po river and plain via multi-disciplinary, educational and action research

1.3	Premise owner	Mr. Yeung Yuk Feng (楊玉峰), Owner of No. 41 (DD54 Lot 1358) Mr. Yeung Kwong Wah (楊廣華), Owner of No. 43 (DD54 Lot 1359, 1360)	
1.4	Location	No. 41 and 43, Ng To, Kuk Po, Luk Keng, N.T.	Fig. 1

EXISTING CONDITION

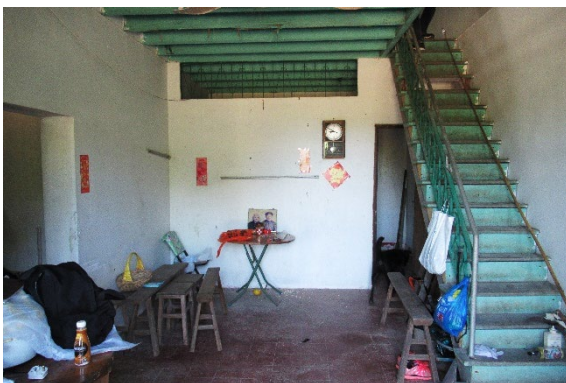
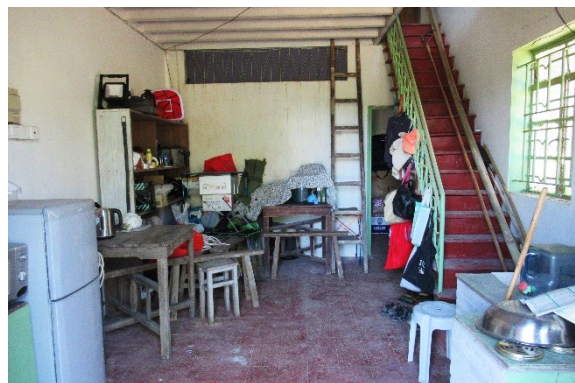
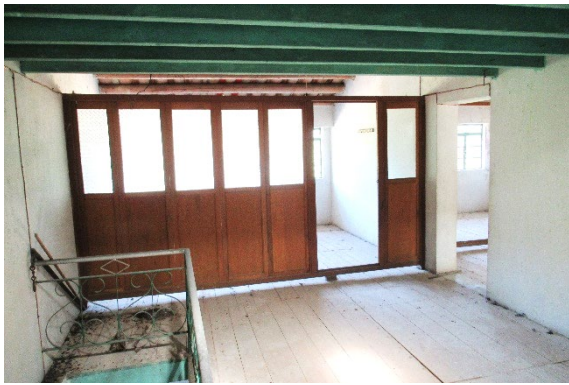
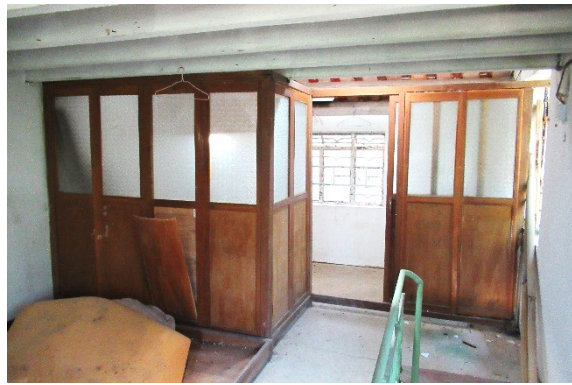
The building was un-maintained. It was told that there has not been any major repair works carried out to the building since its completion in 1967.⁴ The general condition of the walls appeared satisfactory. There was no observable spalling or cracks. Dirt stain and mold growth were noted at the external walls. The interior was dry, and had no noticeable mold or lichen growth. By visual inspection and hammer tapping, the timber roof of China fir purlins and battens had suffered termite attack and many were rotten. Cracks and hollowness were generally spotted on purlins, while mud tubes were found spreading all over the roof structures. The main ridge was otherwise in reasonable condition, except the portion at No. 43 settled slightly. The condition of roof tiles was reasonable for their age. The timber planking of the upper floors and cocklofts was in generally satisfactory condition, while some rectangular joists showed termite infestation checked by hammer tapping.

The decorated parapet wall on top of the front façade was deteriorated but was otherwise in reasonable condition. The motifs in low relief were still intact with traces of original colouring.

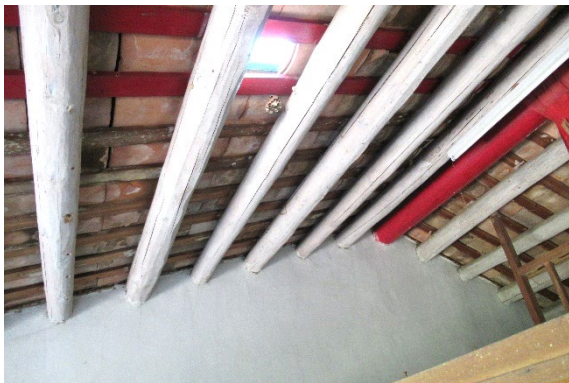
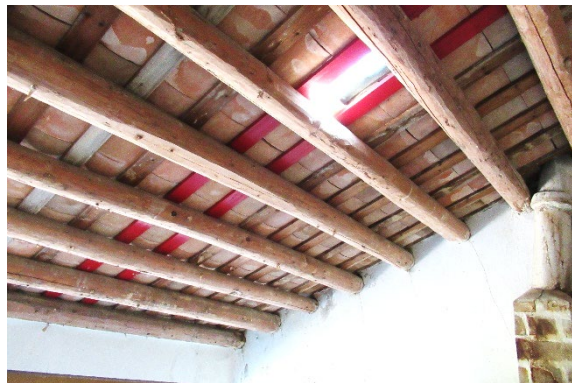
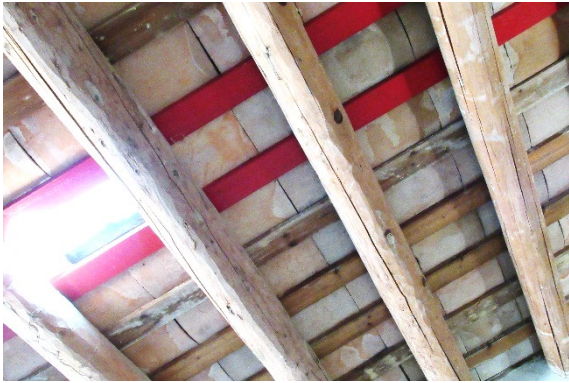
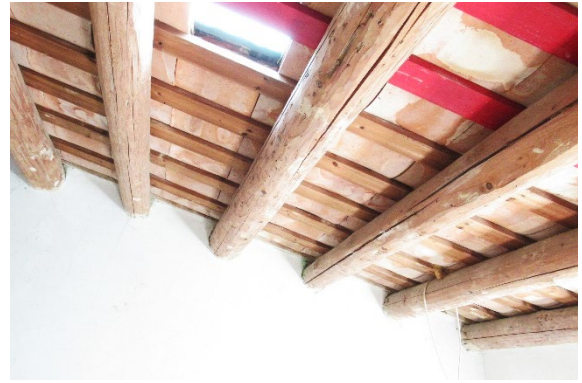
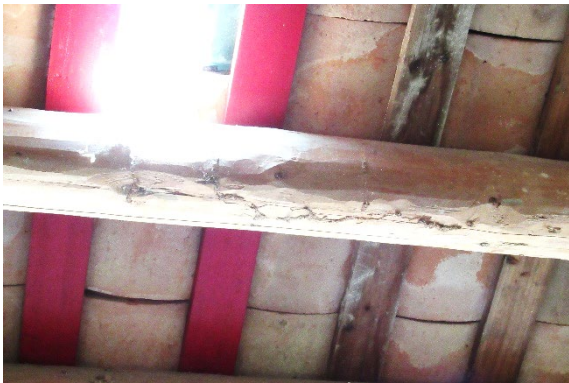
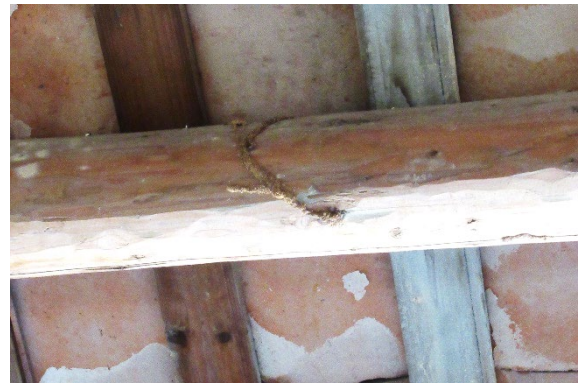
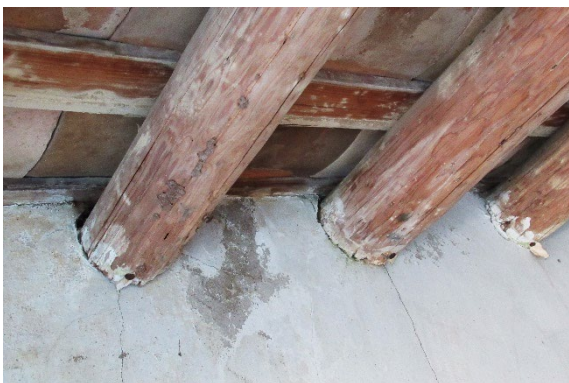
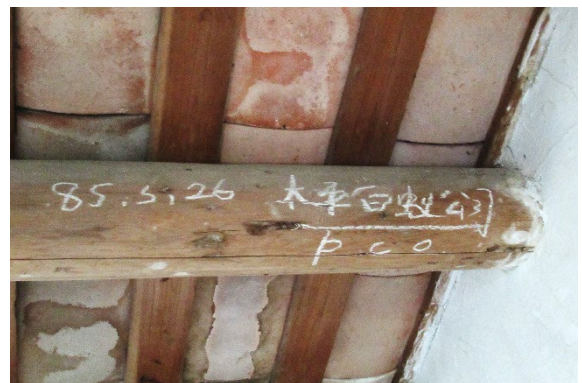
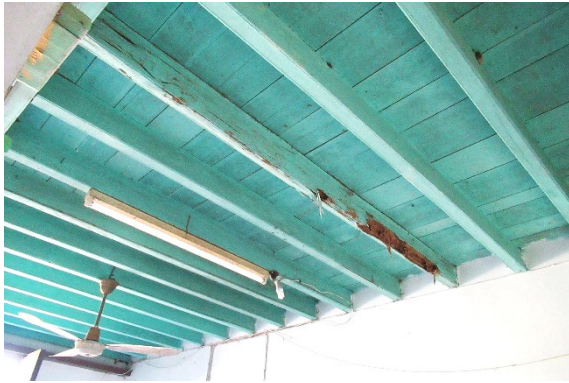
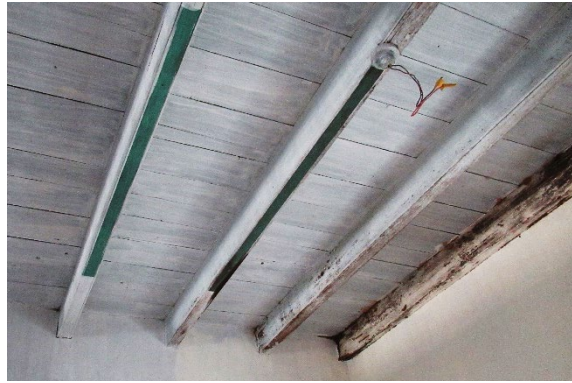
2.2.1 Rotten timbers

By visual inspection and hammer tapping, timber structures at the roofs of both No. 41 and 43, including the timber battens and purlins supporting the tiled roof, suffered termite infestation. Cracks were broadly observed on the purlins that also exhibited different degree of hollowness by hammer tapping. Mud tubes were found at the purlins and battens. A few spots on the purlins were noticed very papery, suggesting serious termite infestation in particular locations. It also appeared that the end of a few purlins at No. 43 sank slightly, including the ridge purlin, probably due to the decaying portion embedded inside the wall. The slight settlement of the ridge purlin subsequently resulted the deflection of the plastered ridge at No. 43. One of the purlins was marked "85. 5. 26 太平白蟻公司 p c o" in each unit, which likely indicated the date of last termite treatment to the timber roof structures. However, there was no termite monitoring or control devices found on site.

The rectangular joists of the upper floors were apparently made by harder wood and demonstrated better condition, as inspected by hammer tapping. Majority of the timber joists were in sound condition, while some of them suffered termite infestation evidenced by presence of mud tubes and hollow sound.

- (a) Take down defective timber battens and purlins at the roofs at No. 41 and 43;
- (b) Supply and install new timber battens and purlins at the roofs at No. 41 and 43; and
- (c) Prepare the surface and apply wood preservative primer and protective finish coating to all timber battens and purlins.

- (d) Take down defective timber joists at the upper floors at No. 41 and 43;
- (e) Supply and install new timber joists at the upper floors at No. 41 and 43; and
- (f) Prepare the surface and apply wood preservative primer and protective finish coating to all new timber joists and existing planking.

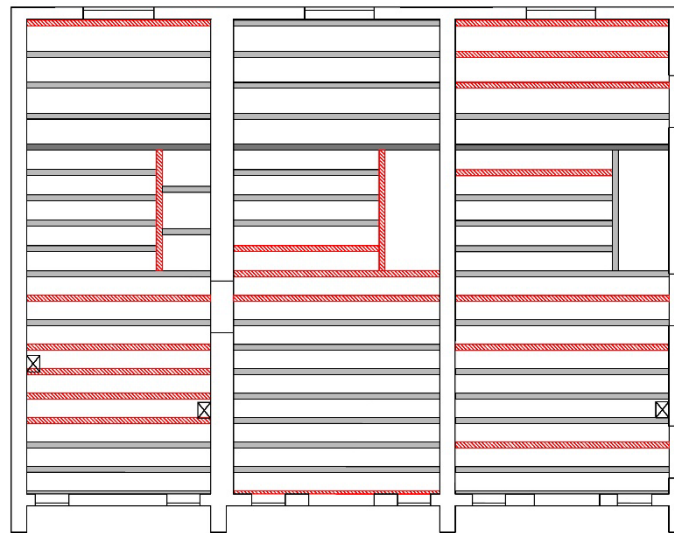
Reflected ceiling plan of ground floor. Rotten timber joists are highlighted.

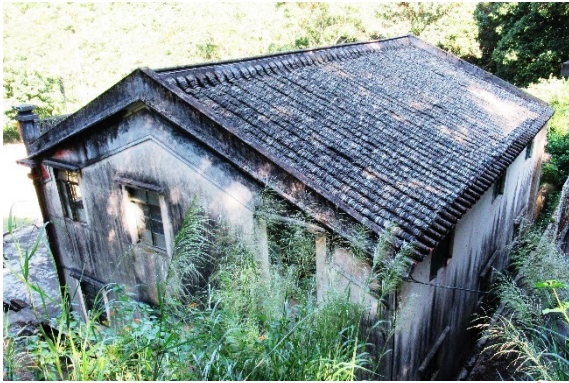
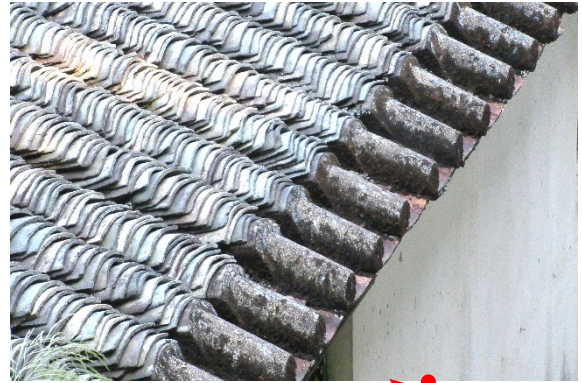
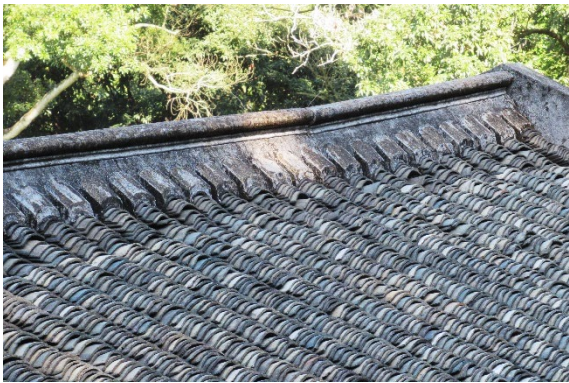
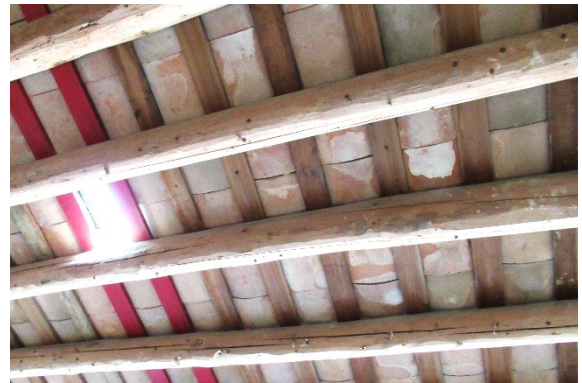
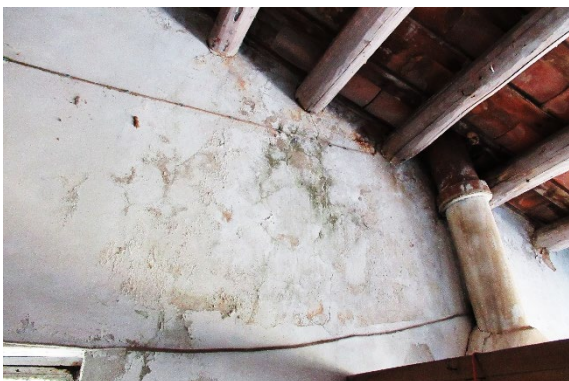
2.2.3 Tiled roofs

The Chinese-styled roofing appears stable and was in generally satisfactory condition.⁵ The roof tiles were of a condition consistent with its age, broken or displaced tiles were not common. The main plastered ridge at No. 43 has settled because of the displaced ridge purlin underneath. Other portions of the main ridge and hanging ridges were in reasonable condition, without having noticeable cracks or severe deterioration.

The bottom layer of reddish pan tiles was unreasonably laid in butt joint. Such tiling is purely decorative and does not perform as a water proofing layer. There was water seepage among the junction between the chimney and roofing at No. 41, leaving water and mold stain on the nearby wall.

- (h) Dismantle existing tiled roof and re-lay salvaged and new tiles to the roofs at No. 41 and 43; and
- (i) Supply and install lead flashing over the ridge purlins and at all hip ridges at No. 41 and 43.

Existing bottom layer of reddish pan tiles was unreasonably laid in butt joint. It is suggested to re-lay the pan tiles with lapping to improve the waterproofing performance of the roofing.

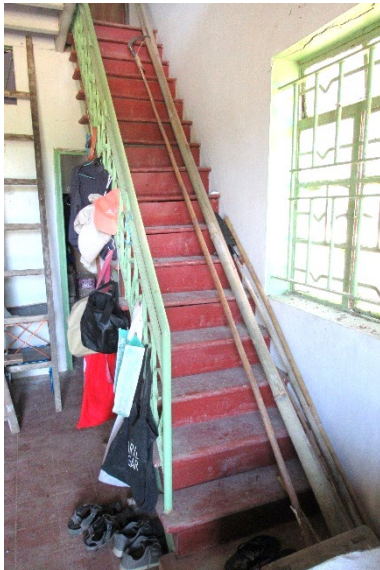
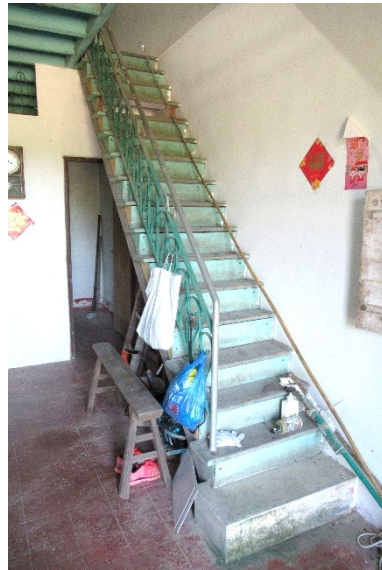
2.2.4 Timber stairs

The stairs connecting the ground and upper floor was constructed of timber treads and risers fixed to timber stringer, which sit on a concrete plinth. The railing was made by metal. It was observed that the timber components did not suffer termite infestation, and was generally in a sound and satisfactory condition, except very few loosen pieces.

- (g) Make good and repair the timber stairs at No. 41 and 43.

The timber stairs in both no. 41 and 43 were in generally satisfactory condition, therefore the works would only include replacement of missing pieces and fixing of loose timber components.

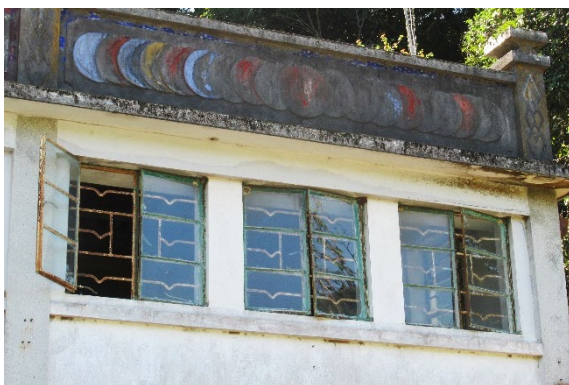
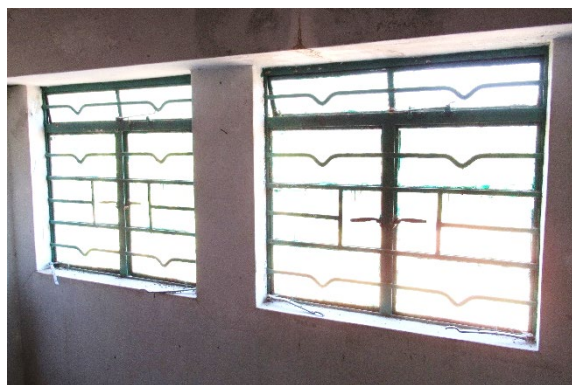
2.2.5 Metal windows

The metal windows were in unmaintained condition and none of them was operable. They are rusty, yet the components, including the ironmongeries and glass panes were kept intact.

- (j) Make good and repair all existing windows, prepare surfaces and apply anti-corrosion primer and enamel paint.

The metal windows were inoperable mainly because of the rusty parts and lack of lubrication in the hinges. Therefore, works would removal of rust and exiting finishes, application of lubricant, and re-finishing.

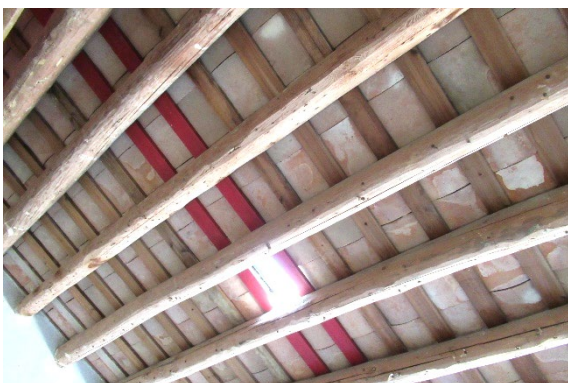
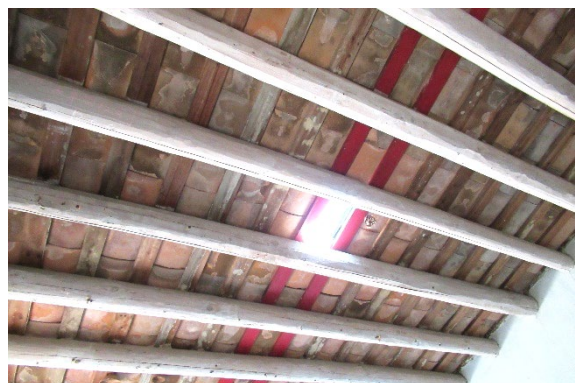
Rotten timber battens and purlins

Numerous purlins exhibited hollowness in hammer tapping test. Subject to available budget, they would be replaced by timber log of the same species, probably Chinese Fir, with priority given to those seriously rotten.

Wood preservative primer with fungicidal and insecticidal treatment would be applied to all new or salvaged timber elements to prevent attack by termites, wood boring insects, fungi, woodrot and decay etc.

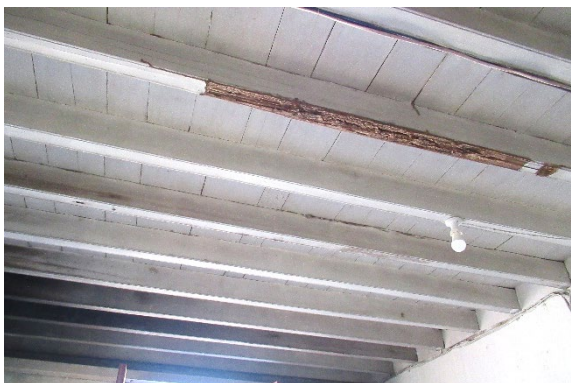
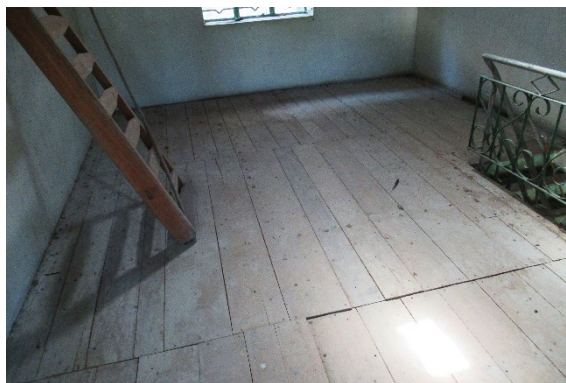
Rotten timber joists and planking

The timber planking on upper floors were in generally satisfactory condition, therefore only preservative treatment would be needed.

It is suggested to identify the species of existing timber joist by accredited laboratory to ensure like-for like replacement.

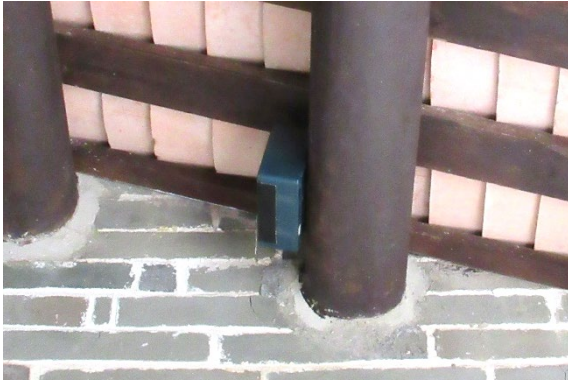
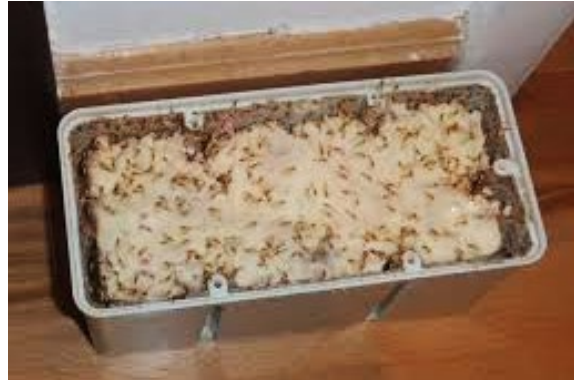
3.4 Termite Control

Termite infestation was the major defects found at timber purlins at roof and joists at the flooring of upper floors, causing severe damages to the structural members that definitely require replacement. To avoid costly repair in future, implementation of a termite control and eradication system is recommended.

- (k) Design and install termite control and eradication system in accordance with the manufacturer's recommendations by termite specialist.
