From Valley to Plain II:

Architectural rehabilitation for integrated, co-creative eco-living experience in Tin Sum Village, Kuk Po

Architectural Study Report on Kuk Po Settlements

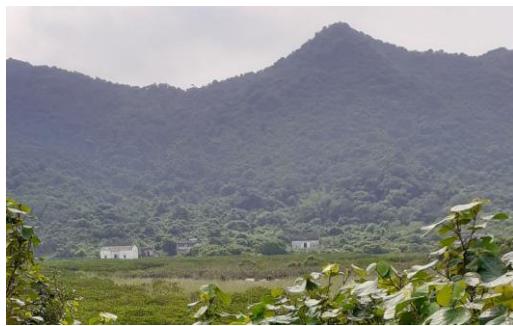
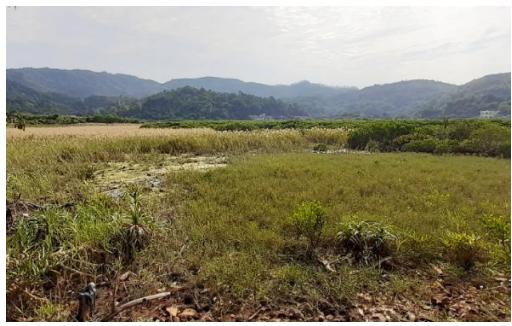
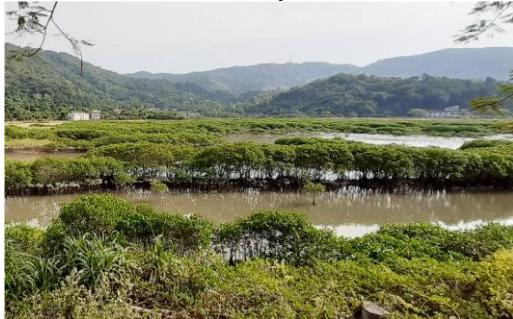
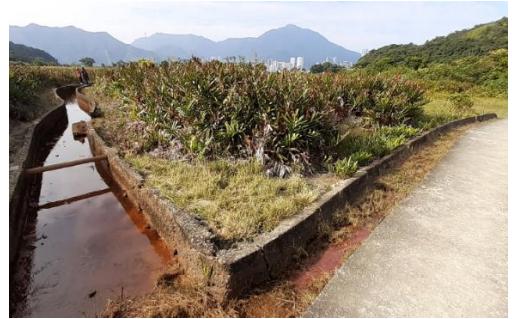
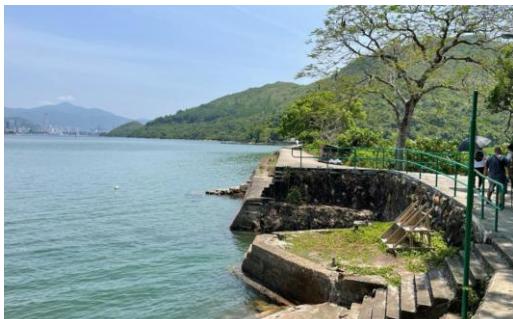
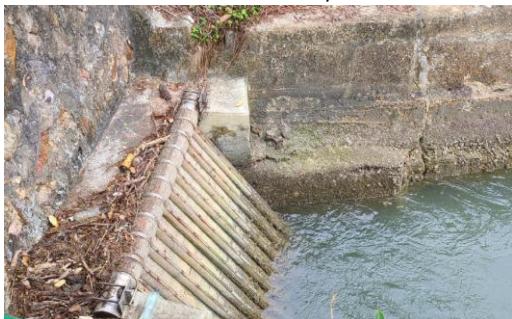
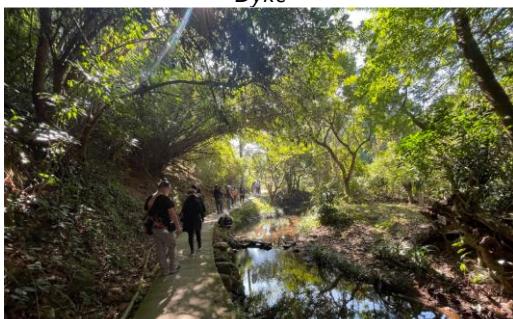
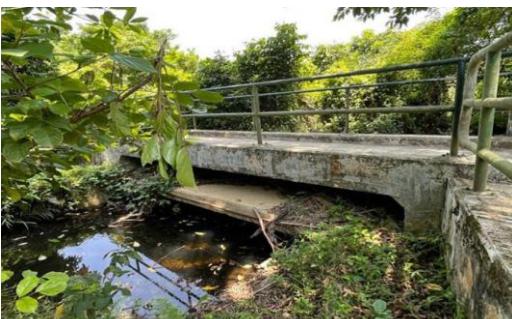
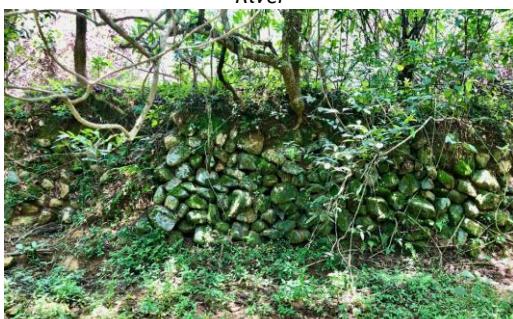
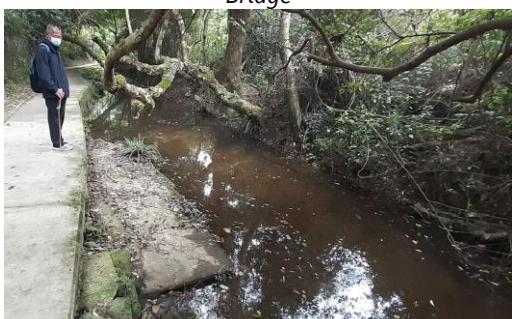
Fig. 1.8- Landscape and human landscape

The seafront of Kuk Po features an open flatland of wetland, marshes and estuarian ponds with mosaic patches of reeds and mangroves⁴. It was formed 200 years ago when the Kuk Po villagers constructed a dyke with sluice (fig. 1.8) to drain out seawater in the bay and converted over two million square feet of salt marsh into farmland (fig. 1.6). This agro-reclamation technique and culture is a common feature of villages around Sha Tau Kok (fig. 1.7).

Kuk Po is crisscrossed by a river from south to north along which various hamlets root in and thrive. Kuk Po River is an “Ecologically Important Stream” (EIS) that boasts high water quality and showcases diverse natural landscapes like waterfalls, pools, marshes and mangroves (fig. 1.8). Villagers utilize these water resources for daily needs and cultivate terraced fields. This harmonious relationship with water and agriculture shapes the cultural landscape of Kuk Po⁶.

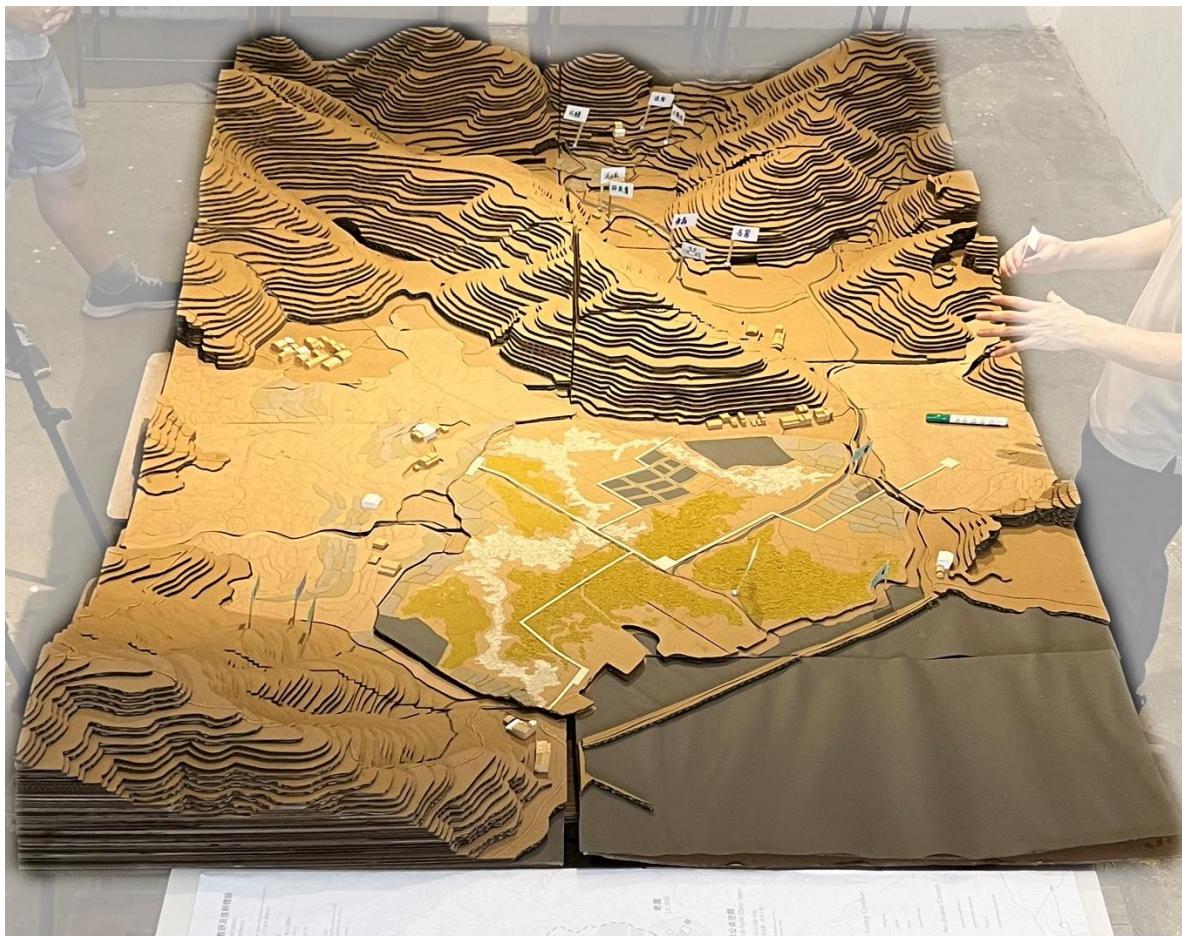
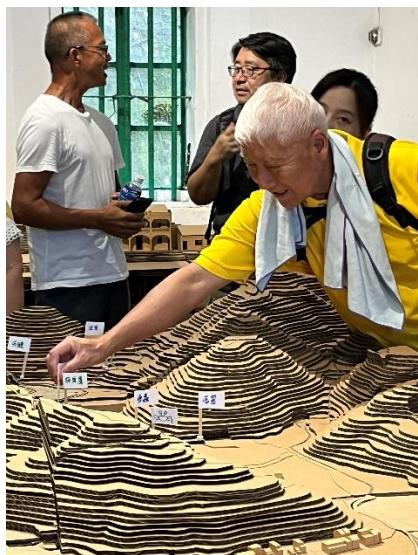
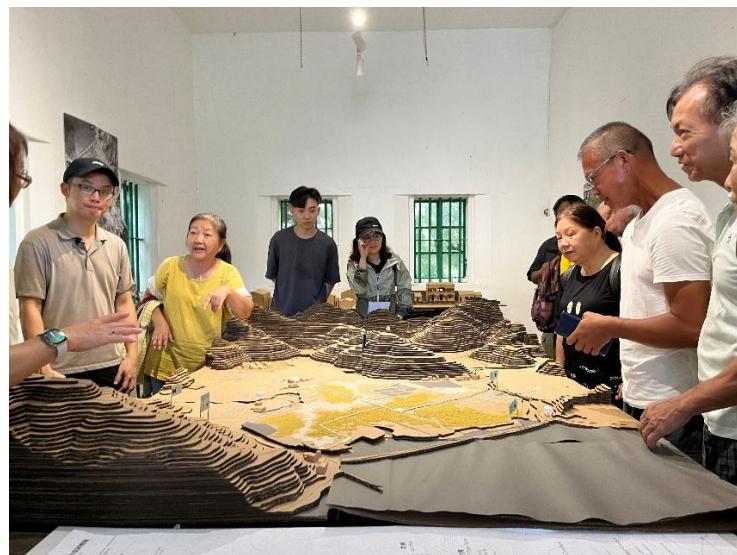
Fig. 1.11- *Kuk Po model and interactive workshop with villagers*

Kuk Po has a rich variety of natural landscapes from valley to plain that were mostly formed due to past agricultural activities (fig. 1.5). An architectural model of the whole Kuk Po was made to visualise the landscape and configuration which is a design tool to communicate with villagers (fig. 1.11).

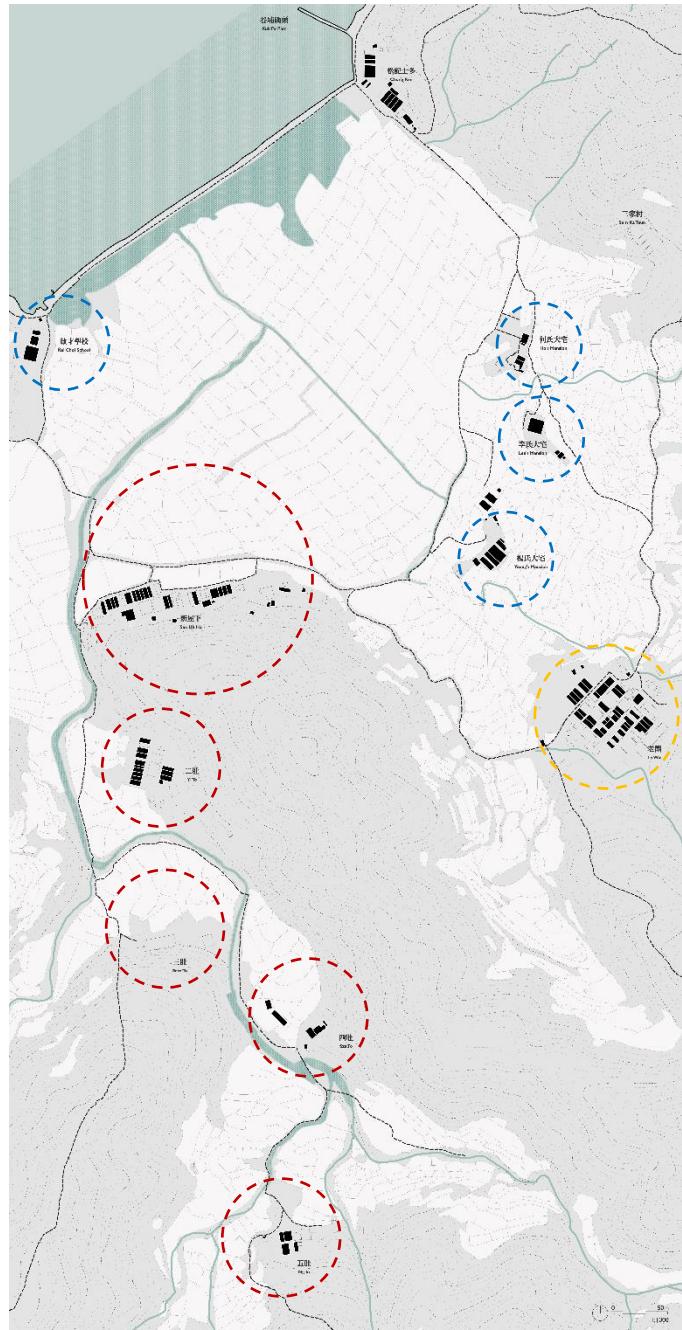
Fig. 1.12- Plan of Kuk Po

Type 1: Walled-village (bracketed in yellow in Fig. 1.12)

Like the early Hakka villages in other parts of New Territories, Lo Wai has encircling walls around the village to defend themselves against pirates. Most of the village houses are one-storey buildings, arranged in rows, traversed by a central axis road.

Type 2: Hamlets (bracketed in red in Fig. 1.12)

When the population increased, the clans spilled out from Lo Wai to various parts of the valley to form hamlets at San Uk Ha (新屋下), Yi To (二肚), Sam To (三肚), Sze To (四肚) and Ng To (五肚)⁷.

Type 3: Hybrid-styled Mansions and Buildings (bracketed in blue in Fig. 1.12)

Tin Sum was established in early 20th century. The hybrid-styled mansions of the Ho, Lee and Yeung families in Tin Sum were completed in the 1930s with the oversea remittance from USA, same as that for Kai Choi School⁸.

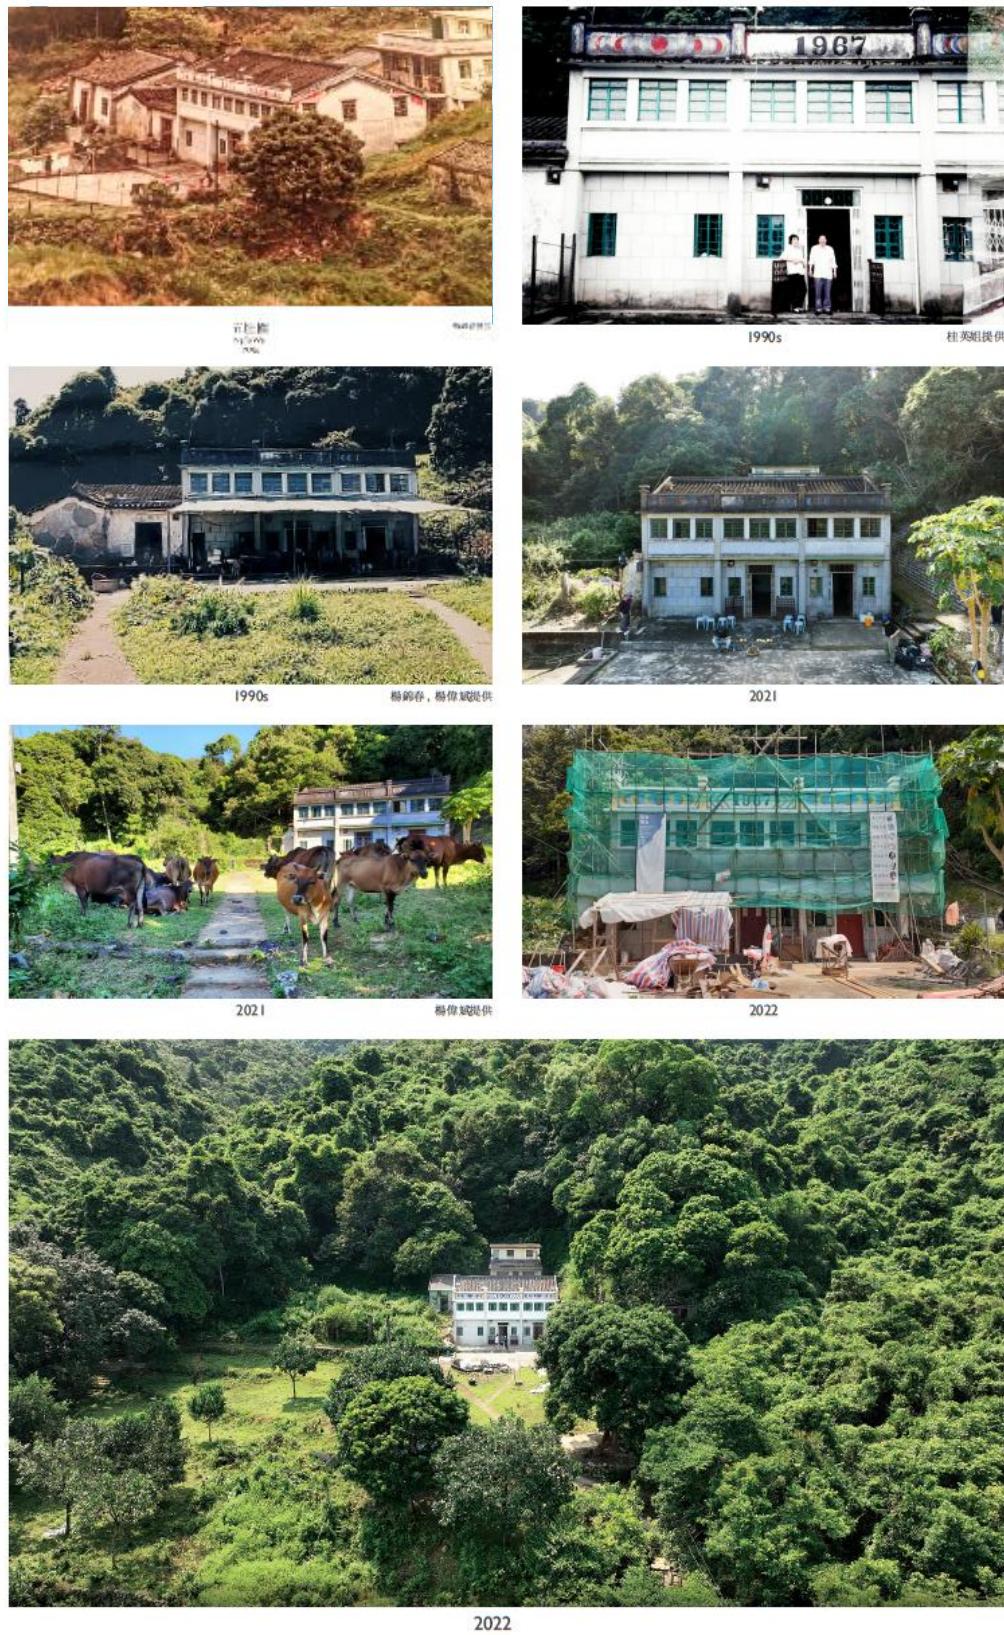
Fig. 2.3- Transformation of Ng To Yeung's Mansion from 1963 - 2022

Deducing from the aerial photo taken in 1963, the main mansion of Ng To has a single roof with three courtyards, it was reconstructed in the late 1960s by a Yeung couple who had worked in the UK (fig. 2.3 & 2.4). The two-storey mansion consists of three bays, integrating traditional Hakka and modern architectural styles and materials. Nature has reclaimed the hills and houses as the Yeungs migrated to the UK and abandoned the houses and fields in the late 1990s.

In 2000s, the family rented the mansion to a cousin who then ran a private Hakka cuisine eatery there. However, there are little visitors due to the remote location of Ng To, they relocated the store to the Watchtower near Kuk Po pier years later and named it "Chung Kee Store", which is operating in weekends currently.

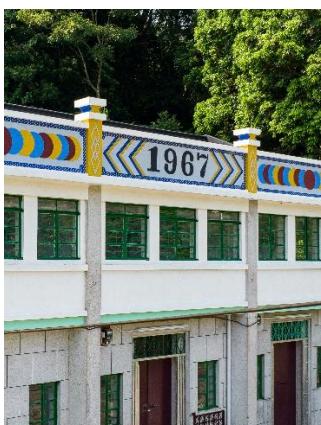
Fig. 2.5- Parapet wall of Ng To Yeung's Mansion

The building was decorated in a few loci. On top of the front façade is a parapet wall that spans the whole width of the elevation. Along the parapet wall are framed panels separated by short columns with simple ornamental cap and motifs in low relief. Number 1967, the construction year of the building, was inscribed on the middle panel, while the panels atop the two side bays feature low relief of circular patterns (fig. 2.5)¹¹.

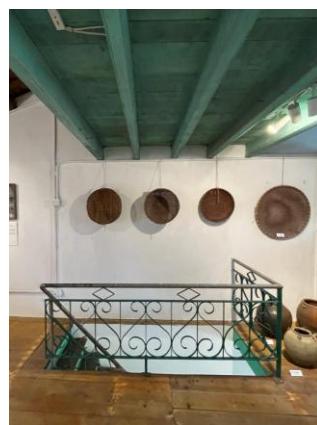
Fig. 2.6- Timber planking of cockloft and staircase rail

It is very likely the building was constructed of concrete masonry commonly found in the rural area in that era. The flooring and cocklofts of upper floors was built by timber planking rested on rectangular joists (fig. 2.6).

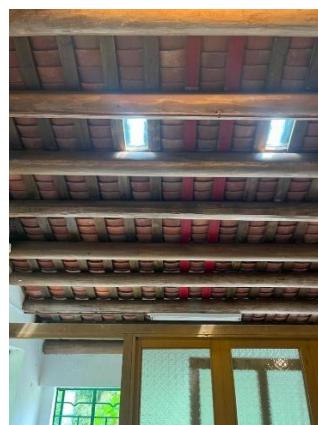
Fig. 2.7- Timber battens and purlins with skylight roofing

Concrete screed was laid on top of timber planking particularly at No. 41. The common Chinese-styled pitched roof was laid with pan tiles of two different sizes, locally known as 'Hakka roofing', sit on timber battens and purlins (fig. 2.7).

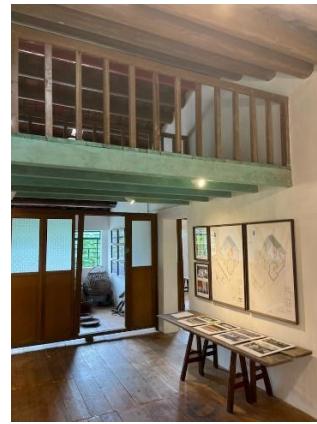
Fig. 2.9- Timber partitions in 1/F

The left bay is one smaller unit (No. 41) while the middle and the right bay combined to form a larger unit (No. 43). The main doors for the two units are located at the middle bay and left bay. Each unit has separate staircases connecting the ground floors and the upper floors. The interior space of the ground floor in each unit can be defined as a front living and cooking space (fig. 2.10) and smaller rooms at the rear, while the upper floors were subdivided into small rooms by timber partitions (fig. 2.9).

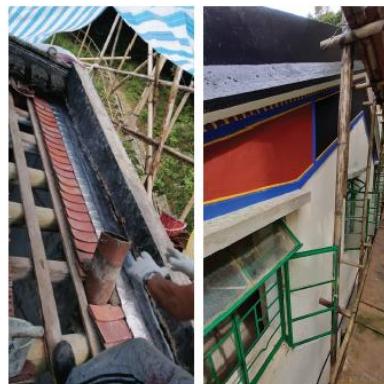
Fig. 2.13- Scope of restoration works

Yeung's Mansion in Ng To was being restored by CUHK with the Countryside Conservation Funding Scheme by Countryside Conservation Office. The scope of this restoration project is mainly to lay salvaged and new roof tiles to the roof; replace defective structures like timber battens and purlins at the roof, timber joists at cocklofts; making good existing features like timber stairs, timber main doors and steel windows; and installing new electrical sockets and conduits¹² (fig. 2.13).

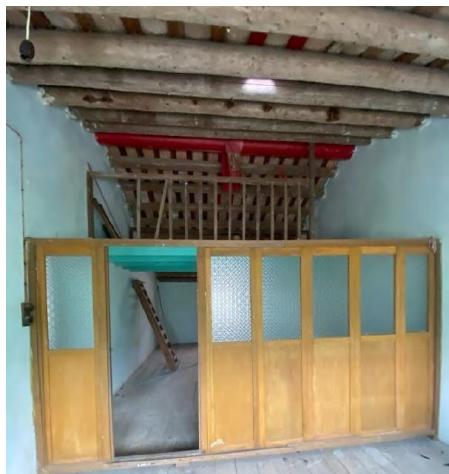
Fig. 2.14- Before restoring the roof

Round Chinese fir purlins were used at the roofs of No. 41 and 43 (fig. 2.14 & 2.15). Despite being softwood, its presence is extremely common in local Chinese-styled pitched roofs. The reason may be because of its easy availability, therefore, relatively lower price.

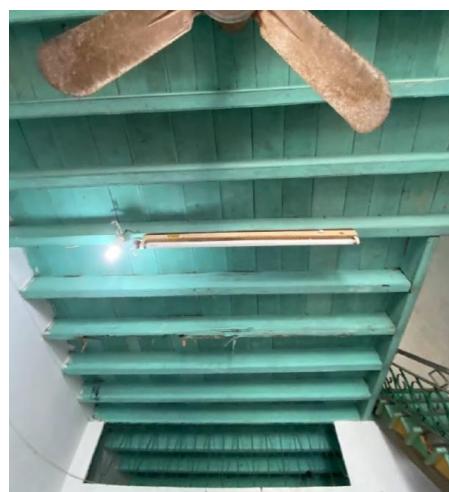
Fig. 2.16- Before restoring the joists of cockloft

Rectangular Kapur joists used at the cockloft of No. 41 and 43 (fig. 2.16 & 2.17). The use of Kapur, an imported hardwood, reveals that the family was wealthy enough to afford better materials for their new house¹³.

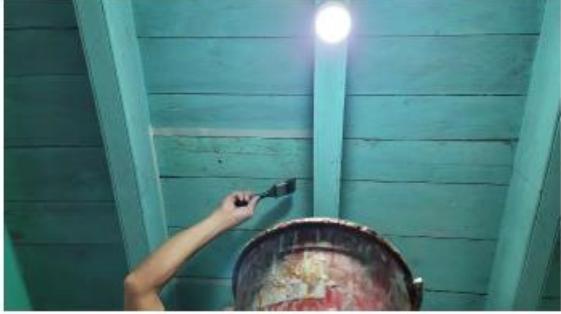
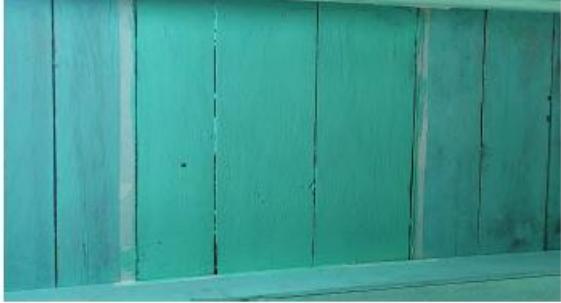
Fig. 2.18- *Trial record of applying protective finish coating to wood surfaces*

Existing rectangular timber joists were finished with popular enamel paint. However, it is not the best choice for conserving historical timbers. A protective finish coating designed for wood surfaces is used on new timbers to provide a very breathable film natural moisture in the wood to escape. Before the application of this finish coating, existing finishes have to be completely stripped off to reveal the original wood surfaces. It is a labour intensive and time-consuming process (fig. 2.18). Therefore, subject to the available funding, it is decided to apply this finished coating on new joists only¹⁴.

1	10:00am	Apply paint remover. Testing area: 400 x 400mm

Allow an hour for the remover to breakdown the paint.

2	11:00am - 11:20am	Strip off existing paint finishes by a scraper

3	11:30am - 11:40am	Apply 3 layers of finish coating for wood surface

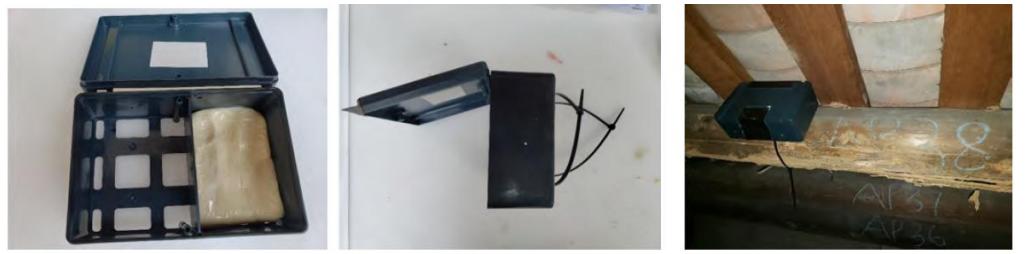
Fig. 2.19- *Installation of termite control*

Termite control was installed (fig. 2.19), and water tightness test was carried out (fig. 2.20) after all repair works are completed¹⁵.

1) Filled baits into stations 2) Putting 2 plastic strip at the back of station 3) Tightening station onto purlins

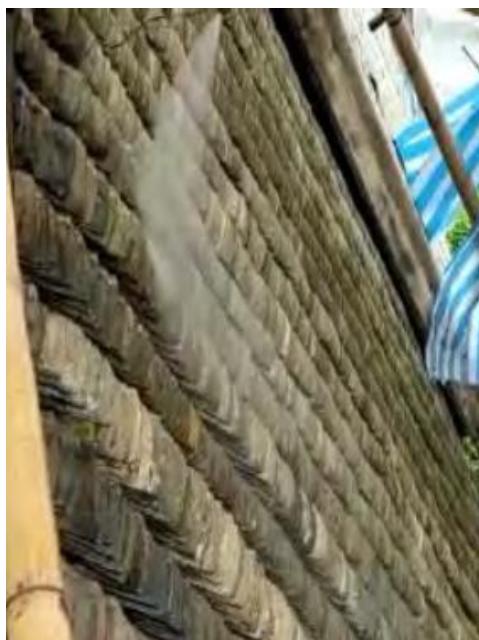
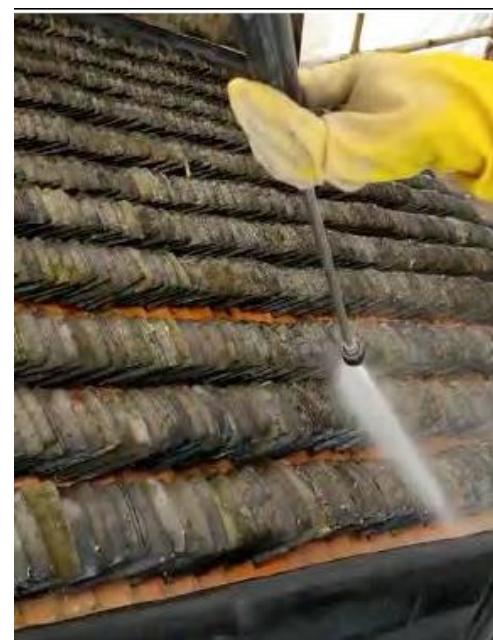
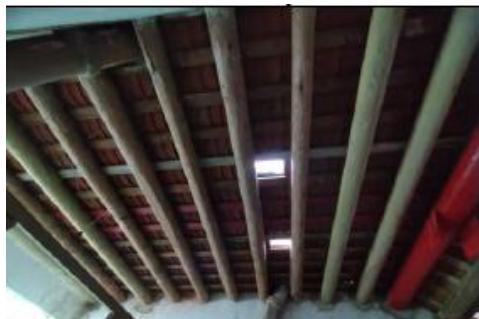
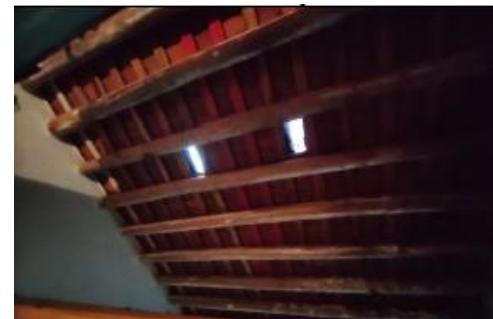
Fig. 2.20- *Record of water tightness test*

Spraying water onto roof surface at front bay

Spraying water onto roof surface at back bay

Interior side during the water test- no seepage is found

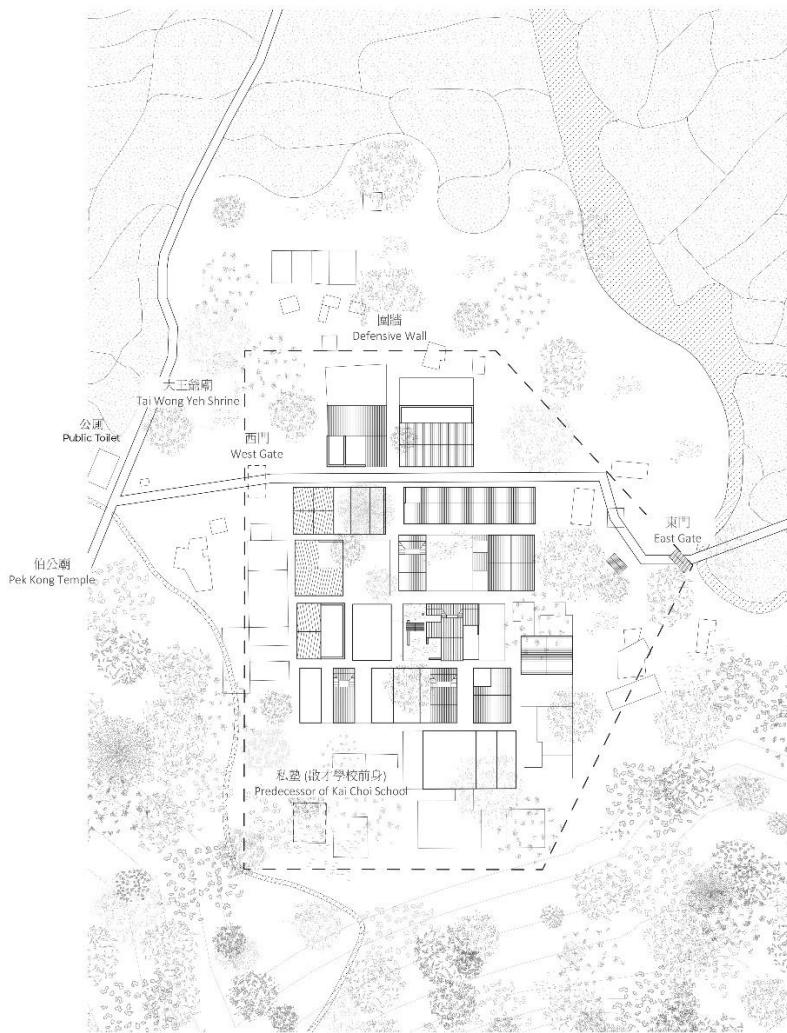
Fig. 3.1- Plan of Lo Wai

Lo Wai exhibits the typical layout of a Hakka village of "mountain, woodland, house, pond and field". The walled village comprises seven rows of houses with a fengshui wood at the back (fig. 3.1 & 3.2). Entrances are at the eastern and western ends, the words 「東來紫氣」 is written on East Gate (fig. 3.4), while "Tai Wong Ye" shrine with a giant Bayan tree are seated at the back near the western gate (fig. 3.3), imploring favourable weather and agricultural blessings. A lane runs north to south in the middle of the village and most sections of the encircling walls had crumbled or covered by vegetation¹⁷.

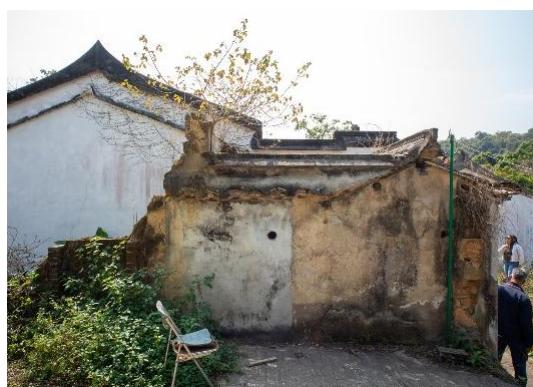
Fig. 3.5- Houses built with stone, mud brick and earth

The construction materials of houses in different eras vary; these are testimonies to the change of time and livelihood of villagers. Earlier houses were built with stones and earth (fig. 3.5). Lime, blue bricks and red bricks appeared later (fig. 3.6). Window sizes, window glass patterns and so on tell about circumstances of the village¹⁸.

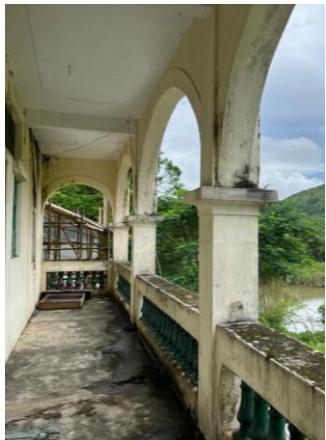
Fig. 4.4- *Balcony with arched openings*

The front façade of the building has an open verandah on the ground floor and a balcony on the upper floor both colonnaded with arched openings and square columns (fig. 4.4). Vase-shaped green ceramic balustrades are fencing the balcony. It is constructed of green bricks, stone rubbles and cement with its wall and columns to support its pitched roofs of timber rafters, purlins and ceramic tiles. A parapet above the flat-roofed balcony has the name of the school plastered in the middle.

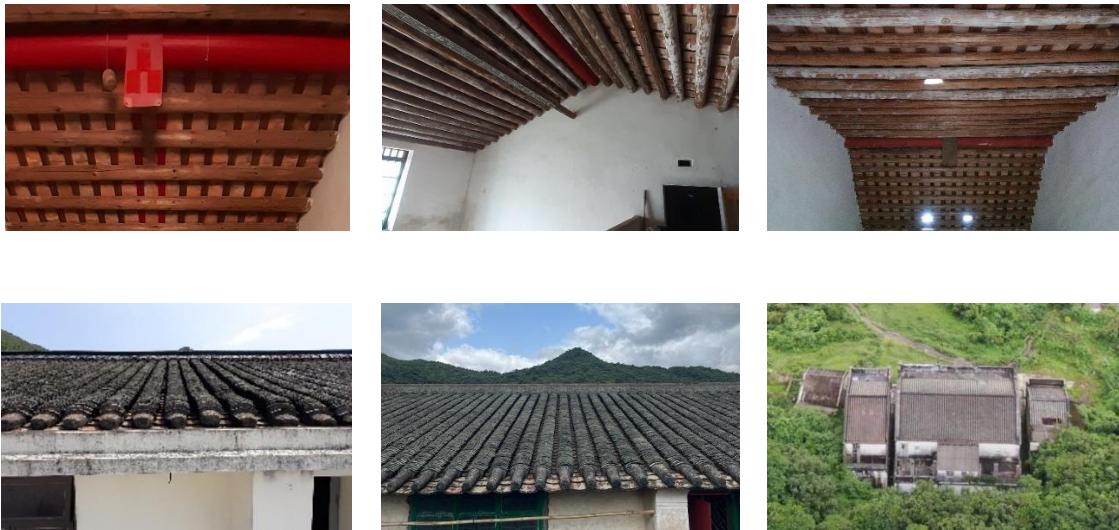
Fig. 4.4- Central beam and 'Hakka roofing' of Ho, Lee, Yeung's Mansion

The three studied hybrid-mansions: Yeung's, Lee's and Ho's Mansion have a similar layout with two storeys and three bays. The main central beam of the ceiling are painted in red, symbolising good fortune. The common Chinese-styled pitched roof was laid with pan tiles of two different sizes, locally known as 'Hakka roofing', sitting on timber battens and purlins (fig. 4.4).

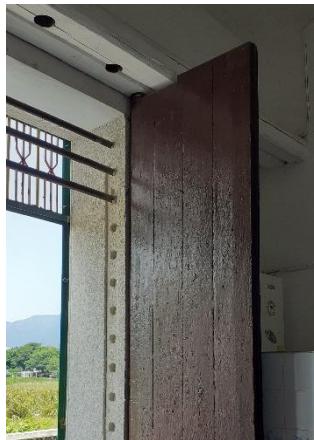
Fig. 4.10- Holes remained of the original shutter

The original horizontal railed shutter was taken down during the innovation works in recent years. Yet the holes for locking the shutter and carved patterns of the door plinth stone remain (fig. 4.10). The twin stoves in the kitchen are large enough to fit two big cast iron woks together (fig. 4.11). Firewood and dry grass are stored by the side. The cistern is placed opposite the stoves²⁷.

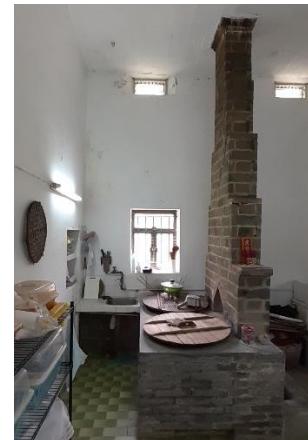
Fig. 4.11- Brick stoves and chimney

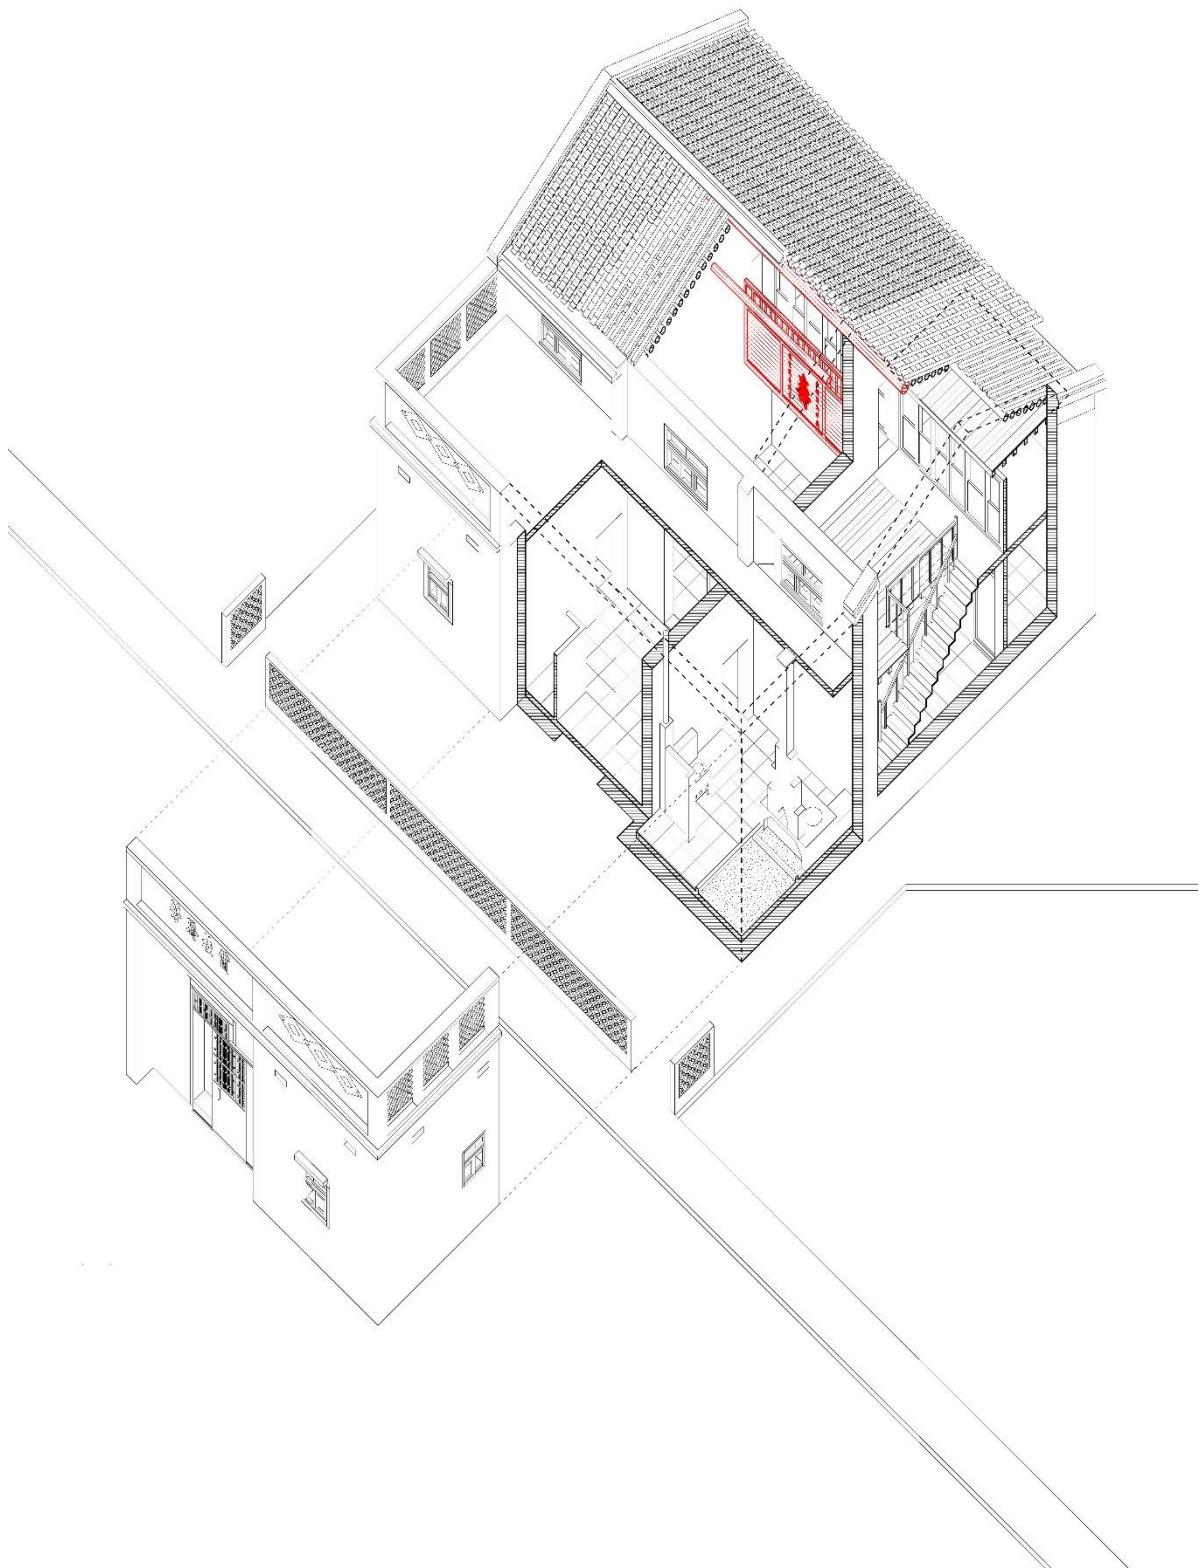
Fig. 4.14- *Exploded axonometric of Ho's Mansion*

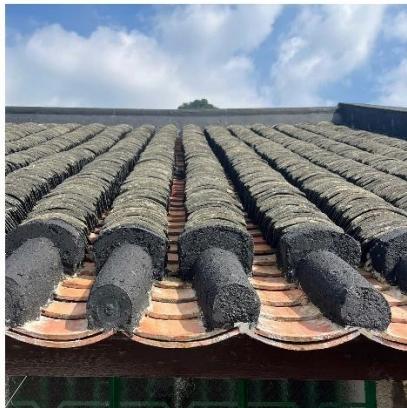
客家瓦頂
Hakka tiled roof

金字頂先以「疊七留三」的方式鋪上板瓦，再於板瓦間疊大量的小青瓦，這種屋頂常見於客家村屋。
The pitched roof is covered with flat tiles and blue tiles, which were commonly used in Hakka vernacular houses.

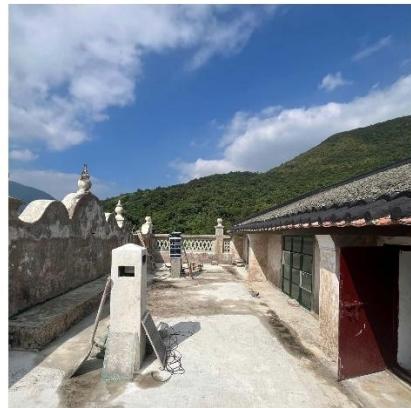
阳台
Balcony

金字頂前方有混凝土露天阳台，可見大宅混合現代技術和材料，曾用於曬穀物。
The sundeck in front of the pitched roof was for sun-drying crops. It was constructed with reinforced concrete, which is a modern technique and material.

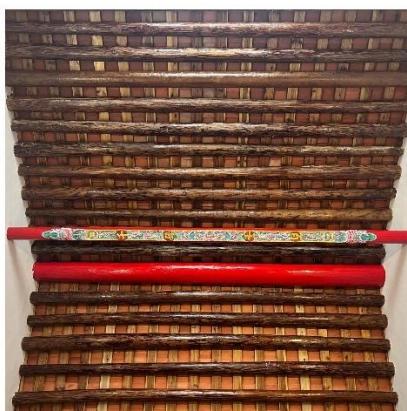
子孫樑
Descendants Beam

主樑下有客家祠堂常見的彩色「子孫樑」，其上有「百子千孫」囍字及花團錦簇畫案，寓意家族繁衍昌盛。
The "descendants beam" with the inscription "countless descendants" and vibrant floral motifs symbolizes the family's prosperity and abundance.

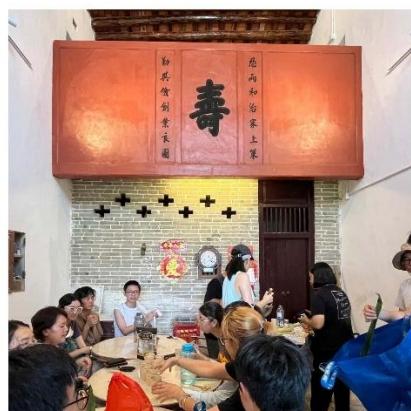
屋匾 (家訓)
House plaque (family motto)

正龕有「壽」字屋匾及家訓對聯，喻意處理家事要包容及協調，而創業的版門則為勤勞及節儉。
A large plaque with the character of "longevity" and a couplet of the family motto emphasizes tolerance and harmony in managing family affairs, and diligence and frugality to successful entrepreneurship.

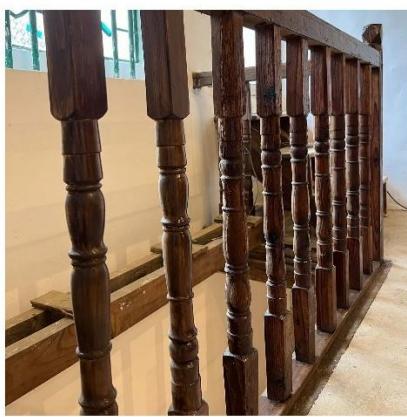
木梯
Timber stairs

接近地下的兩級以水泥做成，防止木材觸碰水而發霉。
原裝木梯一根釘子也沒有用，後期維修時才加上。
The bottom two steps are made of cement, preventing the timber from water. The original staircase did not use any nails, they were only added during later repairment.

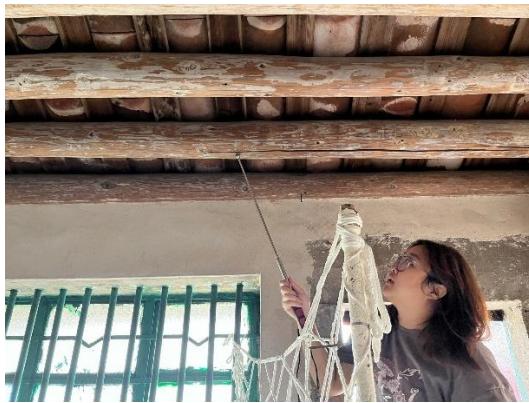
Fig. 5.4.7- Condition survey

Condition survey was conducted to inspect existing timber roof structure, inspecting the cracks and whether if there are any termites (fig. 5.4.7). Results showed that most of the round purlins were in good condition, 10 purlins and all battens were replaced. The original timber structure uses Chinese fir 杉木, so it was also used for the newly replaced purlins and battens (fig. 5.4.8). A protective finish coating designed for wood surfaces is used on all timber structure, preserving the wood character protecting timber against fungus, mould and is water resistant.

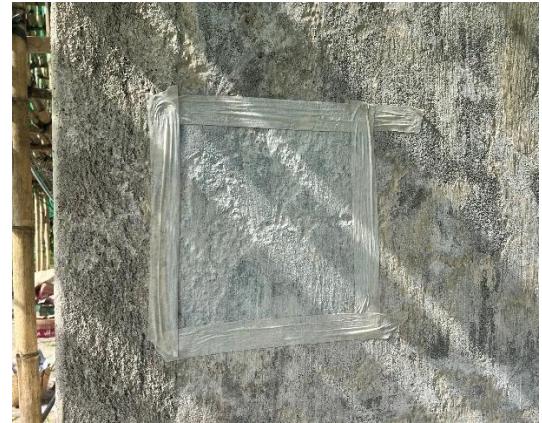
Fig. 5.4.10- Mock up of wall paint

The exterior façade was washed with high pressure water jet, some of the original paint traces can be observed. New paint code was matched with the traces (fig. 5.4.9) and mock up trials were conducted to test out the water to paint ratio (fig. 5.4.10).

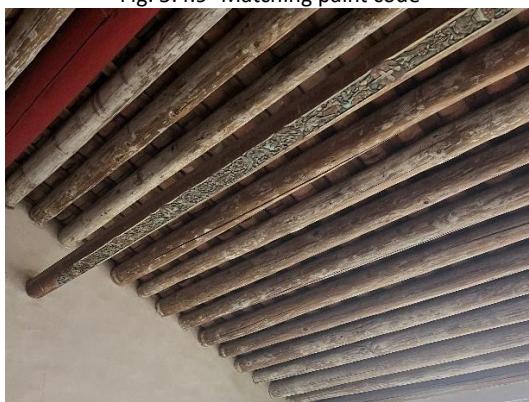
Fig. 5.4.11- Descendants Beam before restoration

One of the significant features of the house is the 'Descendants Beam' which was aged and decolourised (fig. 5.4.11). The craftsman carefully inspects the original traces and repaint it in-situ accordingly, showcasing the art of restoring paint (fig. 5.4.12).

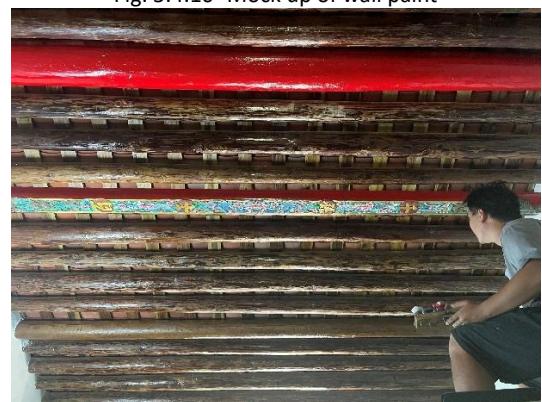
Fig. 5.4.12- Repainting Descendants Beam

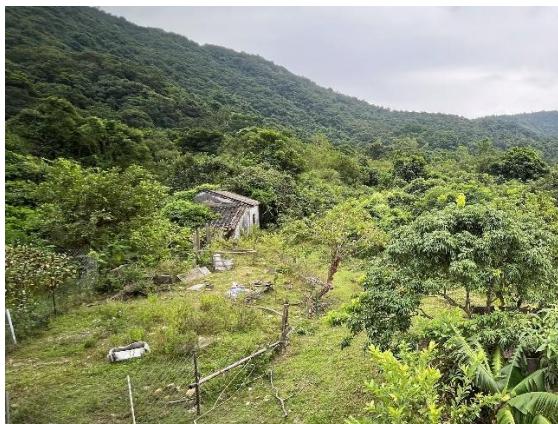
Fig. 5.4.13- Lee's farmshed before restoration

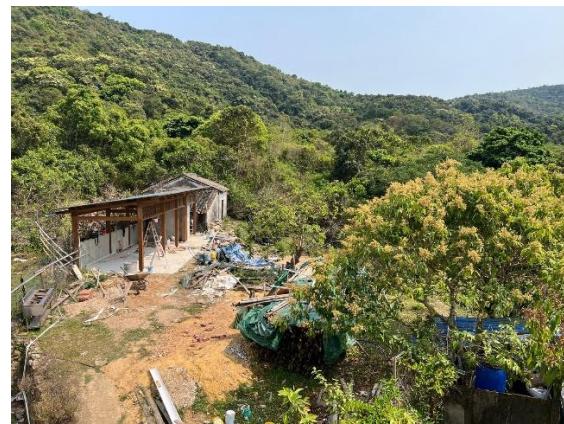
Fig. 5.4.14- Lee's farmshed during restoration

The original structure and materials are dilapidated and not up to modern safety standards, so the structure must be reinvented. The original footprint of the farmshed is being preserved as a principle for the new design (fig. 5.4.17). A new timber frame structure is made according to the original footprint, new metal roof and waist height walls have been installed to provide for basic needs. Sustainable measures are also tested out in the new pavilion, like using solar-powered lights, eco-toilet and rainwater collection system (fig. 5.4.18).

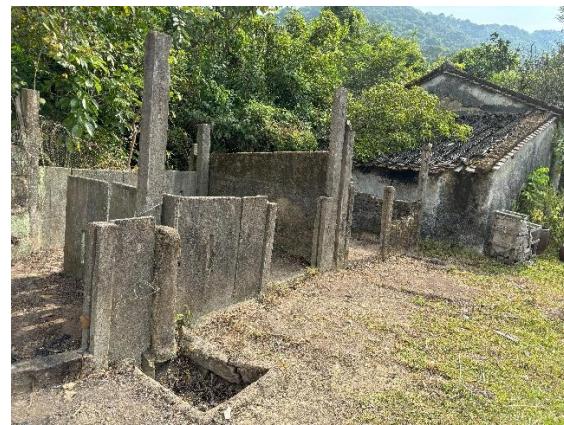
Fig. 5.4.16- Original structure of Lee's farmshed

The farmshed has 4 cubicles separated by concrete columns and concrete planks (fig. 5.4.16 & 5.4.17), according to Mr. Lee, they have kept a pig in each cubicle. As they no longer keep pigs since 1970s, the farmshed is being reinterpreted and redesigned as a pavilion for storing farming tools and hosting eco-living workshops.

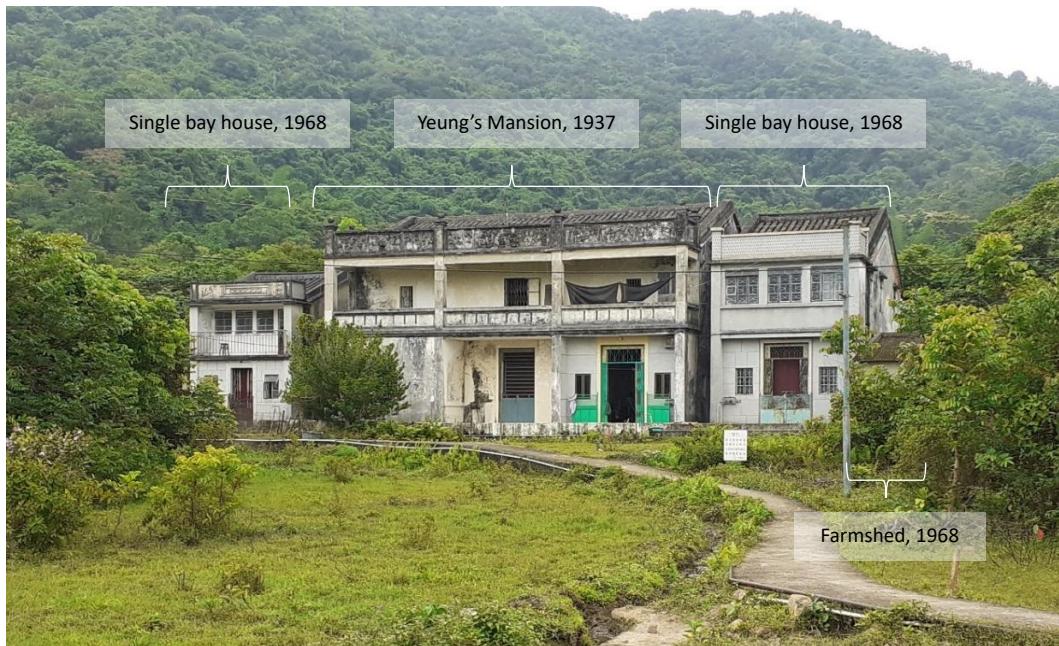
Fig. 5.5.1- *Yeung's Mansion, the two other houses and the farmshed*

The Yeung family was originally from Lo Wai of Kuk Po, later moved to Sze To and Ng To. The houses can no longer fit the growing numbers of the family, so one of the family purchased land in Tin Sum and built a stand-alone mansion with the oversea remittance from the USA. Yeung's Mansion was constructed in 1937, following the form and layout of Kai Choi School. Two more houses and a farm shed were built in 1968 next to the main mansion²⁹ (fig. 5.5.1-5.5.2).

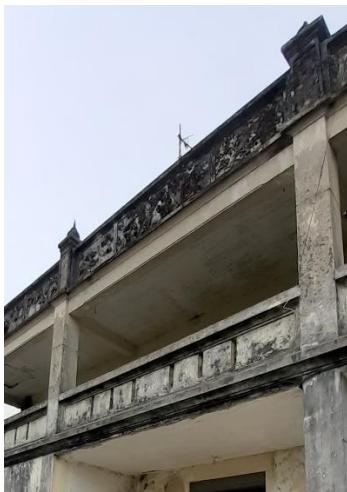
Fig. 5.5.3- Parapet wall and balcony of Yeung's Mansion

Yeung's Mansion is a two-storey three-bay building with a gable roof structure of Chinese tiles. The main doors are located at the right bay and middle bay. The ground floor of the three bays is interconnected, with staircases on the side bays connected to the first floor. There is a balcony on the first floor with concrete balustrades, following the form of Kai Choi School (fig. 5.5.4). The parapet above the flat-roofed balcony has ornamental carving, separated by short columns (fig. 5.5.3).

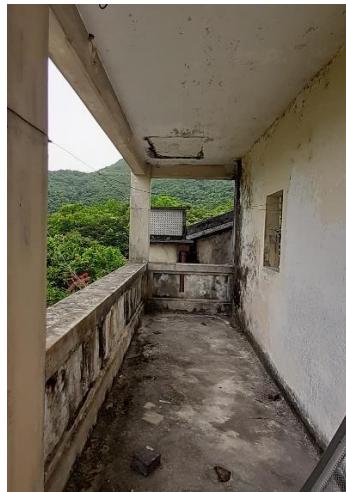
Fig. 5.5.4- Balcony is similar to that of Kai Choi School

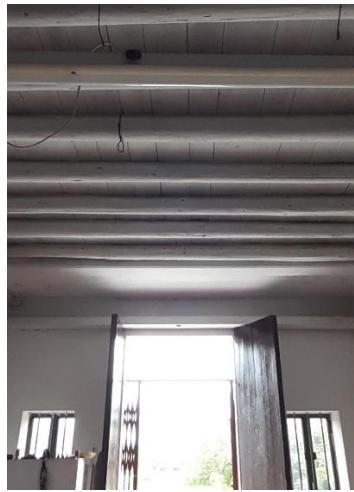
Fig. 5.5.5- Timber plank flooring rested on circular joists of 1/F

The interior space of the ground floor in each unit can be defined as a front living and cooking space (fig. 5.5.6) and smaller rooms at the rear. The walls of the rooms are recessed from the ceiling with decorative steel bars, brightening the rooms and for better ventilation (fig. 5.5.7). The upper floors were subdivided into small rooms by timber partitions (fig. 5.5.8). The flooring and cocklofts of upper floors was built by timber planking rested on circular joists (fig. 5.5.5).

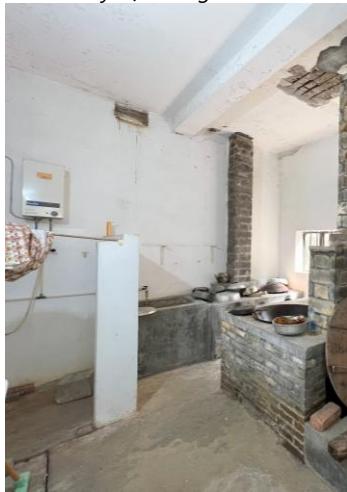
Fig. 5.5.6- Brick stoves and shower area

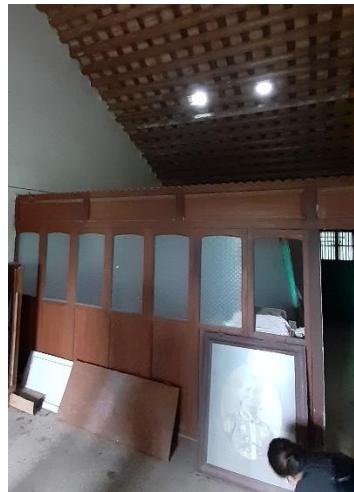
Fig. 5.5.8- Timber partitions on 1/F

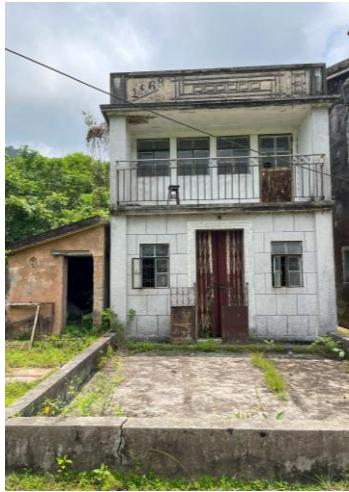
Fig. 5.5.9- Single-bay house with a farmshed on the right-hand side of main mansion

On both sides of the three-bay mansion, single-bay houses and a farmshed were built for various purposes (fig. 5.5.9-5.5.11), such as storing firewood, raising pigs, housing cows, and serving as toilets. In 1968, each uncle had their own family and children, so the adjacent houses were used as separate households.

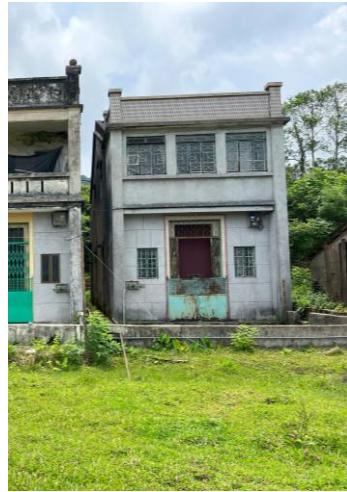
Fig. 5.5.10- Single-bay house on the left-hand side of main mansion

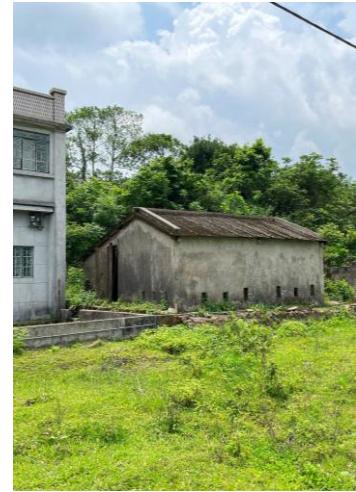
Fig. 5.5.11- Farmshed on the left-hand side of main mansion

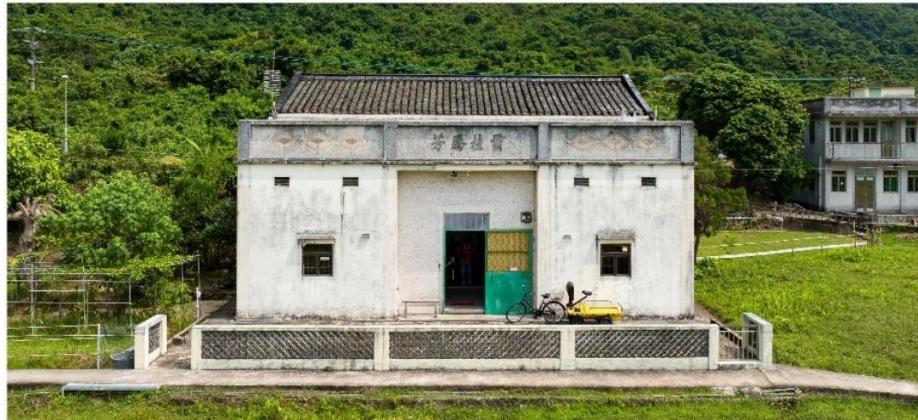
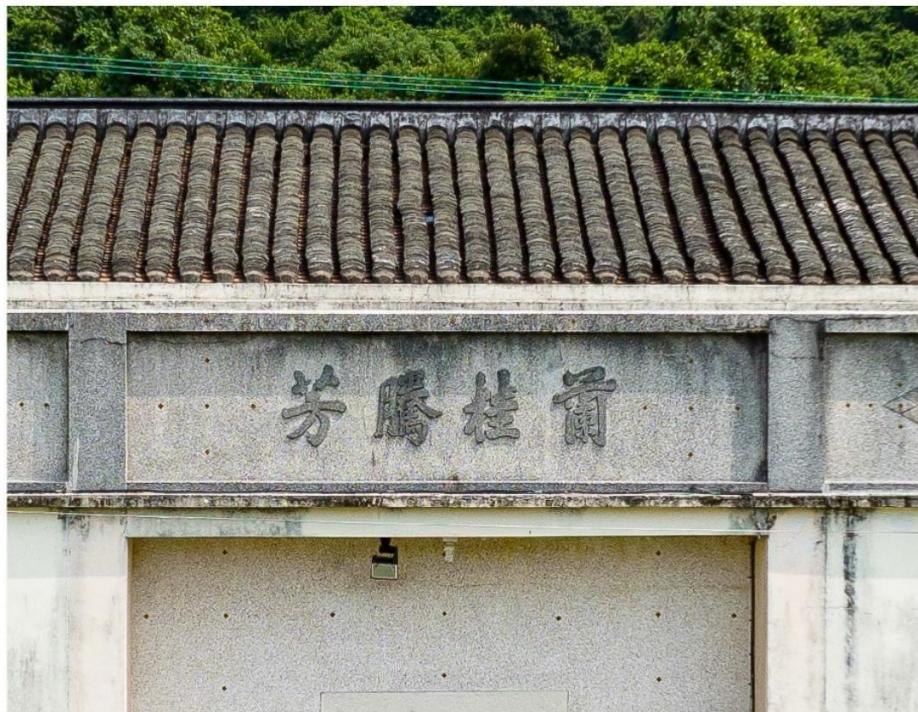
Fig. 6.1- *Lan Kwai Tang Fong* found in Tin Sum Ho's Mansion

Houses with the Chinese inscriptions "Lan Kwai Tang Fong" (蘭桂騰芳) (May orchid and osmanthus flourish and perfume) on the facades are found in Tin Sum, San Uk Ha and Sam To as a blessing to descendants of the families for prosperity and prestige³⁰.

The four-letter words “Lan Kwai Tang Fong” are likely to be carved out of stone from Chinese Mainland in the 20th century as there were no local stone carving factories, reflecting the economic status of the household. The ones found in the mansions in Tin Sum, San Uk Ha and Yi To are constructed on the middle part of the parapet wall (fig. 6.1-6.3), while the one found in Sam To is engraved and painted on a whole piece of stone (fig. 6.4).
