From Valley to Plain II:

Architectural rehabilitation for integrated, co-creative eco-living experience in Tin Sum Village, Kuk Po

Architectural Study Report on Kuk Po Settlements

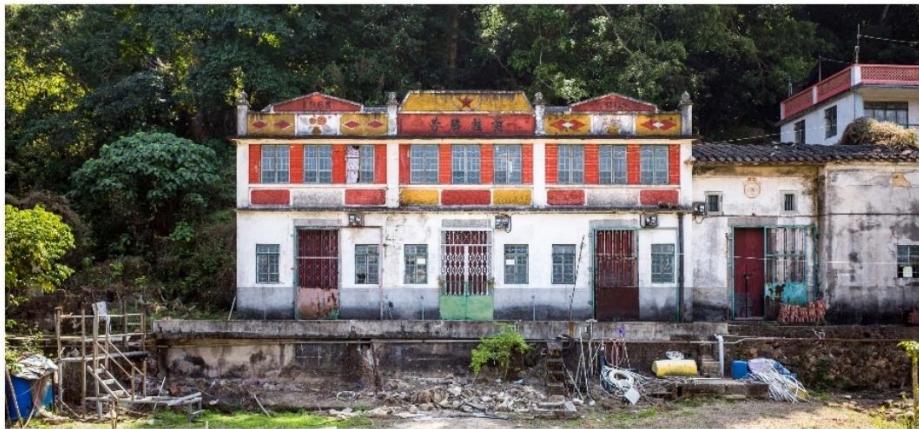
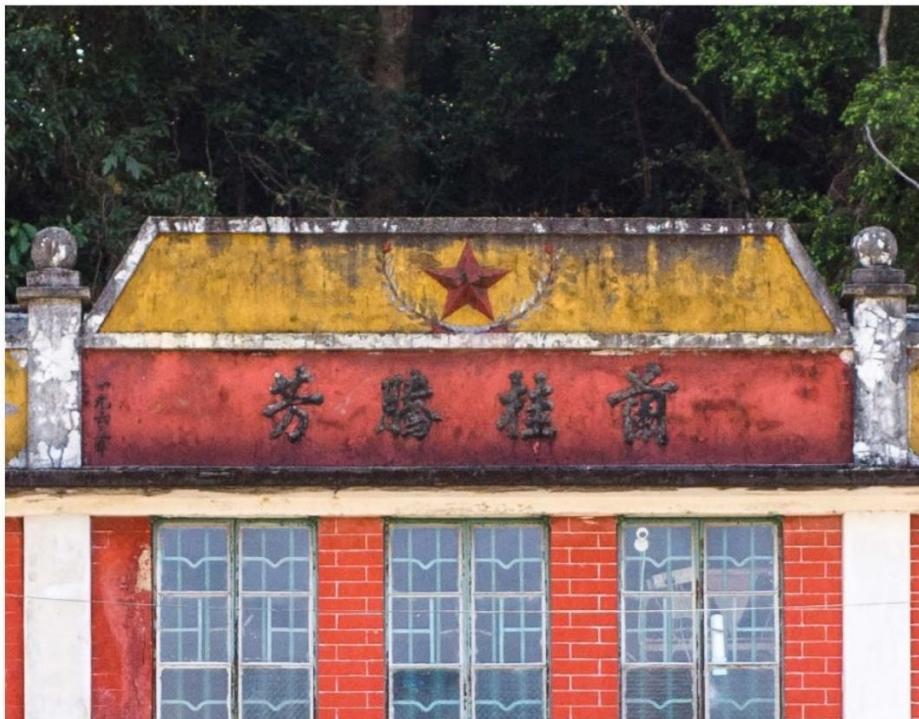
新屋下
San Uk Ha

Fig. 6.2- *Lan Kwai Tang Fong* found in San Uk Ha

The four-letter words “Lan Kwai Tang Fong” are likely to be carved out of stone from Chinese Mainland in the 20th century as there were no local stone carving factories, reflecting the economic status of the household. The ones found in the mansions in Tin Sum, San Uk Ha and Yi To are constructed on the middle part of the parapet wall (fig. 6.1-6.3), while the one found in Sam To is engraved and painted on a whole piece of stone (fig. 6.4).

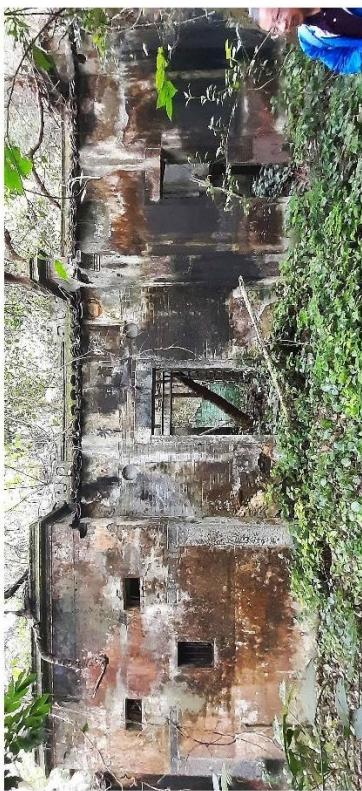
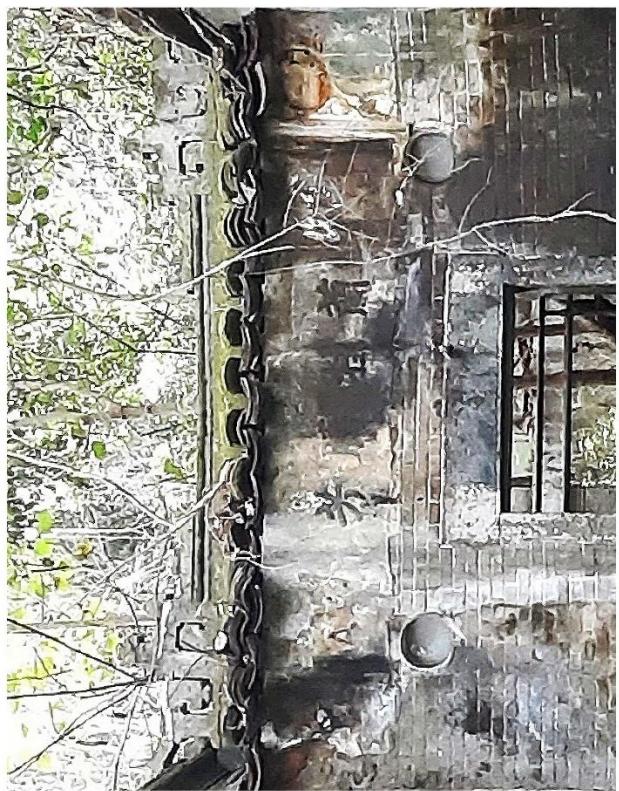
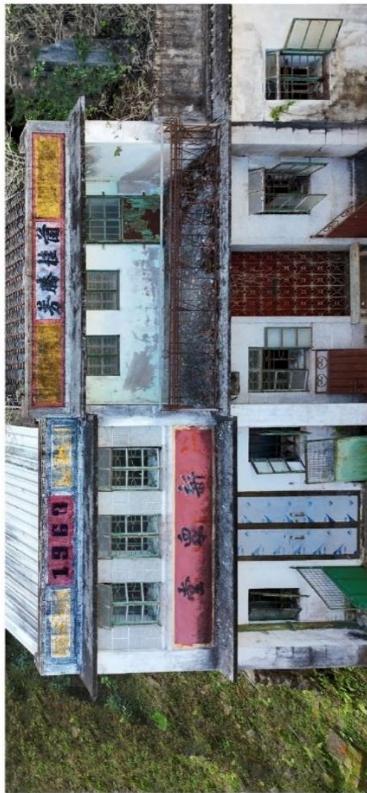
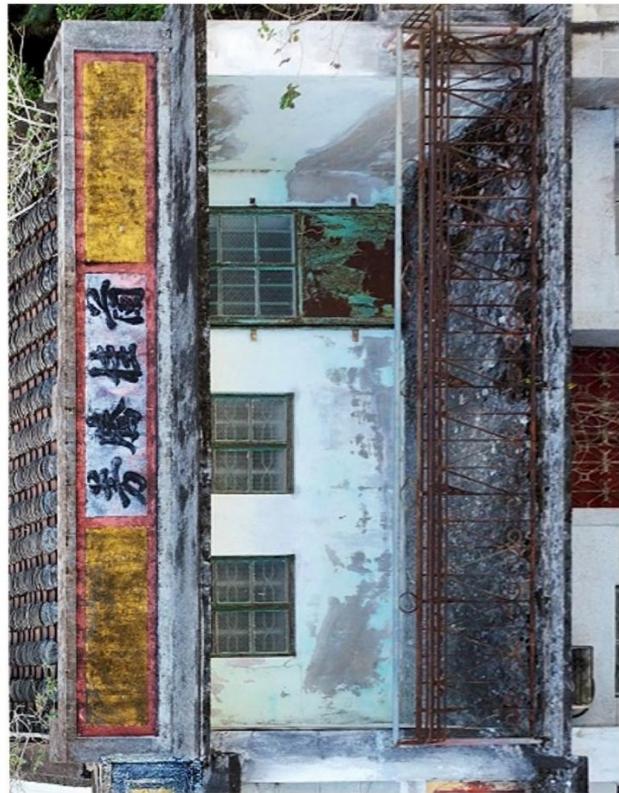
新屋下
San Uk Ha

Fig. 6.3- *Lan Kwai Tang Fong* found in San Uk Ha
