大埔郊野徑是連接沙羅洞和八仙嶺郊野公園的一段路徑，早前由於頻繁的使用和風化遭受了嚴重的侵蝕。為了改善情況並保護自然風貌，鄉郊辦試驗以手作步道手法及重用土木工程拓展署填料庫的廢石修復路徑。鄉郊辦期望以修復大埔郊野徑的經驗改善在沙羅洞中的步道。

The Tai Po Country Trail, a hiking trail connecting Sha Lo Tung and Pat Sin Leng Country Park, had suffered severe erosion due to frequent use and weathering. To improve the situation and protect the natural landscape, the Countryside Conservation Office carried out a experimented restoration to the trail with the use of handmade technique and waste rock from the Civil Engineering Department's Fill Bank.

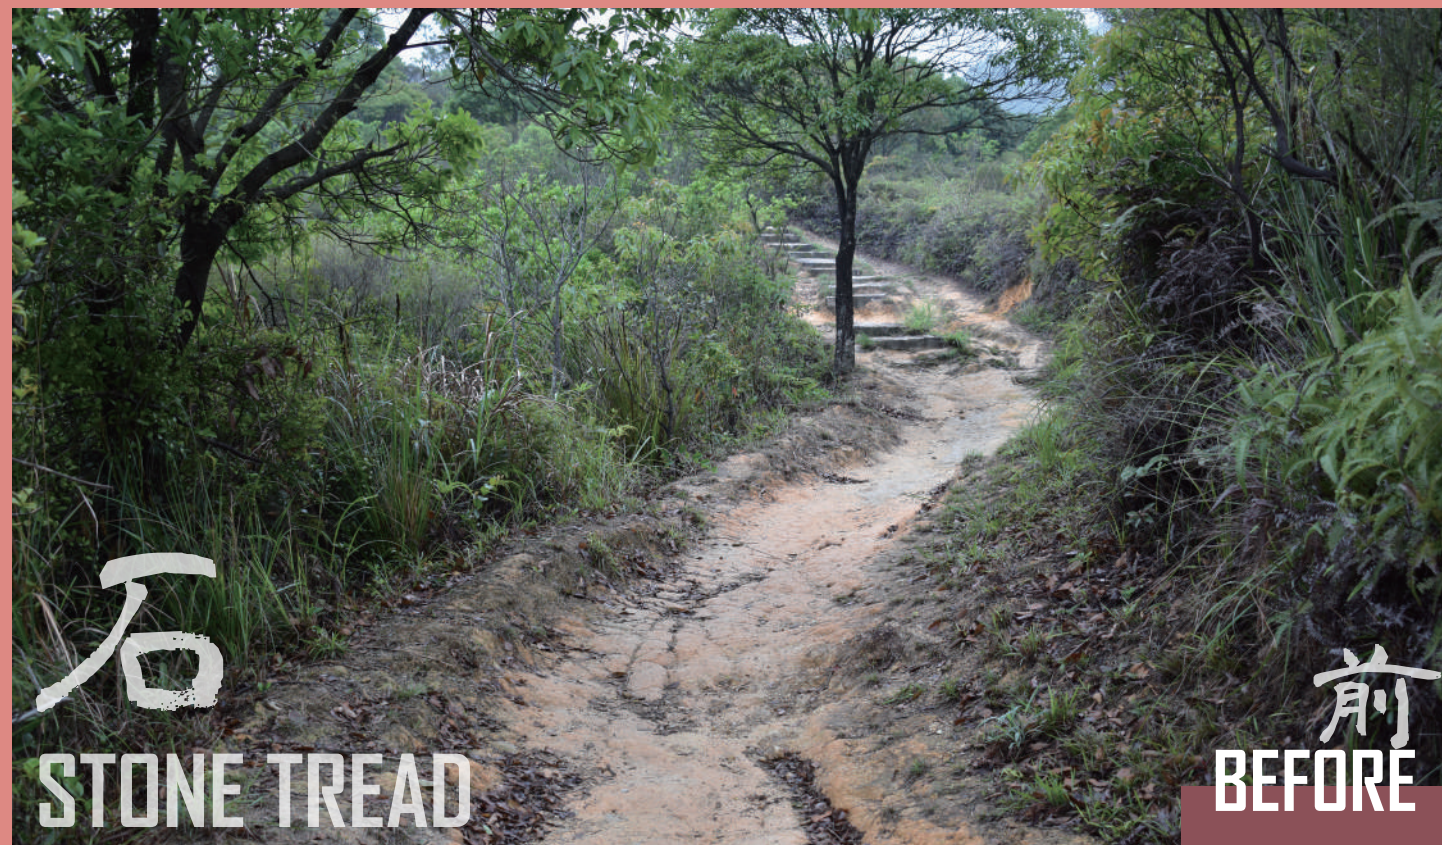
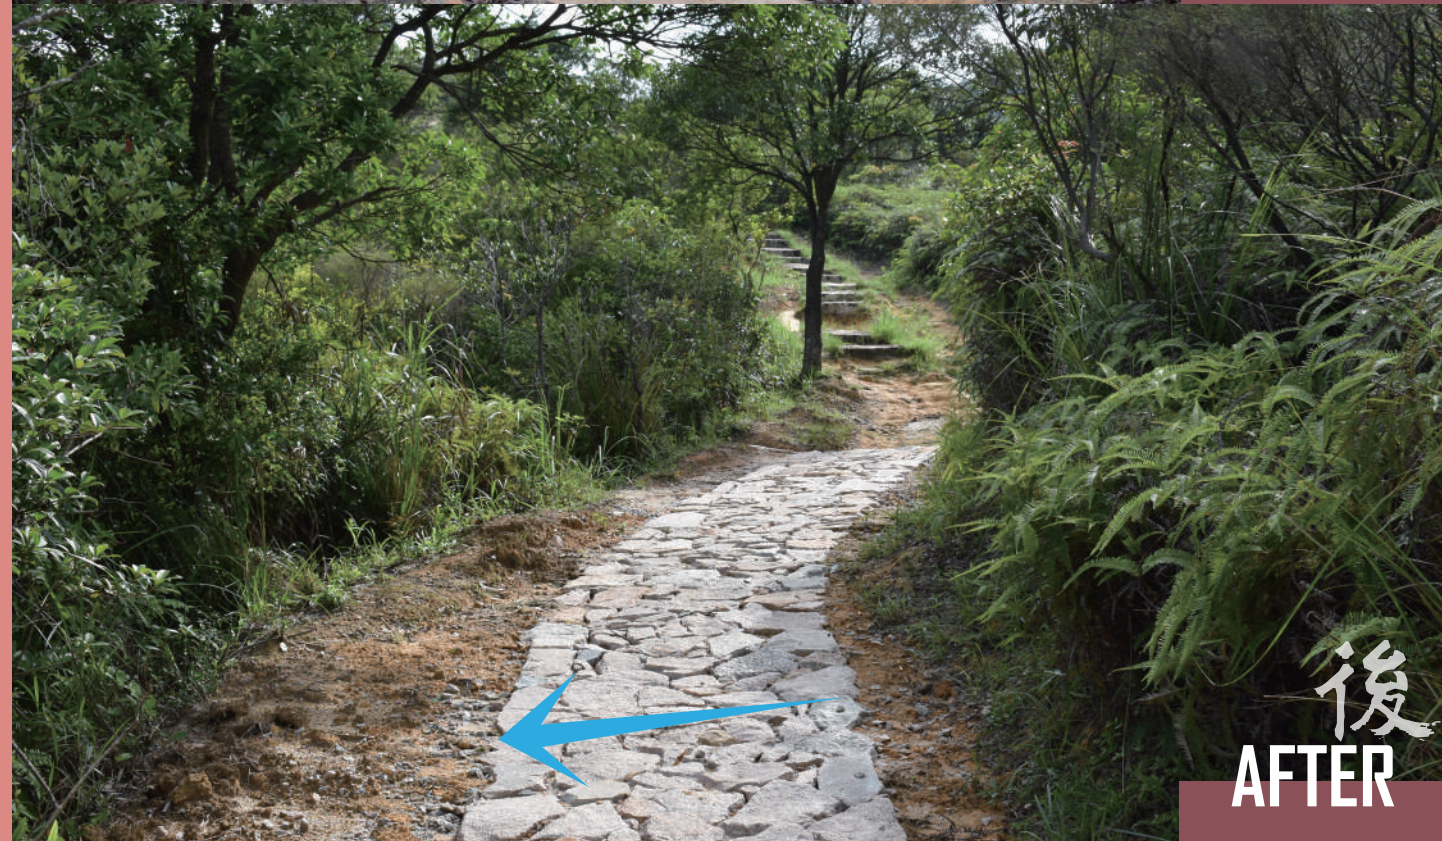
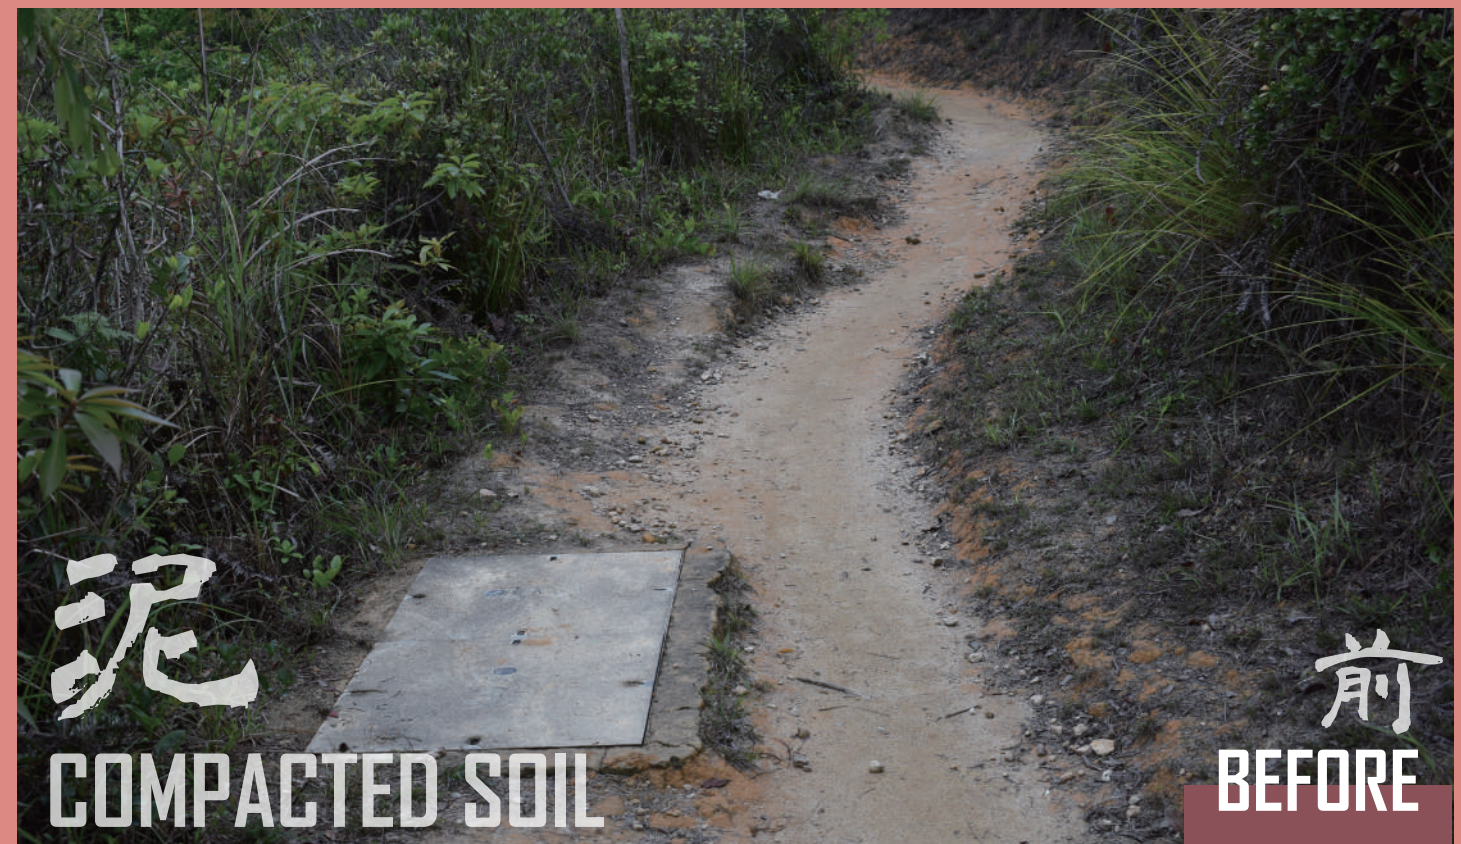
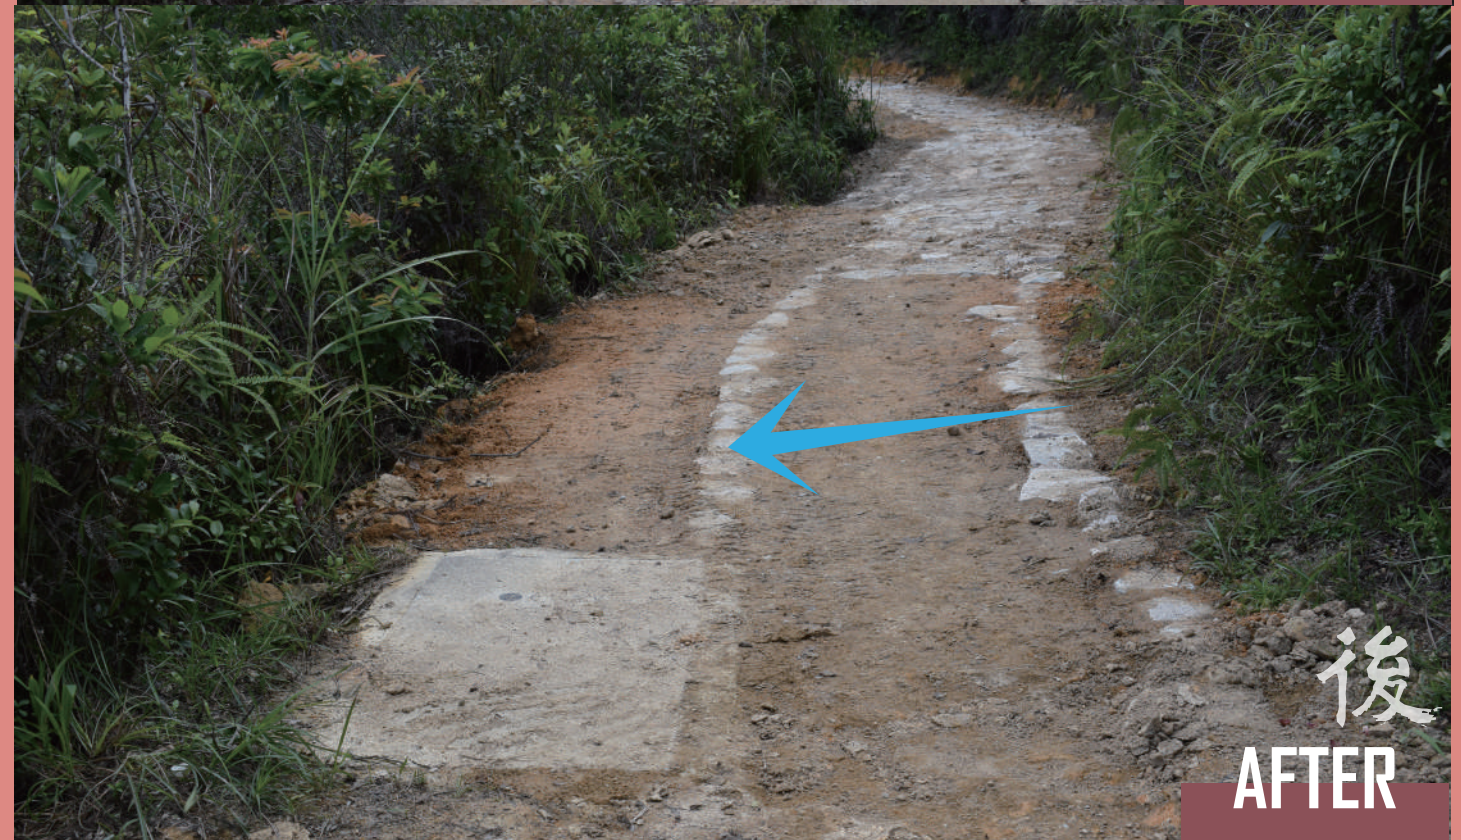
現場已經做了四種不同的修復。
Four different types of restoration have been carried on site.

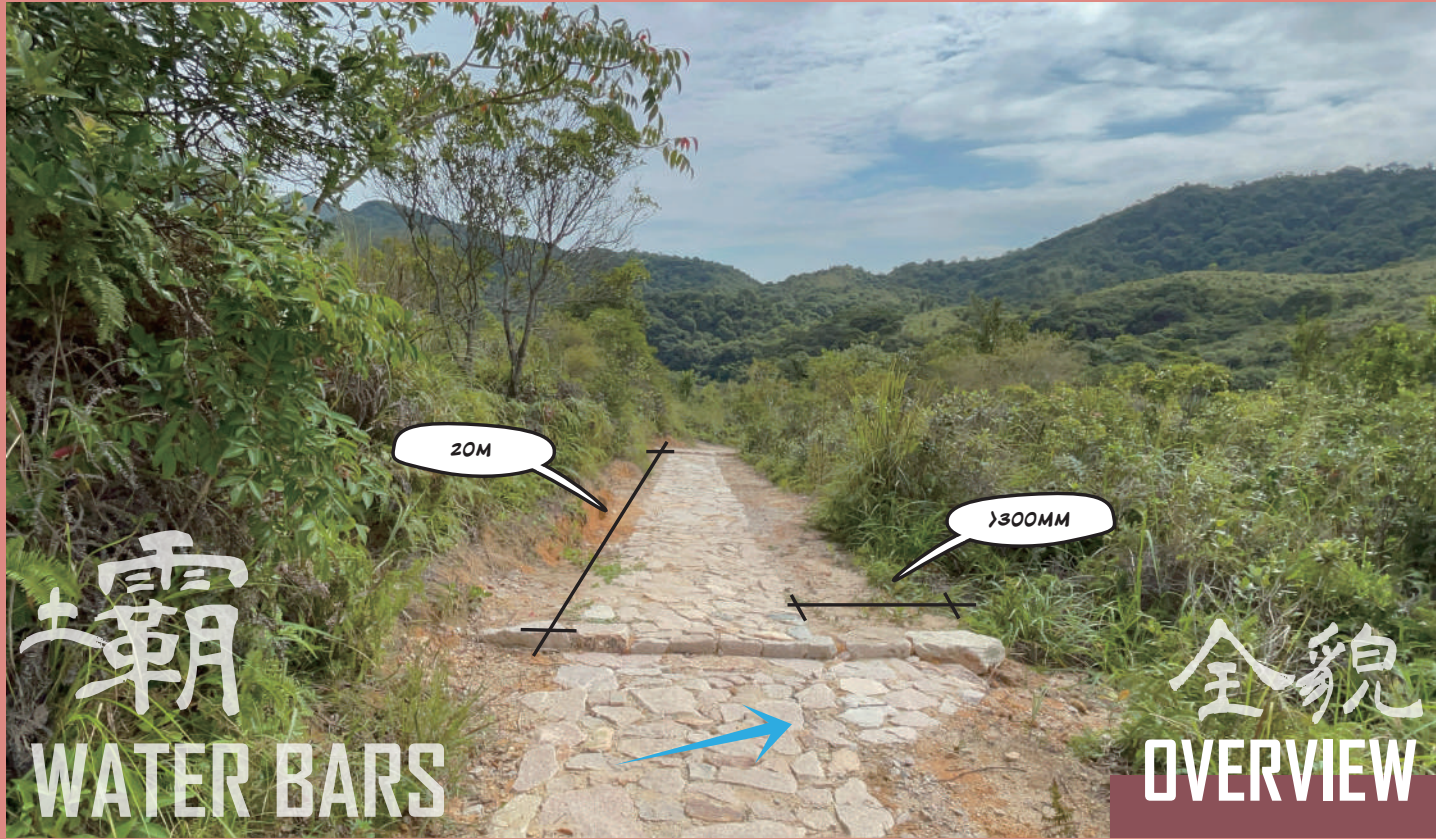
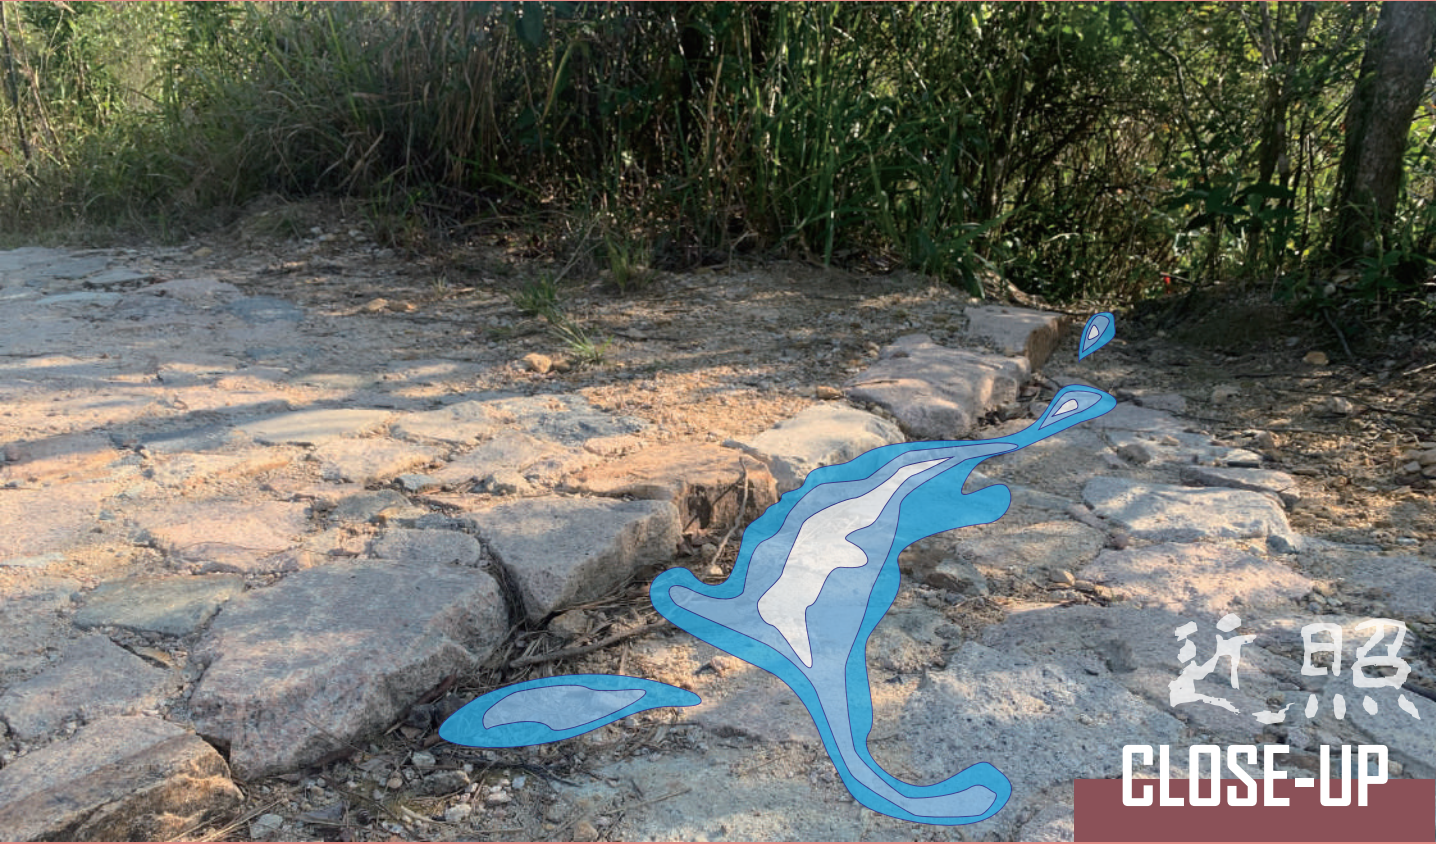
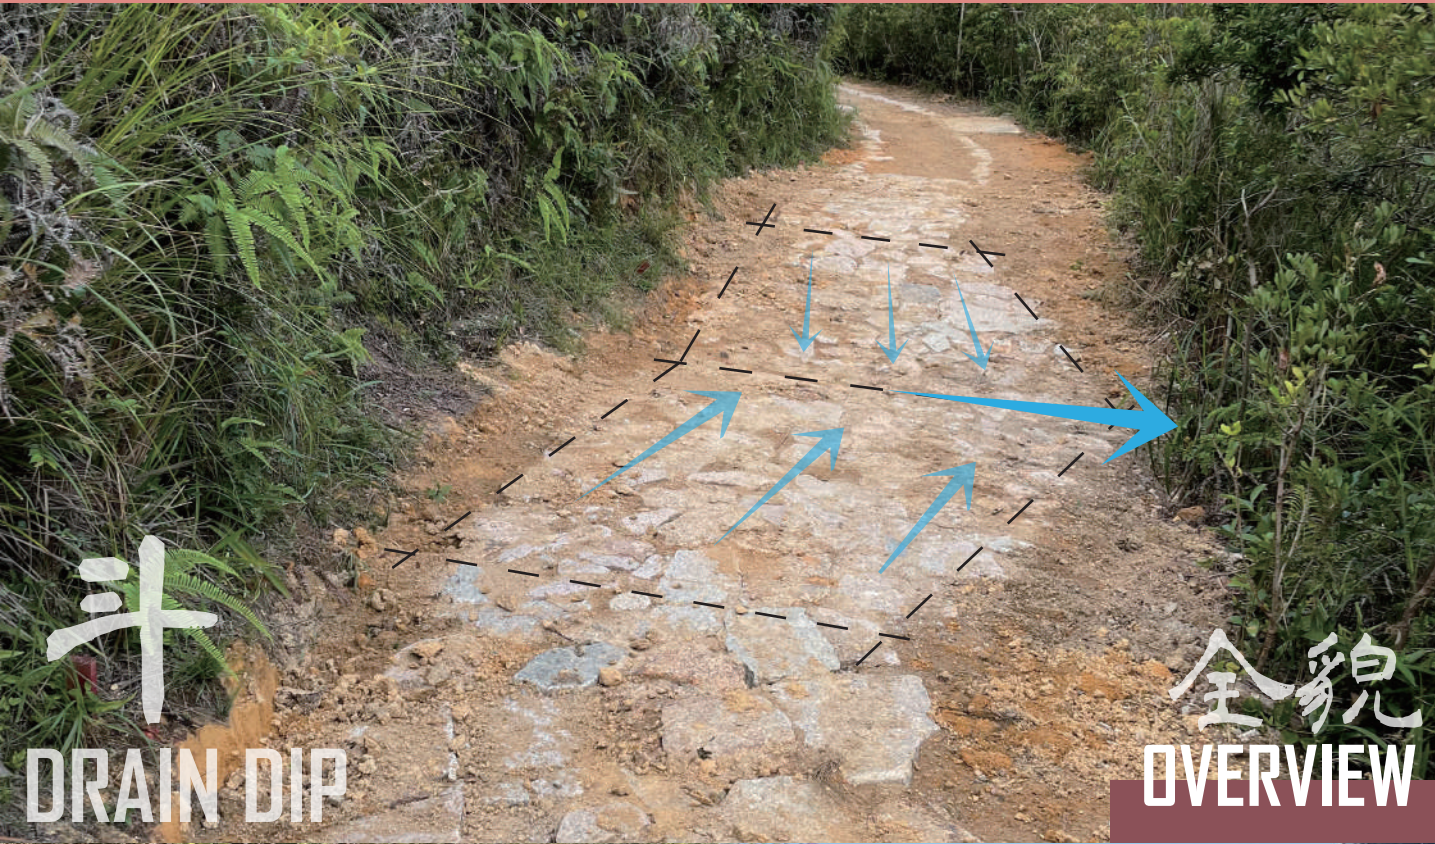
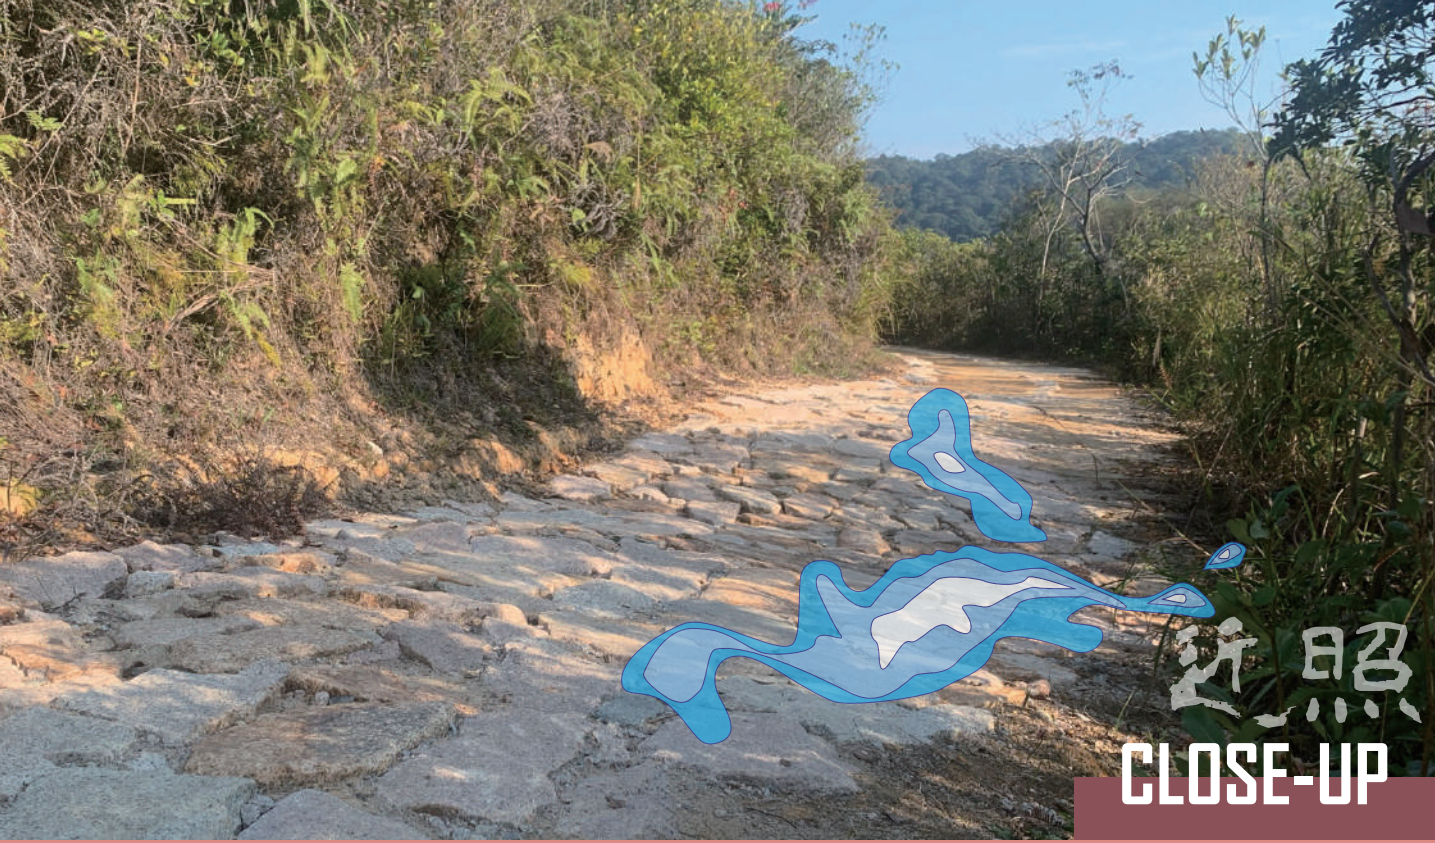
現場已經做了四種不同的修復。
Four different types of restoration have been carried on site.
