# **“SMART WETLAND” – WHERE TRADITIONAL MANAGEMENT MEETS INNOVATION & TECHNOLOGY**

## **Technical Report on Internet of Things (IoT) Application for Wetland Conservation in Mai Po Nature Reserve**

PREPARED BY WWF-HONG KONG

OCTOBER 2024

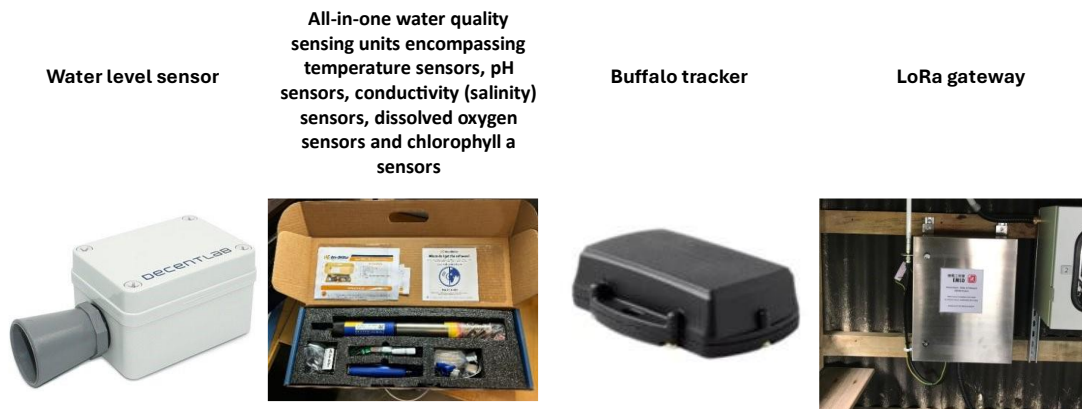
Figure 2. Hardware - water level sensor, water quality sensors, buffalo tracker and LoRa gateway

The IoT system architecture can be divided into hardware and software. The hardware components include tracking devices, ultrasonic level sensors, and all-in-one sensing units encompassing temperature sensors, pH sensors, conductivity (salinity) sensors, dissolved oxygen sensors and chlorophyll a sensors, 923 MHz LoRa gateway (Figure 2). Both solar panels and battery-powered mechanisms are involved in the system, subject to the type of applications. LoRa gateways are installed and maintained by the Electrical and Mechanical Services Department (EMSD) of Hong Kong.

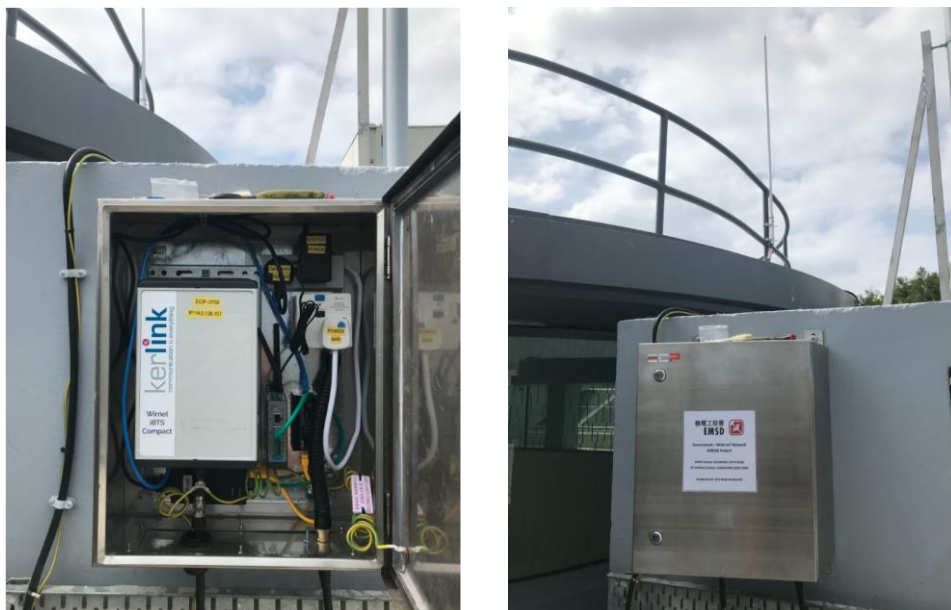
Figure 5. On-site deployment of LoRa gateway

With support from the Electrical and Mechanical Services Department (EMSD), four Government-Wide IoT Network (GWIN) LoRa gateways were installed in four sites within MPNR: Mai Po Marshes Wildlife Education Centre (EC), Southern Hide (as known as Floating Hide #1), Peter Scott Field Studies Centre (PSFSC) and at the top of the tower at post #27, which can provide high elevation points with minimum blockage (Figure 5). The sensors installed at MPNR are connected to gateways via the low-power and private LoRa network and eventually connected back to the GWIN backend via the 5G network. Besides the four installed ones, other GWIN gateways near MPNR can further secure data transmission.

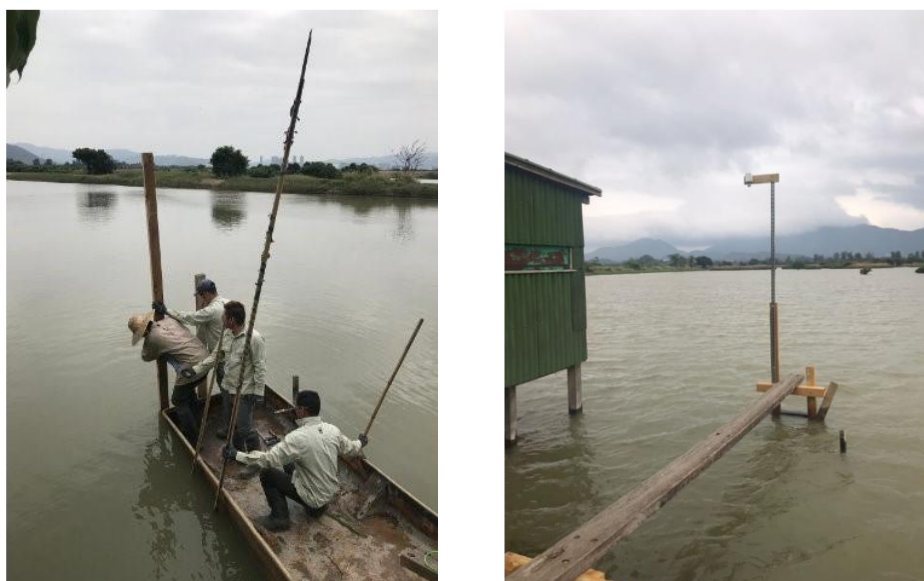
Figure 6. On-site deployment of water level sensor

The monitoring nodes of water level sensors sent packets constituting water level, battery voltage, Received Signal Strength Indicator (RSSI) and Signal-to-Noise Ratio (SNR). The specifications of water level sensors are summarised in Table 2. To seek a balance between the requirement of more frequent data retrieval from those water level-sensitive *gei wai*/ponds and the resources needed for sensor battery replacement, three different measurement intervals were set for the ultrasonic level sensors (Table 2). 30 water level sensors were deployed at various locations to cover all monitoring targets (i.e. *gei wai*, ponds and Deep Bay mudflat). Supporting infrastructure was also installed when needed. For instance, the extension of frames was installed so that the water level sensors could operate directly above the water (Figure 6).

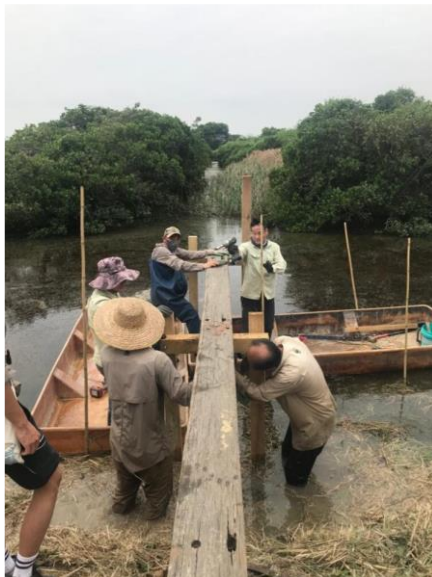
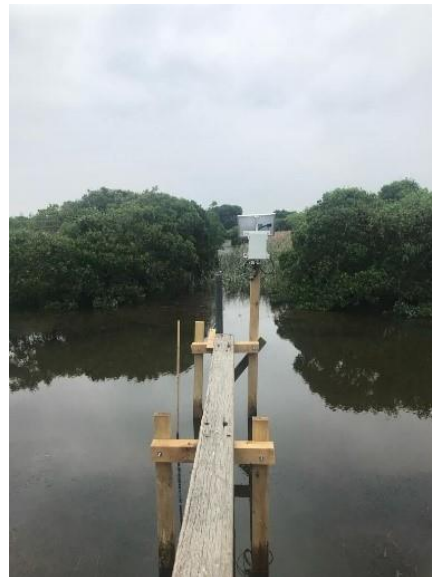
Figure 7. On-site deployment of water quality sensor

The monitoring nodes of water quality sensors sent packets containing temperature, pH, salinity, dissolved oxygen concentration, chlorophyll a, and battery voltage. RSSI and SNR were not included due to the limited space in the packets. The specifications of water quality sensors are summarised in Table 3. A measurement interval of 60 minutes was set for both sensors installed at GW #12 and the water channel near NH. Infrastructures were set to ensure that the sensors could submerge under water and that sufficient solar energy could be received (Figure 7).

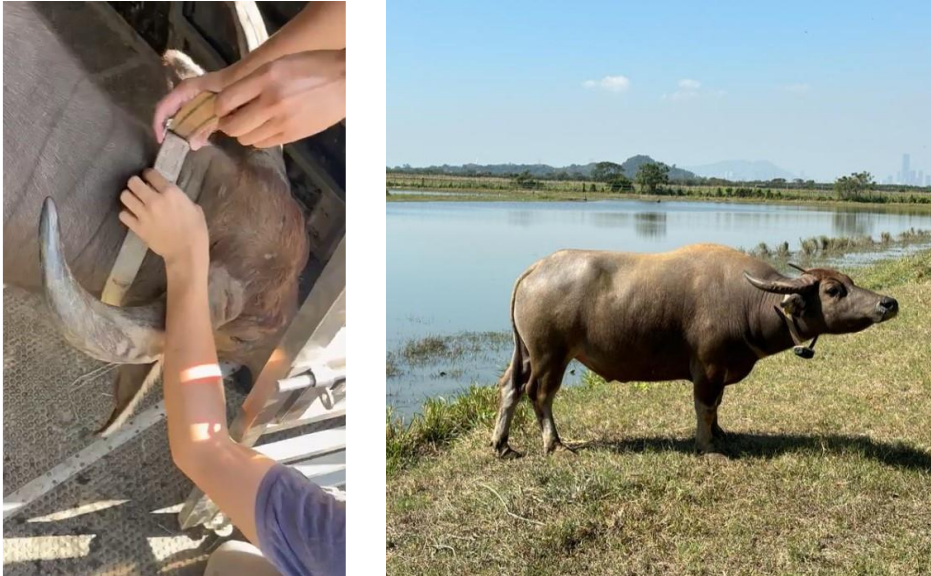
Figure 8. On-site deployment of buffalo tracker

The trackers' monitoring nodes sent packets constituting latitude, longitude, RSSI, SNR, and battery voltage. Details of the buffalo trackers can be found in Table 4. Both trackers were designed to be attached to the collar and deployed on buffalo at Pond #17b and Pond #24 (Figure 8), with a measurement interval of 20 minutes. In addition, geofencing was applied to pinpoint the buffalo's location within the enclosures.

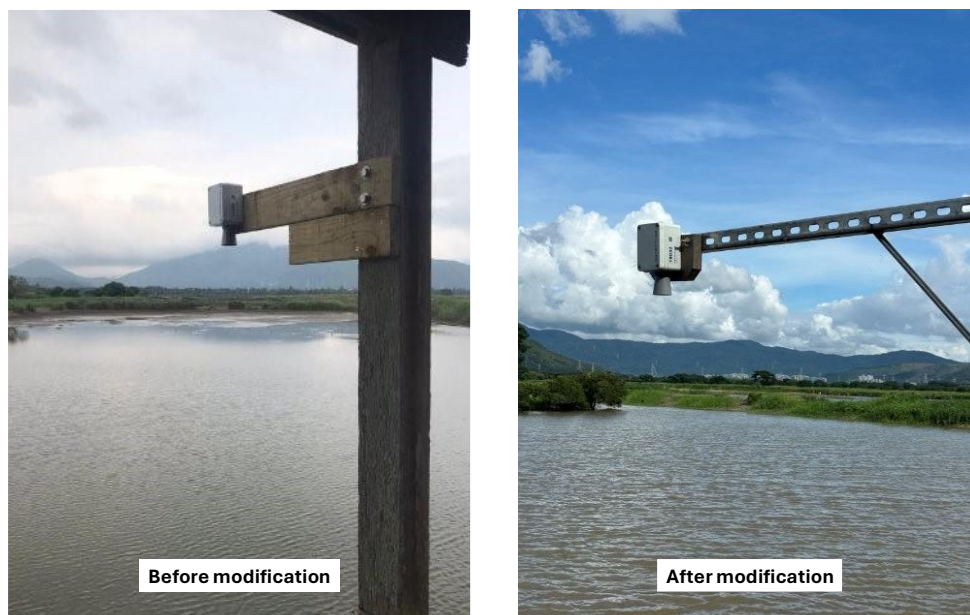
Figure 10. Water level sensor and its supporting infrastructure before and after replacing supporting materials

Initially, the water level sensor installation incorporated wood as the design material for the horizontal supports. However, after installing the first batch of sensors, we noted that wood is prone to thermal expansion and cold contraction, which can compromise measurement stability. Consequently, we replaced the wood with stainless steel for the horizontal supports (Figure 10).

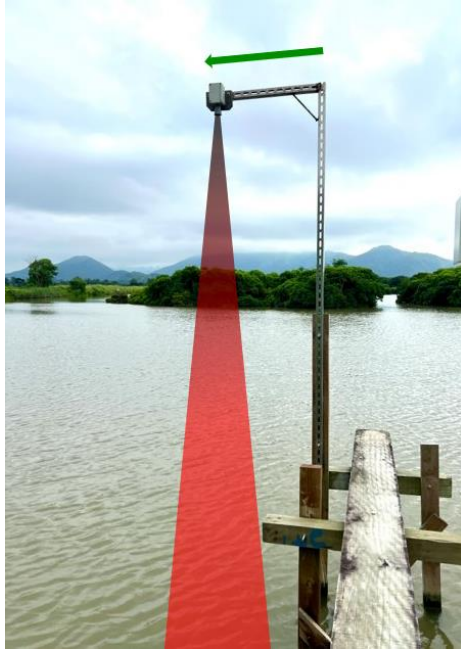
Figure 11. Extension of horizontal support

In the original design, the length of the horizontal supports for many sensors was insufficient, leading to occasional inaccurate water level readings. Some measurements reflected obstacles along the sensor's projection path rather than the water surface. To tackle this issue, we extended some horizontal supports, considering the umbrella-shaped signal projection from the sensors (Figure 11).

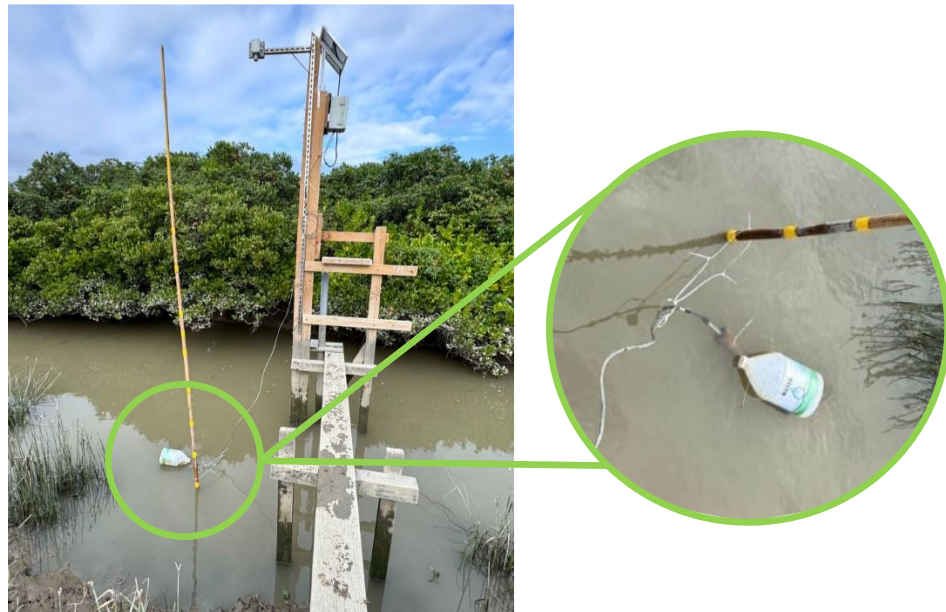
Figure 13. Design of buoyant set-up

We customised a buoyage solution to address the dual challenges of submerging the sensors while preventing contact with the muddy bottom. This design involves attaching a floatation to the sensors (Figure 13). The buoyage system allows the sensor to stay underwater for accurate readings while avoiding interference from bottom sediments. This approach enhances data reliability and protects the sensitive sensors from potential damage from being exposed.

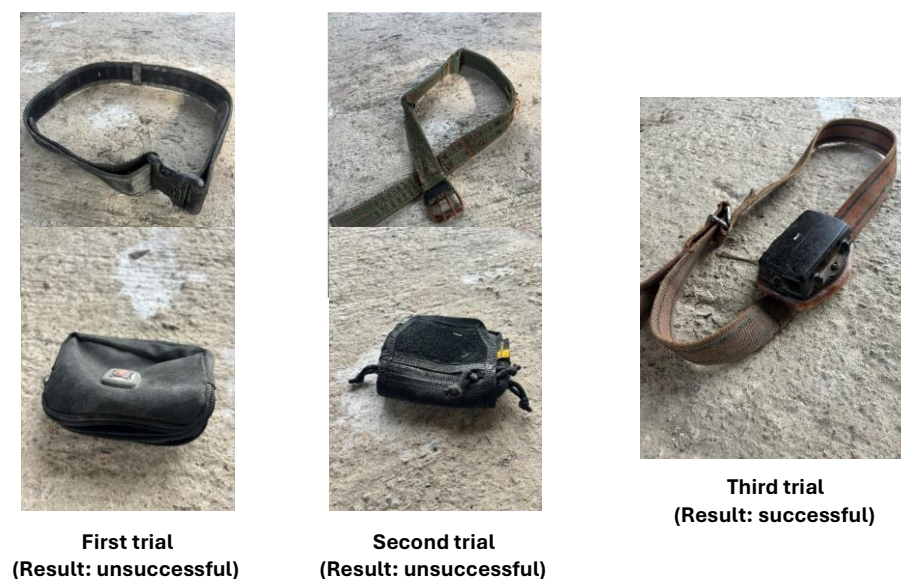
Figure 15. Trials of collar and tracker housing method

During the initial phase of deploying the buffalo tracker, we faced significant challenges in attaching the device to the collar and securely fastening it to the buffalo. Several attachment methods did not succeed, and each attempt required close coordination and assistance from the AFCD cattle team. Ultimately, we developed a custom plastic platform that effectively secures the tracker to the buffalo (Figure 15).

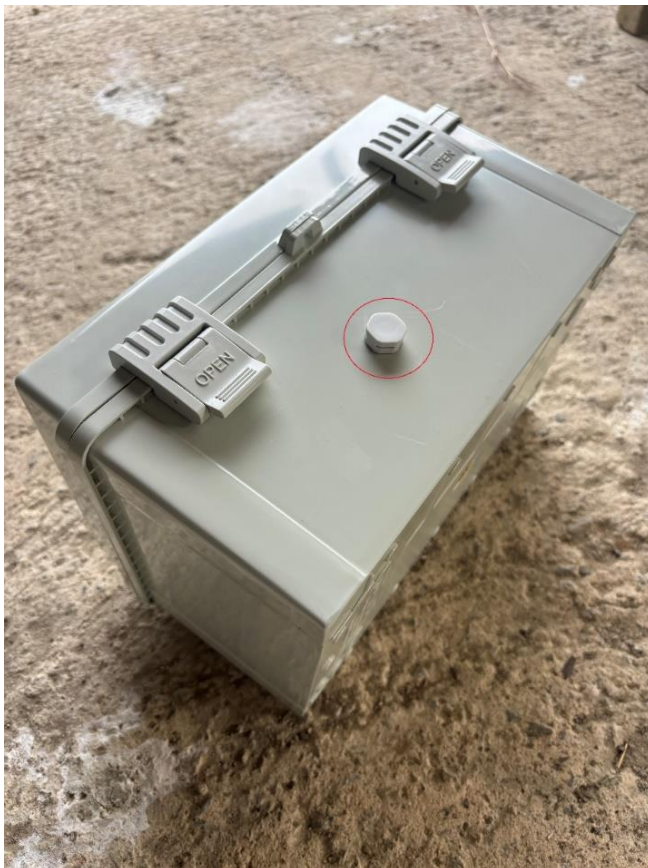
Figure 16. Waterproof box with exhaust hole

The waterproof box containing the equipment for the water quality sensor was discovered to be damaged a few months post-deployment. It is believed that high pressure inside the box during hot weather may have caused the failure. Modifications were implemented to the waterproof box where an exhaust hole was made to alleviate internal pressure (Figure 16).

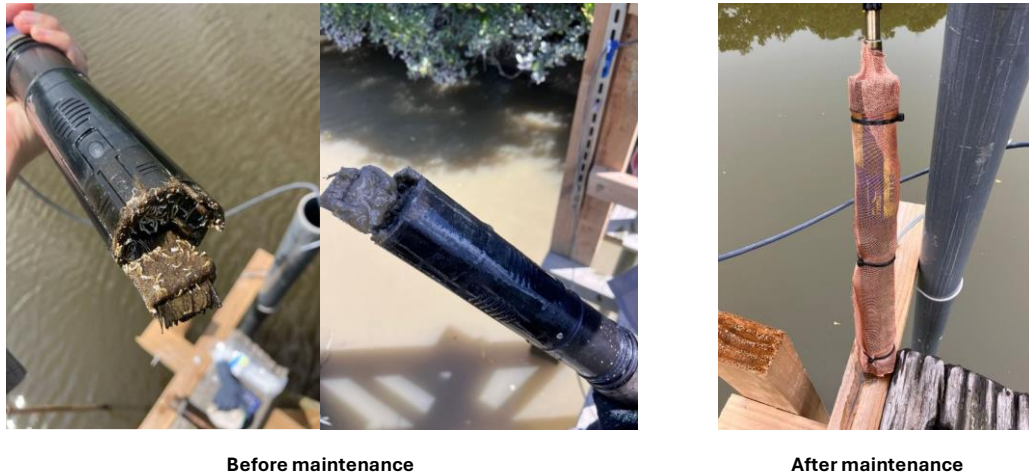
Figure 17. Water quality sensors before and after maintenance

Biofouling on the sensor can severely compromise measurement accuracy and even sensor conditions. To mitigate this issue, we encased the sensors in copper mesh. Copper's natural anti-fouling properties help deter the growth of organisms on the sensor surface (Figure 17).

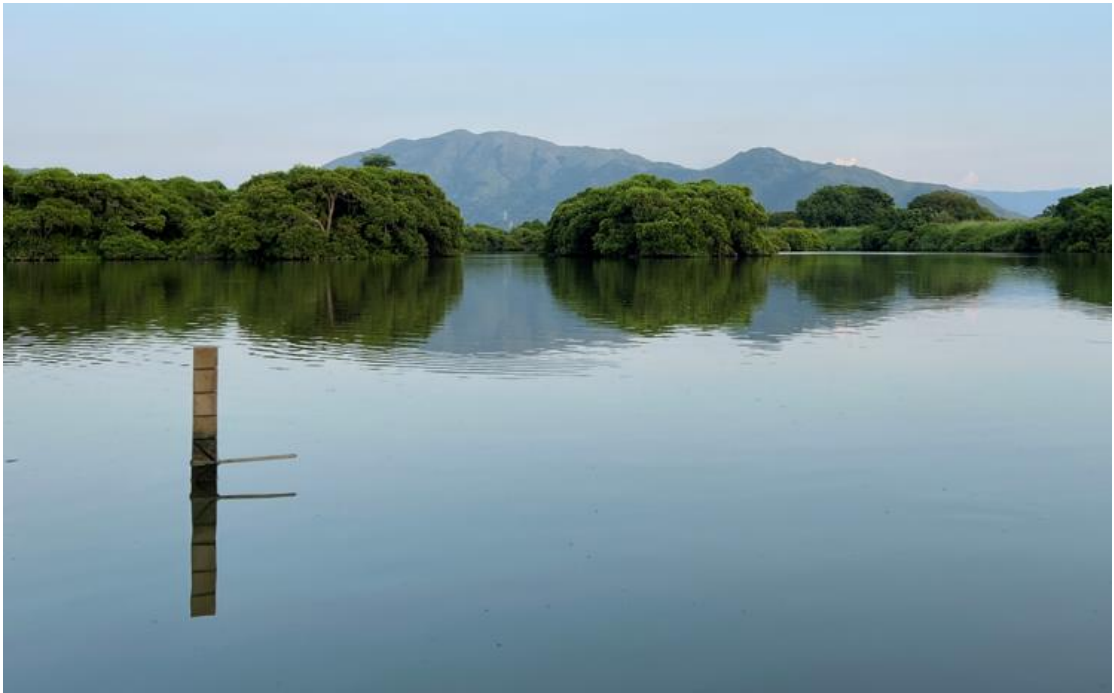
Figure 24. Wooden scale for manual observation

The digital visualisation of water level data via mobile devices facilitated field operation and elevated occupation safety, especially during night water exchange shifts, where the wooden scale that placed in the *gei wai* was difficult to observe under dim conditions.

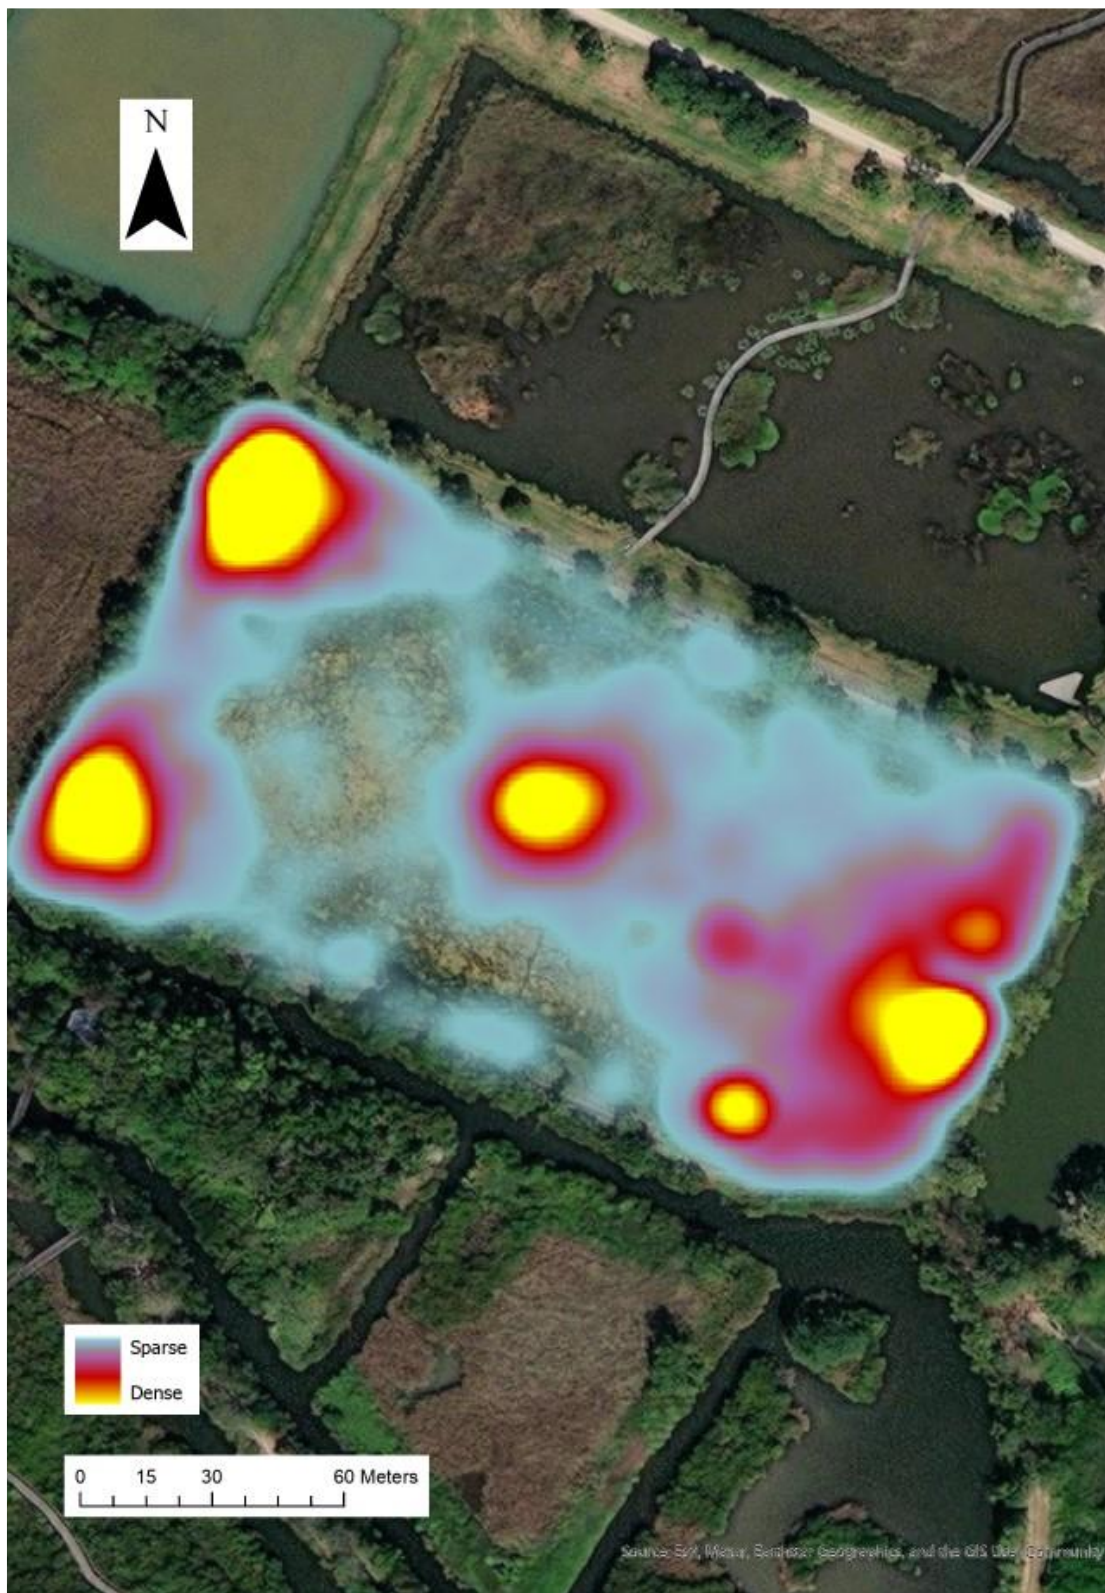
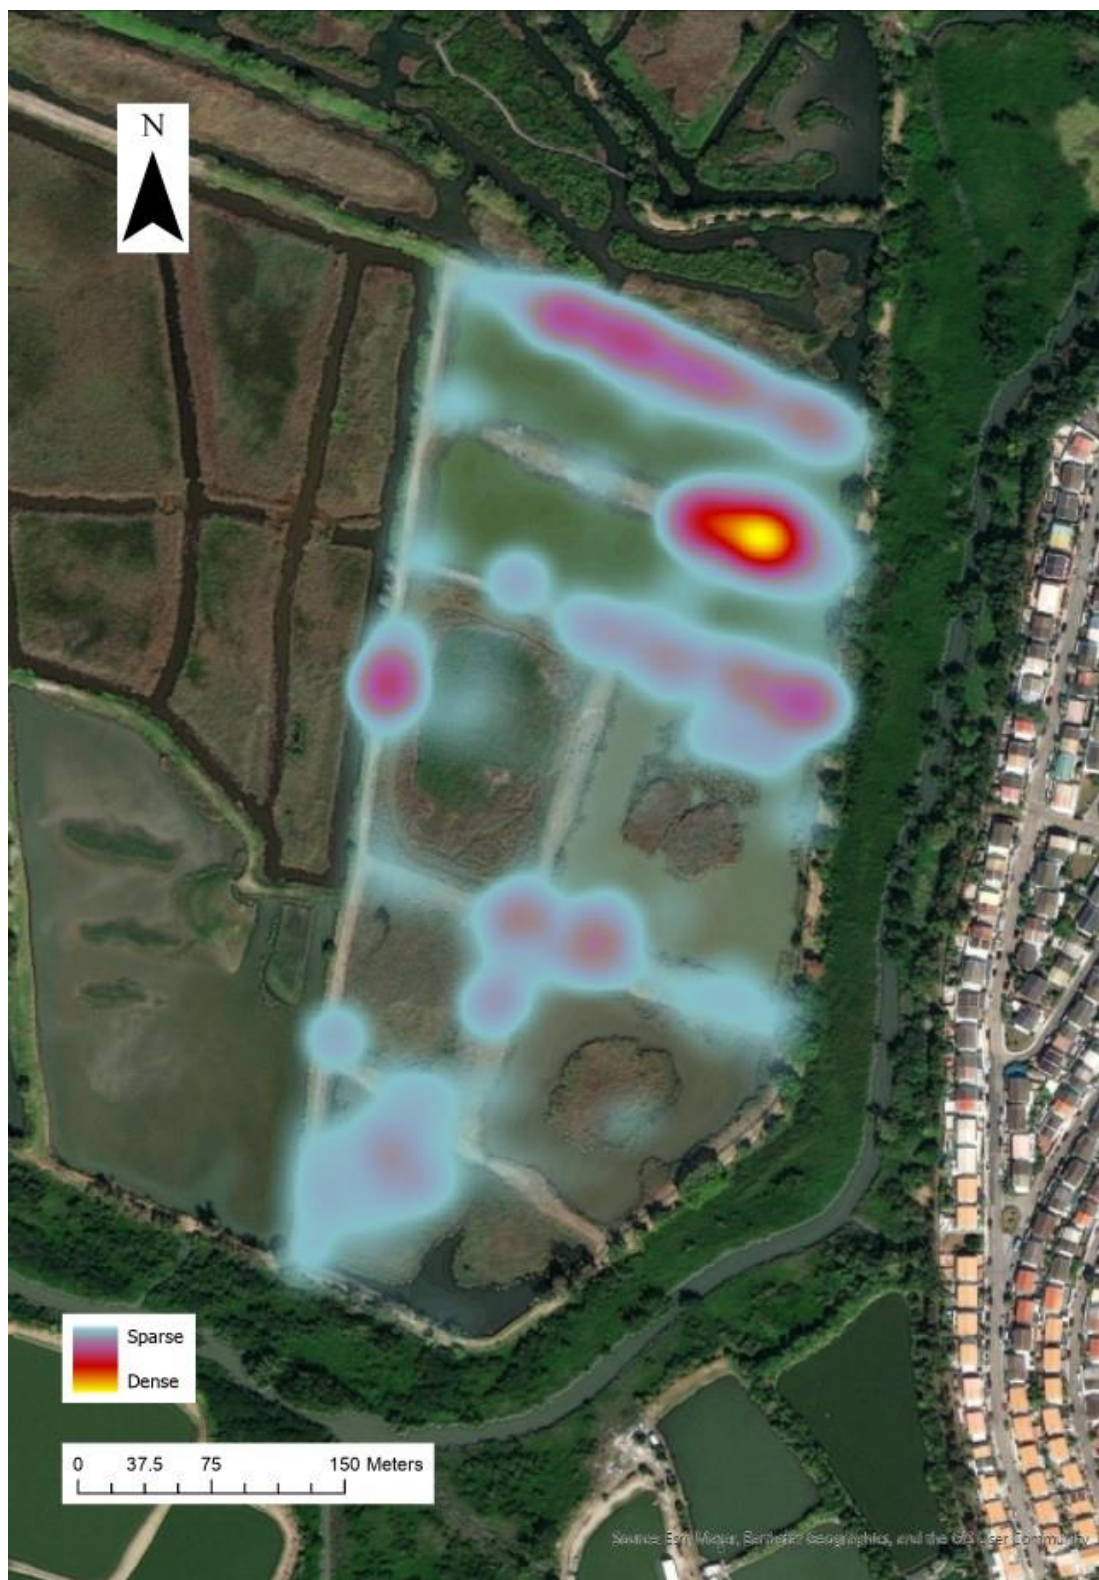
Figure 30. Heatmap of buffalo's location fixes at Pond #17b in daytime

Figure 31. Heatmap of buffalo's location fixes at Pond #17b at night

Figure 32. Heatmap of buffalo's location fixes at Pond #24 in daytime

Figure 33. Heatmap of buffalo's location fixes at Pond #24 at night

The trackers captured 24-hour buffalo's location so that day-night differences in distribution could be assessed. For Pond #17b, area usage was implied by the similar diurnal and nocturnal presence in the middle and eastern areas. A higher preference for staying at the edge of the enclosure at night was also noted (Figure 30 and Figure 31). For Pond #24, there was a considerable difference in day and nocturnal area usage (Figure 32 and Figure 33). The herd prefer staying in the centre part of Pond #24 (i.e. sub-Pond#24b-e) in daytime while staying along the bund between sub-Pond #24f and sub-Pond #24g at night. By analyzing the correlation between GPS data and vegetation height across various sub-bunds within Pond #24, we found that areas with higher buffalo activity were associated with lower vegetation heights (Figure 22). This suggests that the presence and movement of buffaloes may have played a role in controlling vegetation. The grazing and trampling behaviors of the buffaloes likely influenced the vegetation structure of the pond. Given that the buffalo area usage covered most of the land within the enclosure and that the vegetation was maintained at an acceptable height (equal or less than 20 cm), we concluded that no additional habitat management efforts were necessary during the study period.
