Method of Condition Survey

Project	Restoration Works of Lee Mansion at DD54 Lots 258, 262, 263 and 393, Kuk Po, Sha
	Tau Kok, N.T.
Location	Lee Mansion at DD54 Lots 258, 262, 263 and 393, Kuk Po, Sha Tau Kok, N.T.
Surveyed	All purlins (The area observed on the bottom is marked as P with purlin number. The

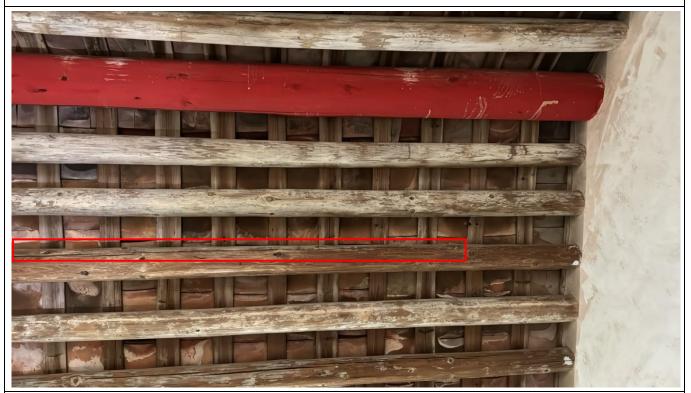
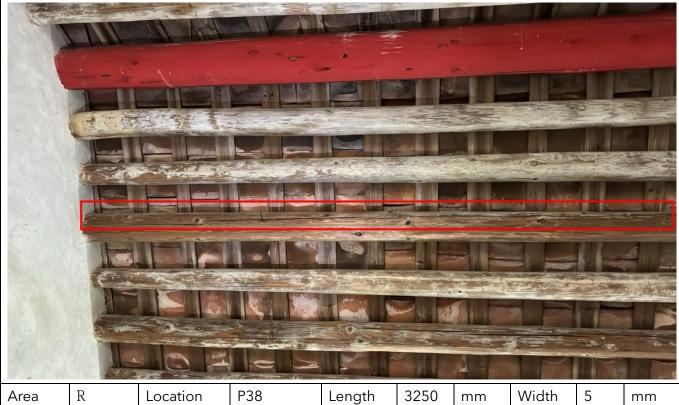
Photo of Defects Photo of Defects

Length

500

Width

<5

Pt25	3800			mm	Repair with wood adhesive
	P26	2000			mm	Replace with new purlin
	Pt26	3800			mm	Replace with new purlin
	P27	2000			mm	Repair with wood adhesive
	Pt29	2500			mm	Repair with wood adhesive
	P30	2750	_		mm	Repair with sawdust
	P31	1250	mm	<5	mm	Repair with wood adhesive

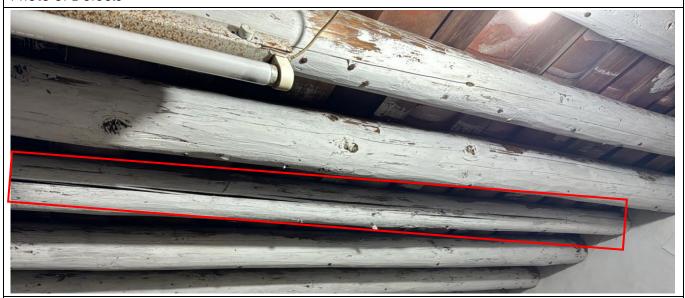
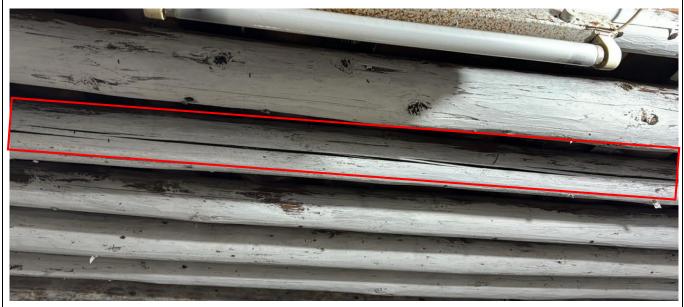
P20

Photo of Defects The state of the state of

Length

2750

Width

<5

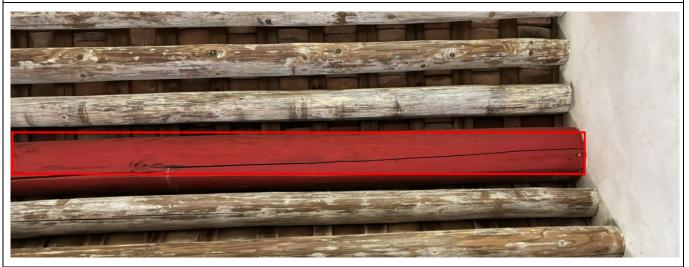
Area M Location P35 Length 3250 mm Width <5 mm

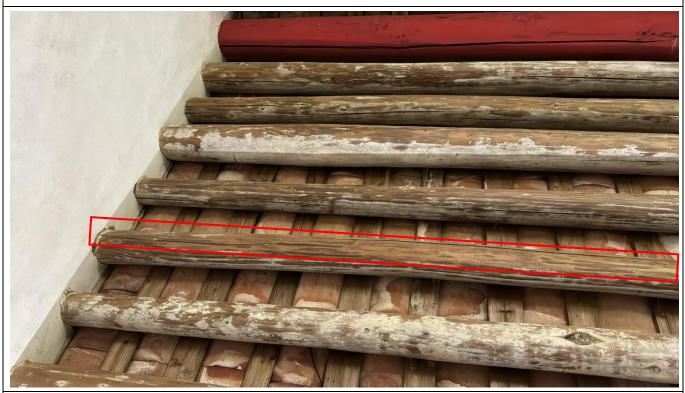
P39

1000

Width

<5

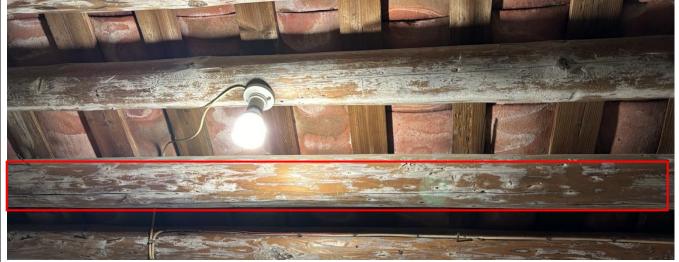
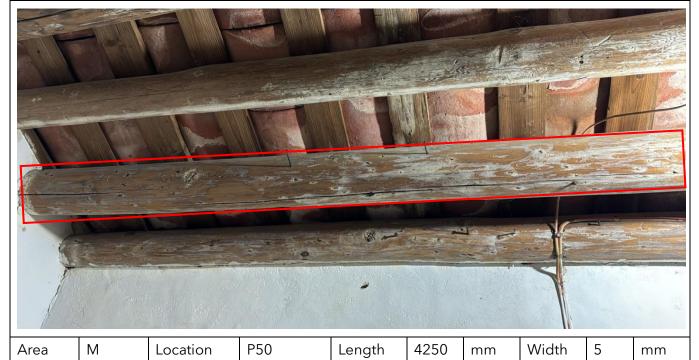
Purlins Photo of Defects P23-a Length 1000 Width Area Location mm <5 mm

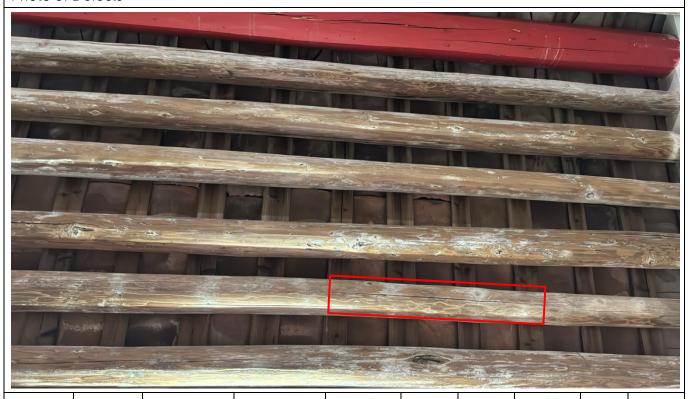
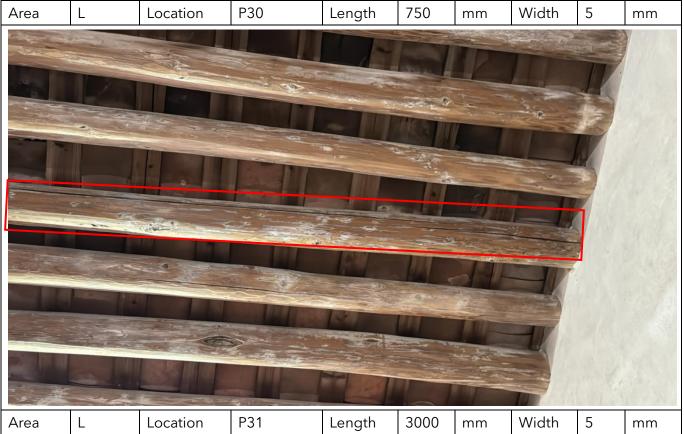
Length

750

Width

<5

P35-a	2250	mm	<5	mm	Repair with wood adhesive
	P35-b	1500	mm		mm	Repair with wood adhesive
	P38	3250	mm		mm	Repair with sawdust
	P39-a	1500	mm	<5	mm	Repair with wood adhesive
	P39-b	750	mm		mm	Repair with wood adhesive
	Pt39	750	mm	<5	mm	Repair with wood adhesive
	P40	3000	mm	<5	mm	Replace with new purlin
	Pt40	2250			mm	Replace with new purlin
	Pt41-a	1000		<5	mm	Repair with wood adhesive
	Pt41-b	1000	mm	<5	mm	Repair with wood adhesive
	Pt43	1000	mm		mm	Repair with wood adhesive
	P45	2000	mm		mm	Repair with wood adhesive
	P47	3750	mm		mm	Repair with sawdust
	Pt48	3000	mm		mm	Repair with wood adhesive
	Pt51	2000	mm		mm	Repair with wood adhesive
М	P18	3800	mm		mm	Replace with new purlin
	P20	2750	mm	<5	mm	Replace with new purlin
	Pt20	1500	mm	<5	mm	Replace with new purlin
	Pt21	3800	mm	<5	mm	Repair with wood adhesive
	Pt22	800	mm	<5	mm	Repair with wood adhesive
	P23-a	500	mm		mm	Repair with wood adhesive
	P23-b	1500	mm	<5	mm	Repair with wood adhesive

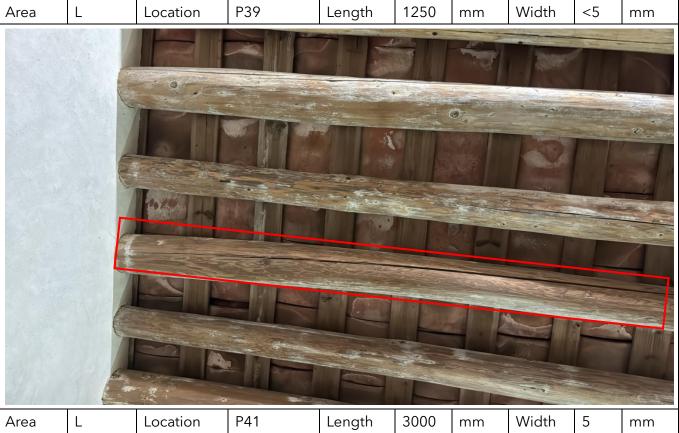
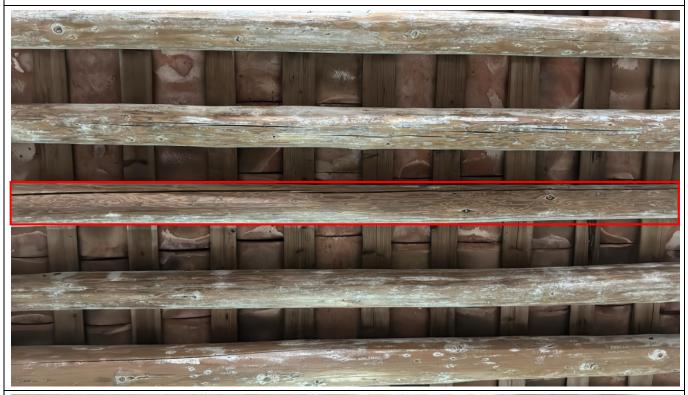
1500

Length

Location

Area

P46

Width

<5
